# Aviation Investigation Preliminary Report

<b>Location:</b>	Truckee, CA	<b>Accident Number:</b>	WPR24FA119
<b>Date &amp; Time:</b>	March 30, 2024, 18:37 Local	<b>Registration:</b>	N960LP
<b>Aircraft:</b>	Daher TBM700	<b>Injuries:</b>	2 Fatal
<b>Flight Conducted Under:</b>	Part 91: General aviation - Personal

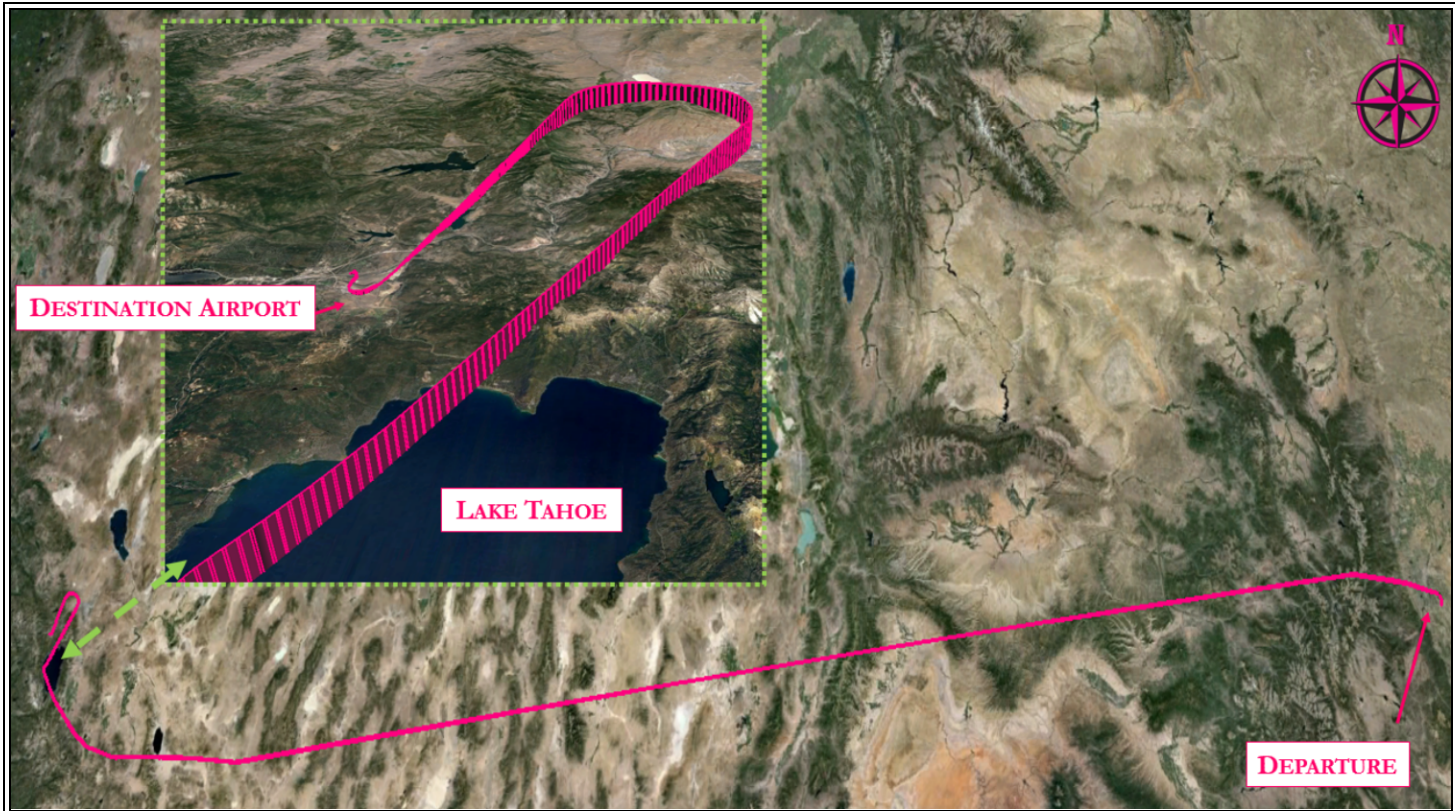
Figure 1: ADS-B Flight Track

The Federal Aviation Administration (FAA) provided automatic dependent surveillance-broadcast (ADS-B) information disclosed that the airplane departed from Centennial Airport in Denver, Colorado about 1525. Following departure, the airplane turned to a westerly heading and eventually climbed to a cruise altitude of about 30,000 feet mean sea level (msl). The airplane continued on that course until reaching about 120 nautical miles (nm) from the Truckee-Tahoe Airport (TRK), Truckee, California. The airplane then made a right turn to the north and gradual descent to about 15,000 ft as it passed over Lake Tahoe (see Figure 1 below). The track then turned to the northeast directed to the Initial Approach Fix (IAF), WUDPA, for the RNAV (GPS) RWY 20 instrument approach.

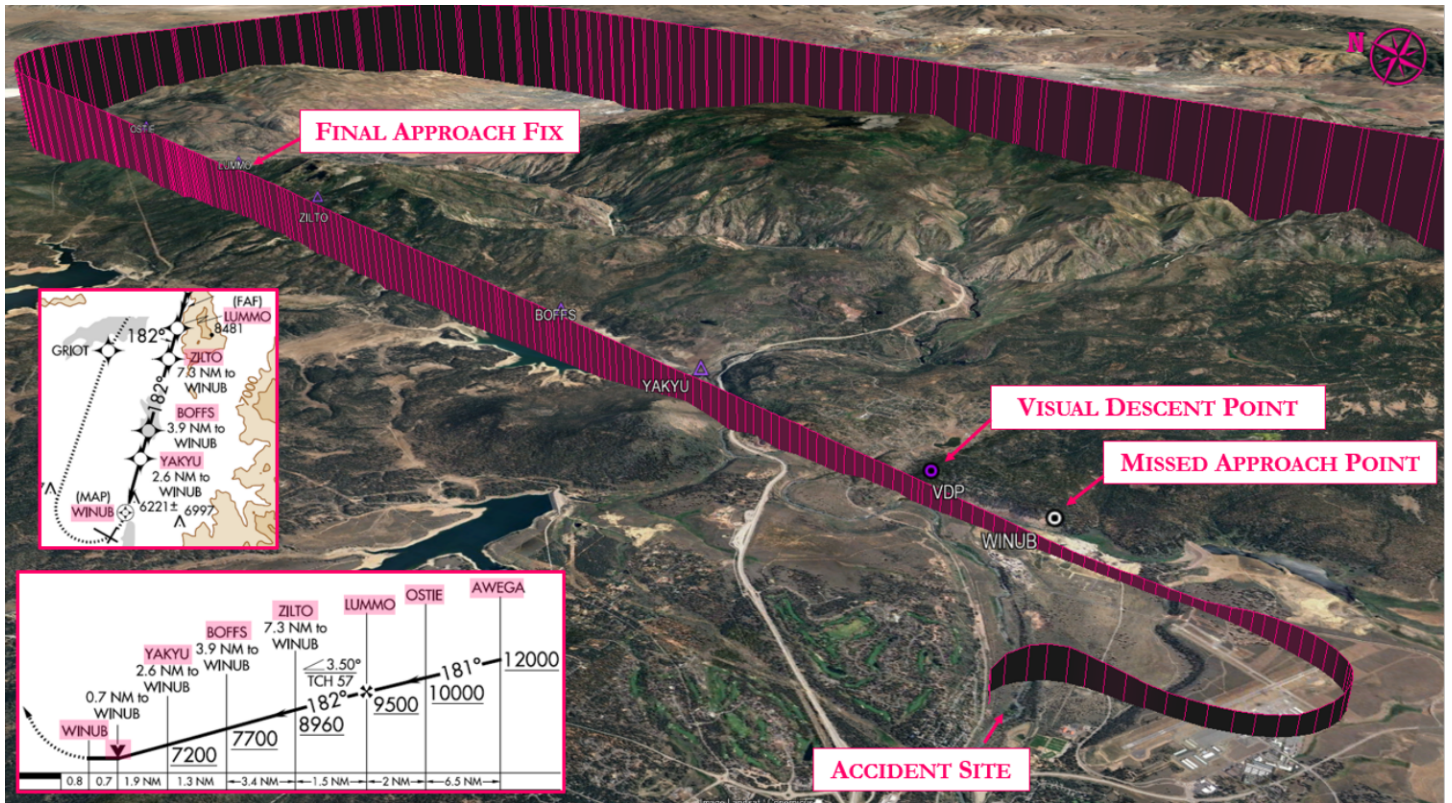
Figure 2: ADS-B Flight Track Referencing the Approach Procedure

The airplane passed over the Final Approach Fix (FAF), LUMO, at 1832:37 and the ADS-B data showed that immediately thereafter the Approach Mode (APP Mode) was turned on and the Altitude Hold (ALT Hold) was turned off. The airplane continued along the approach path and continued to descend. The flight track then passed over the Visual Descent Point (VDP) at 1835:43 at about 121 kts and an approximate altitude of 6,475 ft msl (see Figure 2 below). Approximately 20 seconds later, the track passed over the Missed Approach Point at an altitude of 6,200 ft msl and at 100 kts (total inertial speed) and continued between that altitude and 6,100 ft until abeam the runway identifier numbers (about 1,300 ft east).

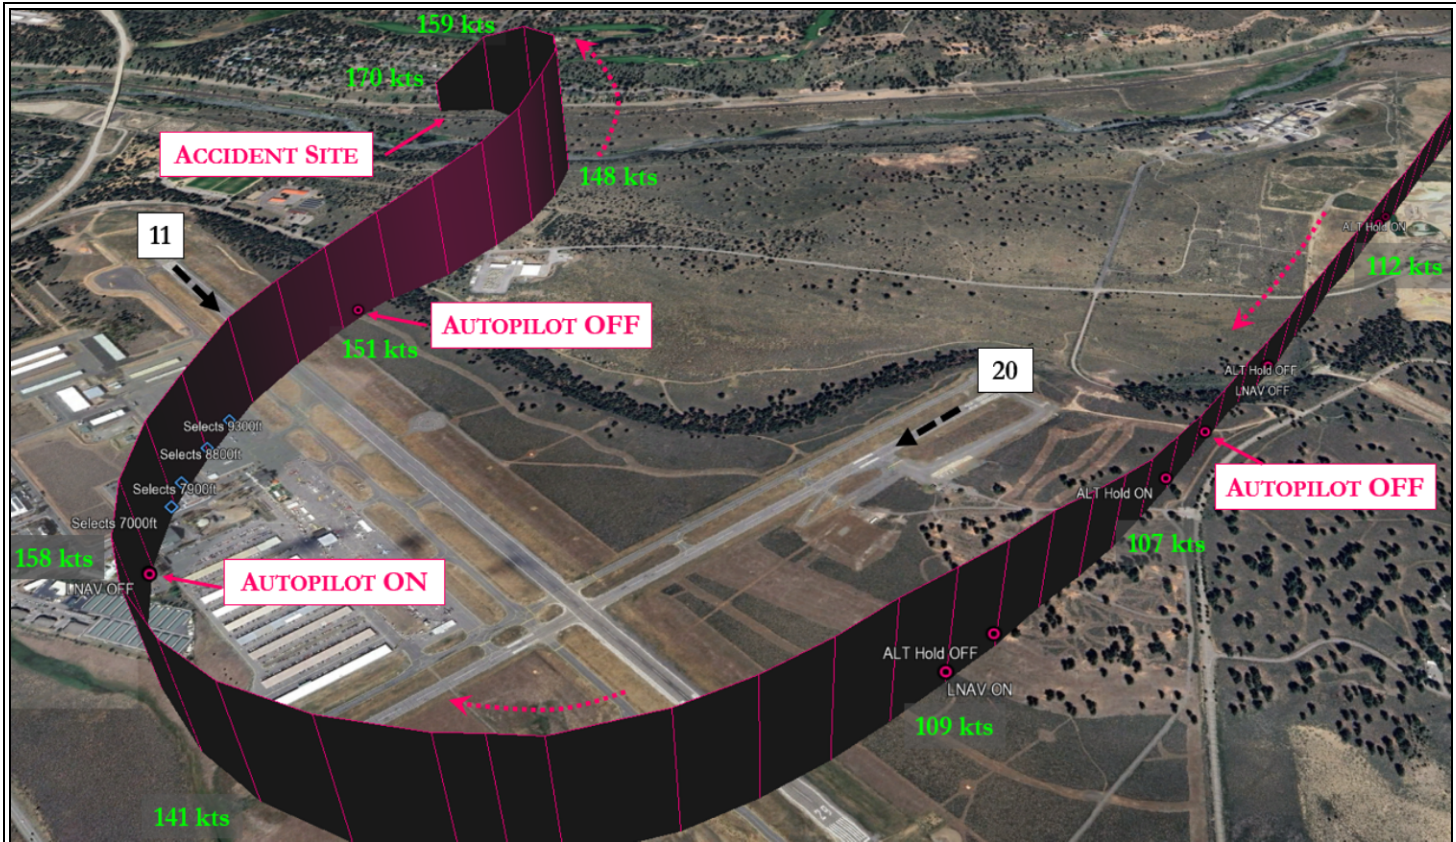
Figure 3: Flight Track Showing Speeds and Airplane Modes Selected

The Autopilot mode was turned off and the altitude increased as the airplane began a gradual 180° turn to the right. The airplane climbed to about 6,750 ft at the base of the turn. During the turn, the following selections were made ALT Hold on, ALT Hold off, Lateral Navigation Mode (LNAV) on, Autopilot on, LNAV off, a series of altitude selections (ending with 9,300 ft), and lastly, the Autopilot was turned off at 1837:20 as the airplane passed over runway 11 (see Figure 3 below).

The airplane then momentarily climbed to about 6,850 ft (about 1,075 ft above ground level) while making a left turn. The turn tightened and the last three ADS-B returns, which showed a rapid decrease in altitude and an increase in speed. The last ADS-B return was at 1837:40 and indicated the airplane was at an altitude of about 280 ft above the ground and a speed of 170 kts; the return was about 200 ft northeast of the first identified impact point.

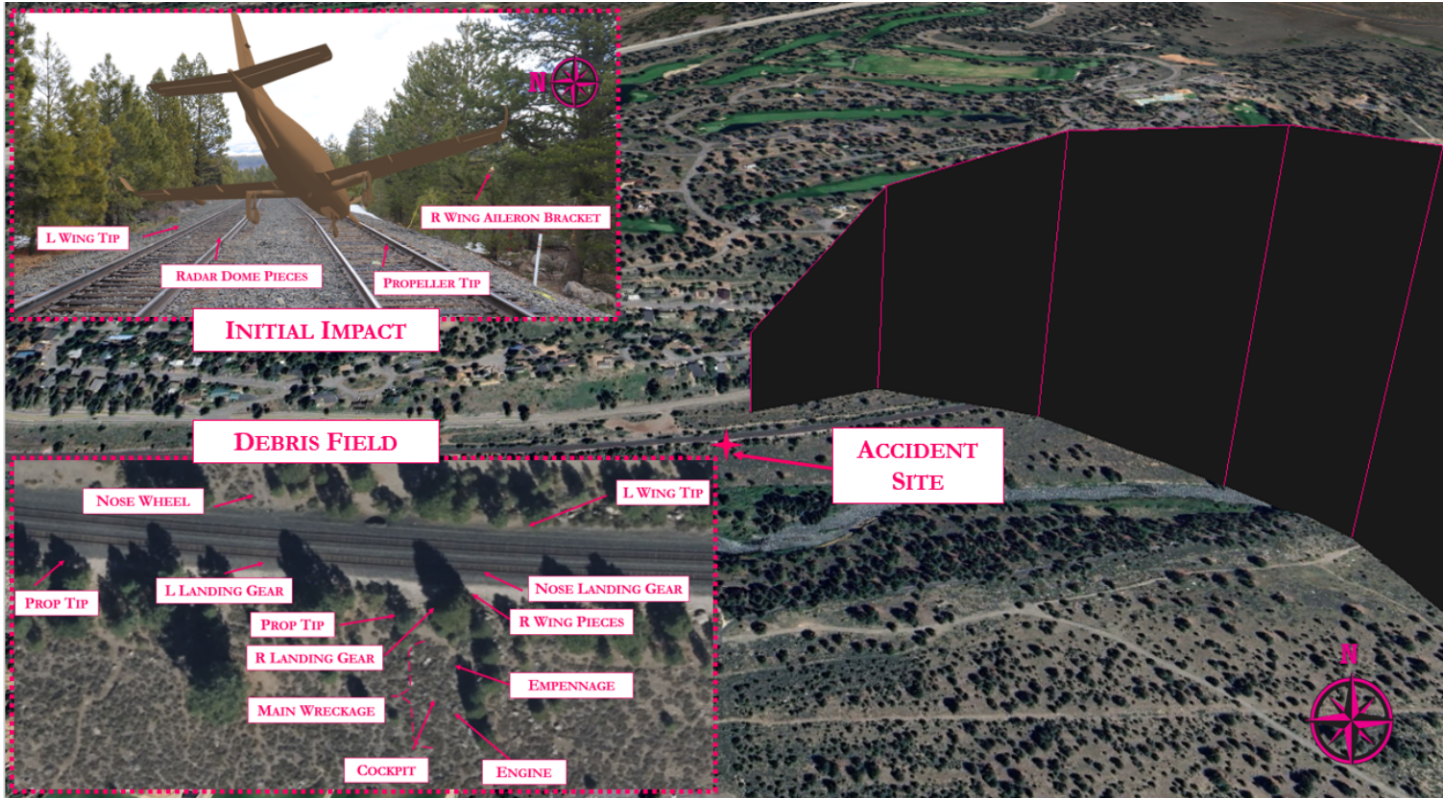
Figure 4: Debris Field and Initial Impact in Reference to the Accident Site

The accident site was located in snow-covered terrain adjacent to railroad tracks about 3,200 ft north from the approach end of runway 11. In character, the terrain was dense thick brush and mature trees. The initial impact area was across four rails with the north area embedded with left-wing tip fragments and the south area had a severed tree with right-wing pieces see Figure 4 below). The initial impact was upslope from the main wreckage, which was located about 100 ft on a heading of 200°. The wreckage was found distributed over 300 ft with the nose wheel tire being one of the farthest pieces of recognizable debris, consistent with the airplane impacting with the landing gear in the extended position. The main wreckage included

the fuselage, inboard wings, empennage, and engine. The fuselage and main cockpit area were severely fragmented and partially consumed by fire, consistent with impact. The Light Data Recorder (LDR) was not located in the wreckage and is presumed to be in the vicinity of the accident site.

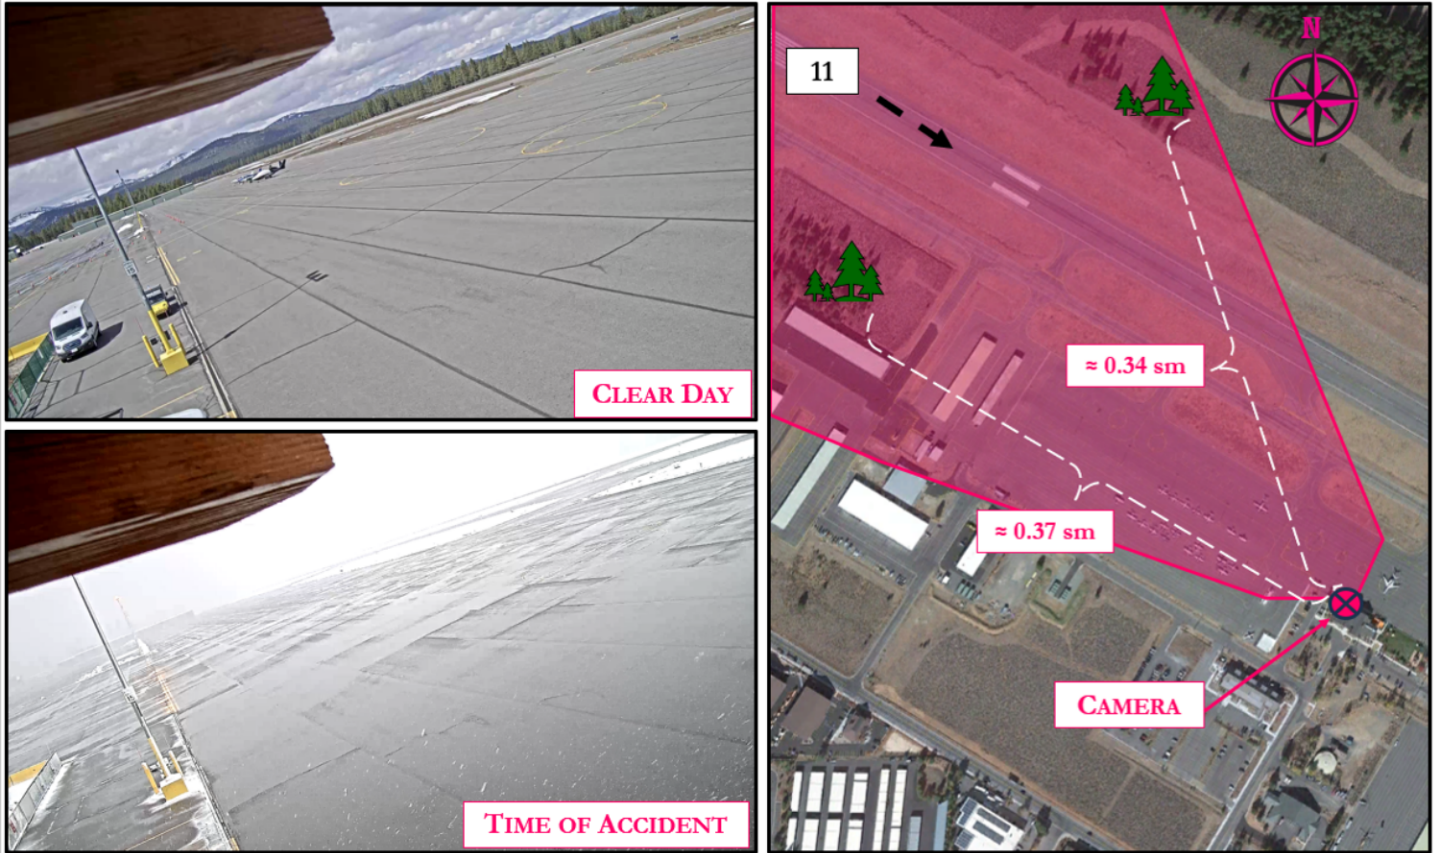
Figure 5: Weather at the Airport

A routine aviation weather report (METAR) for TRK was issued about 2 minutes before the accident. It stated: wind calm, visibility 3/4 mile in light snow, ceiling overcast at 900 ft agl, temperature 30° Fahrenheit, dew point temperature 30° Fahrenheit, altimeter 29.66 inches of mercury (inHg). A review of video camera footage at the airport and near the accident site revealed that the visibility at the time of the accident was under 0.34 statute miles (see Figure 5 below).
