Aviation Investigation Preliminary Report

Location:	Truckee, CA	Accident Number:	WPR24FA119
Date & Time:	March 30, 2024, 18:37 Local	Registration:	N960LP
Aircraft:	Daher TBM700	Injuries:	2 Fatal
Flight Conducted Under:	Part 91: General aviation - Personal

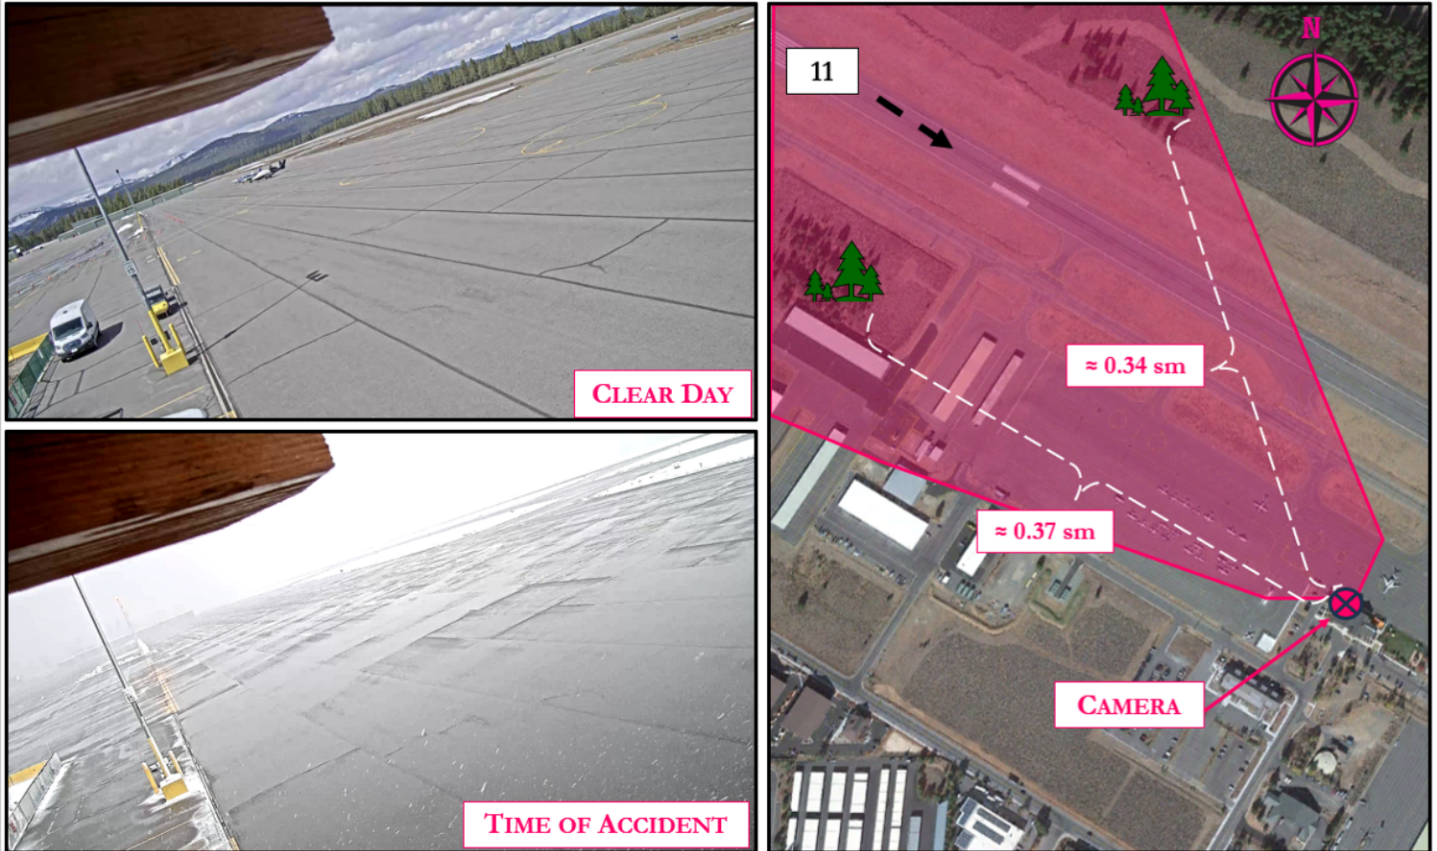
Figure 5: Weather at the Airport

A routine aviation weather report (METAR) for TRK was issued about 2 minutes before the accident. It stated: wind calm, visibility 3/4 mile in light snow, ceiling overcast at 900 ft agl, temperature 30° Fahrenheit, dew point temperature 30° Fahrenheit, altimeter 29.66 inches of mercury (inHg). A review of video camera footage at the airport and near the accident site revealed that the visibility at the time of the accident was under 0.34 statute miles (see Figure 5 below).
