Aviation Investigation Preliminary Report

Location:	Hartsburg, MO	Accident Number:	CEN24FA160
Date & Time:	April 16, 2024, 12:05 Local	Registration:	N451MA
Aircraft:	PIPER AIRCRAFT INC PA 46-350P	Injuries:	1 Fatal
Flight Conducted Under:	Part 91: General aviation - Personal

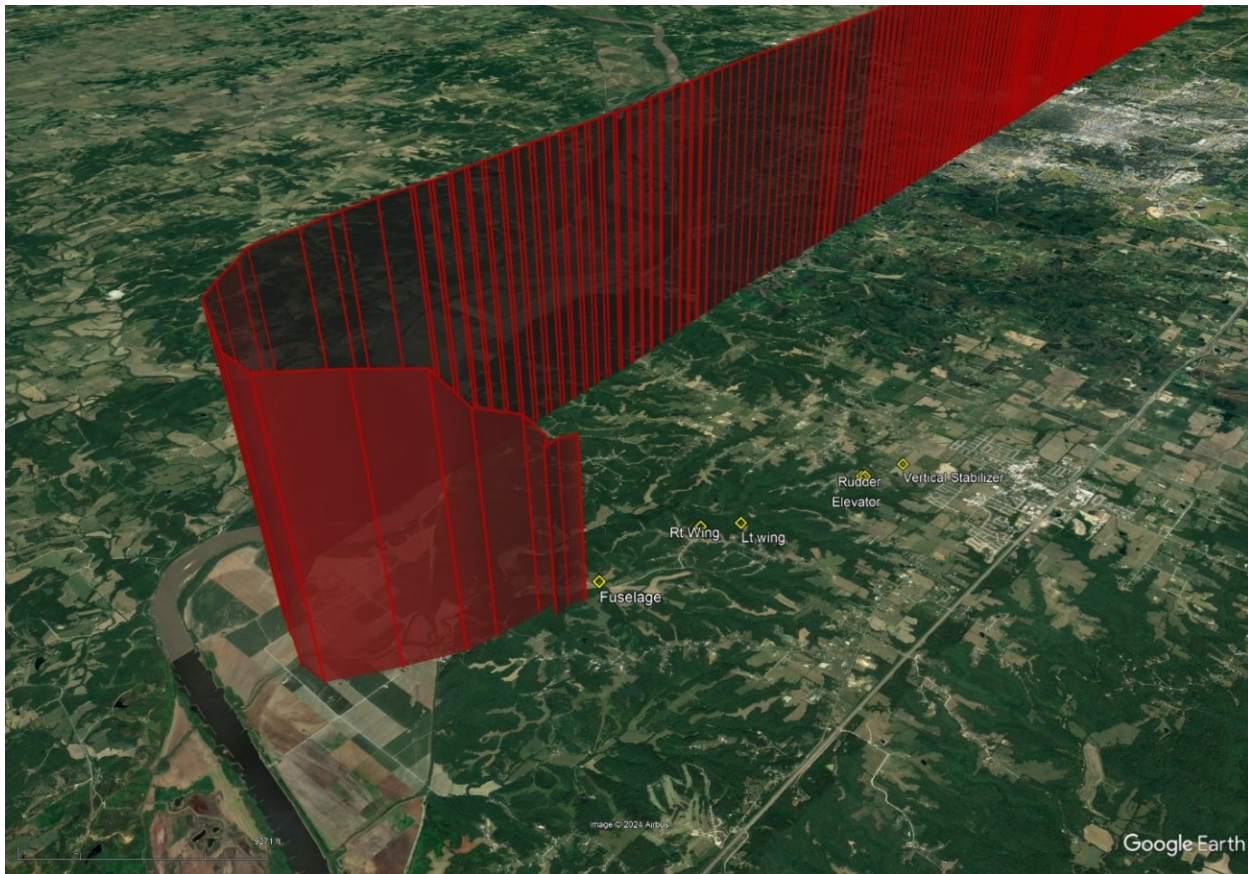
Review of flight track data provided by the Federal Aviation Administration (FAA) revealed that after departing MSN, the airplane turned to the southwest and climbed to about 16,000 ft mean sea level (msl). The airplane's course was a direct line to SLG. The airplane remained on this course and altitude until 1149 when it turned left to a south-southeast direction, and a few minutes later made a right turn to the south. The airplane continued south until 1204 when it entered a descending left turn. At the end of the data, the airplane was heading north and had descended to about 9,400 ft msl. The calculated descent rate during the final portion of the turn was more than 16,000 ft per minute. The airplane's fuselage came to rest about 0.14 nm north of the last in-flight recorded position of the airplane.

FIGURE 1. Plot of the final portion of the airplane's flight path.
