Aviation Investigation Preliminary Report

Location:	Bristol, IN	Accident Number:	CEN24FA170
Date & Time:	April 30, 2024, 14:18 Local	Registration:	N6271F
Aircraft:	RIDENOUR WENDELL RAY CH-601 HDS	Injuries:	2 Fatal
Flight Conducted Under:	Part 91: General aviation - Personal

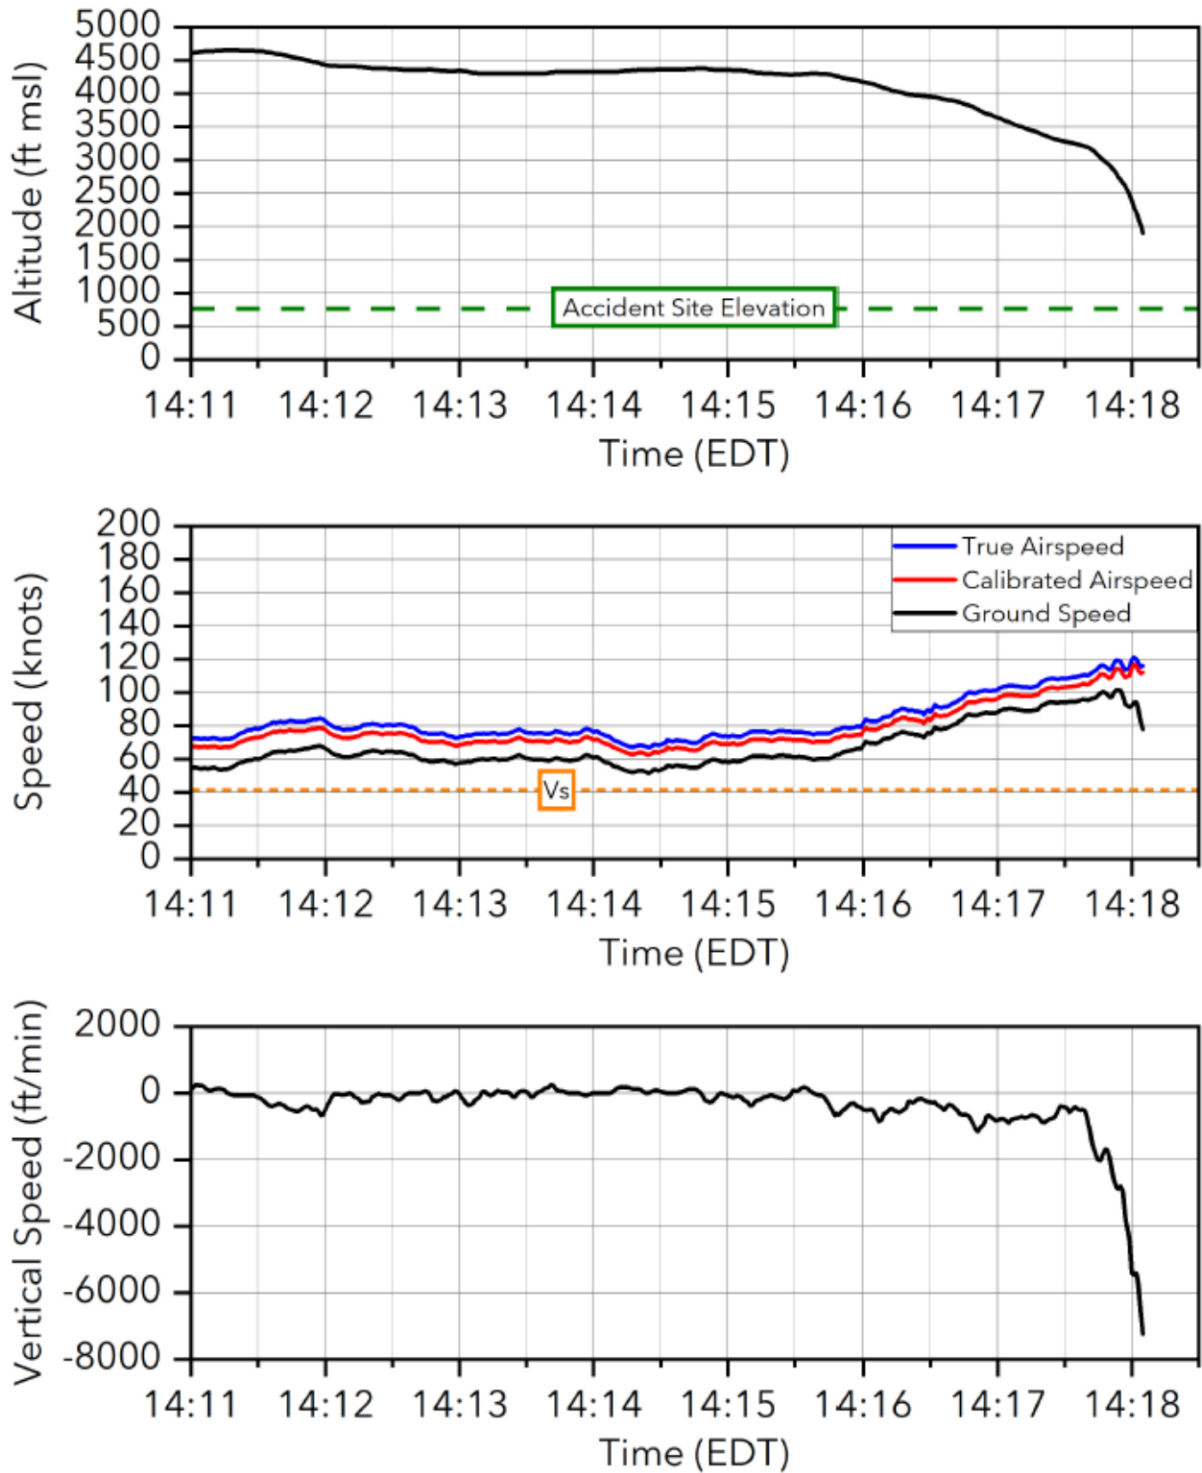
Federal Aviation Administration (FAA) Automatic Dependent Surveillance – Broadcast (ADS-B) data indicated that the airplane originally departed EKM at 1152 and landed at OEB at 1225. The return flight departed OEB at 1339 and proceeded southwest at a cruise altitude about 4,500 ft mean sea level (MSL) and true airspeed about 80 kts. At 14:15:44, the airplane started a descent and continued west toward EKM. During the next 2 minutes, the true airspeed increased to about 110 kts and the average descent rate was about 600 ft per minute (fpm). At 14:17:44 the airplane started a steep descent, the airspeed increased to about 120 kts, and the airplane descended more than 7,000 fpm. The final data point was recorded at 14:18:05 at an altitude of 1,836 ft MSL (1,072 ft AGL), which was 7 nautical miles (nm) east of EKM, and about 400 ft east of the accident site.

Figure 1. Altitude, Speed, and Vertical Speed Based on FAA ADS-B Data.

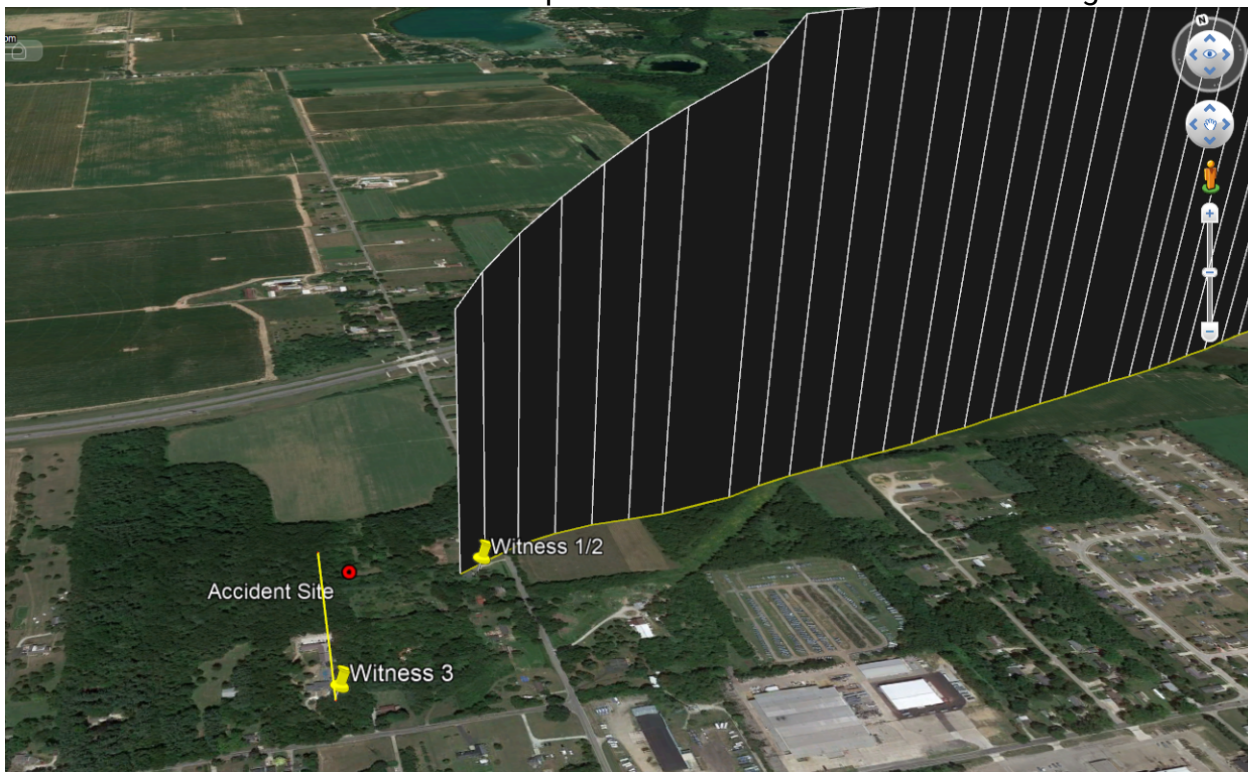
A witness, labeled as witness 1 in Figure 2, stated that the airplane flew over the top of him from the east to the west, then entered a nosedive. The engine sounded like it was “cutting in and out” and was not making a consistent sound as it descended. The airplane impacted the

Another witness, witness 3 in Figure 2, stated that she was outside of her house facing southeast when she heard the airplane behind her. She turned around and saw the airplane descending straight down toward the ground. She thought she saw the top of the airplane because she didn’t notice any wheels. She did not see any smoke or fire coming from the airplane. The engine was very loud and continued to operate very loud until the impact, which sounded like a loud explosion. The yellow line in Figure 2 is the estimated sight path from her location to where she observed the airplane in a vertical descent toward the ground.

Figure 2. The ADS-B flight track overlaid onto Google Earth with the witness locations in yellow and accident site in red.

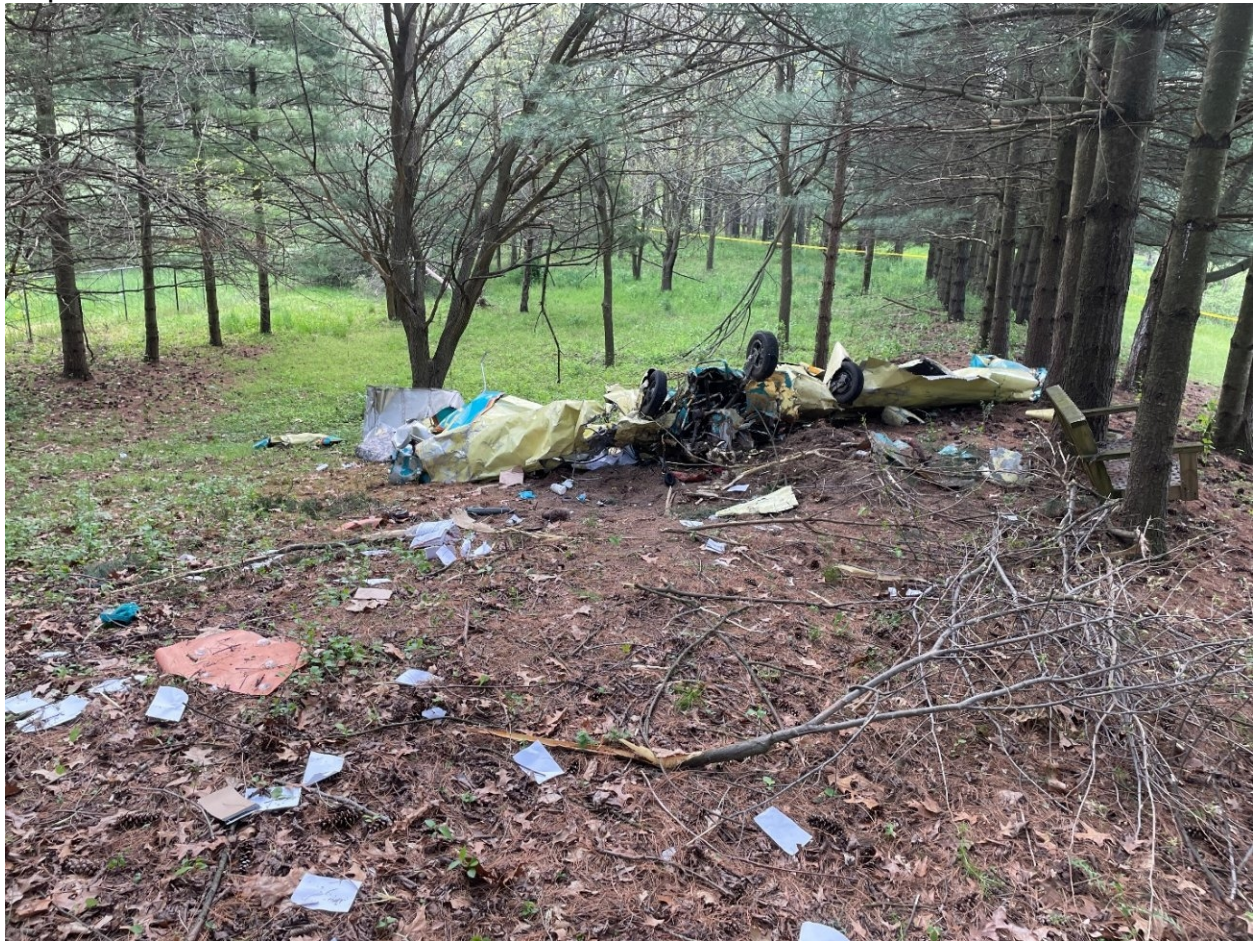
The airplane impacted trees and terrain in a near vertical attitude and nosed over (Figure 3). The left wing exhibited crushing to the leading edge and the outboard half of the wing was bent aft. The right wing sustained impact damage and hydraulic deformation to the inboard leading edge near the fuel tank. The outboard 2 ft of the wing sustained ground impact damage and was bent aft. The elevator and rudder control cables were traced from their control surfaces to the cockpit through cuts near the rear fuselage, which were made by first responders during their extraction efforts. The aileron control cables were continuous from the cockpit to the aileron bellcrank. The engine remained partially attached to the firewall and was crushed into the cockpit. The engine sustained significant impact damage to the front and to the rear accessories, but the case and cylinders remained intact. There were no holes in the

case or signs of catastrophic failure. The wooden propeller blades were found shattered and dispersed around the accident area.

Figure 3. The airplane where it came to rest inverted.
