# Aviation Investigation Preliminary Report

<b>Location:</b>	Plant City, FL	<b>Accident Number:</b>	ERA24LA205
<b>Date &amp; Time:</b>	May 1, 2024, 16:10 Local	<b>Registration:</b>	N413JM
<b>Aircraft:</b>	Airbus Helicopters AS350	<b>Injuries:</b>	2 None
<b>Flight Conducted Under:</b>	Part 91: General aviation - Positioning

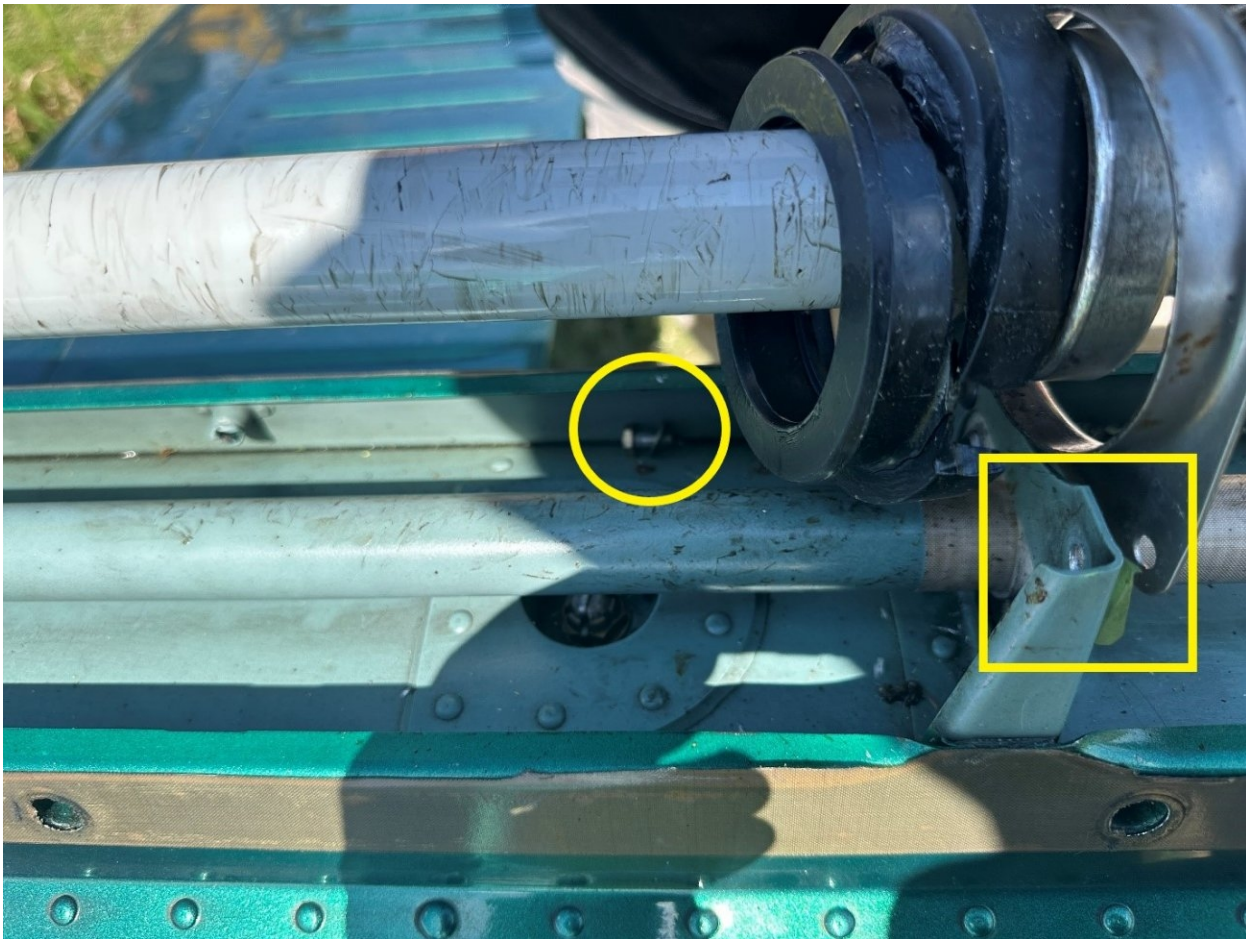
Removal of the tail rotor driveshaft cover revealed that the most aft-mounted hanger bearing (No. 1 of 5) was severely damaged and free of its mount and bearing race, while the tail rotor driveshaft itself remained intact and connected. The left side bearing mount attach bolt was

not installed but found atop the tailboom next to the mount. The right-side bolt was installed, but the attachment nut was not fully seated (see figure 1).

Figure 1. View of No.1 tail rotor driveshaft hanger bearing. Note bearing mount attach bolt as found (yellow circle), and its mounting position (yellow square). (Photo courtesy HCSO)
