Aviation Investigation Preliminary Report

Location:	Houston, TX	Accident Number:	DCA24FA179
Date & Time:	May 3, 2024, 18:00 Local	Registration:	N942JX
Aircraft:	Embraer EMB-145LR	Injuries:	1 Minor, 23 None
Flight Conducted Under:	Part 135: Air taxi & commuter - Non-scheduled

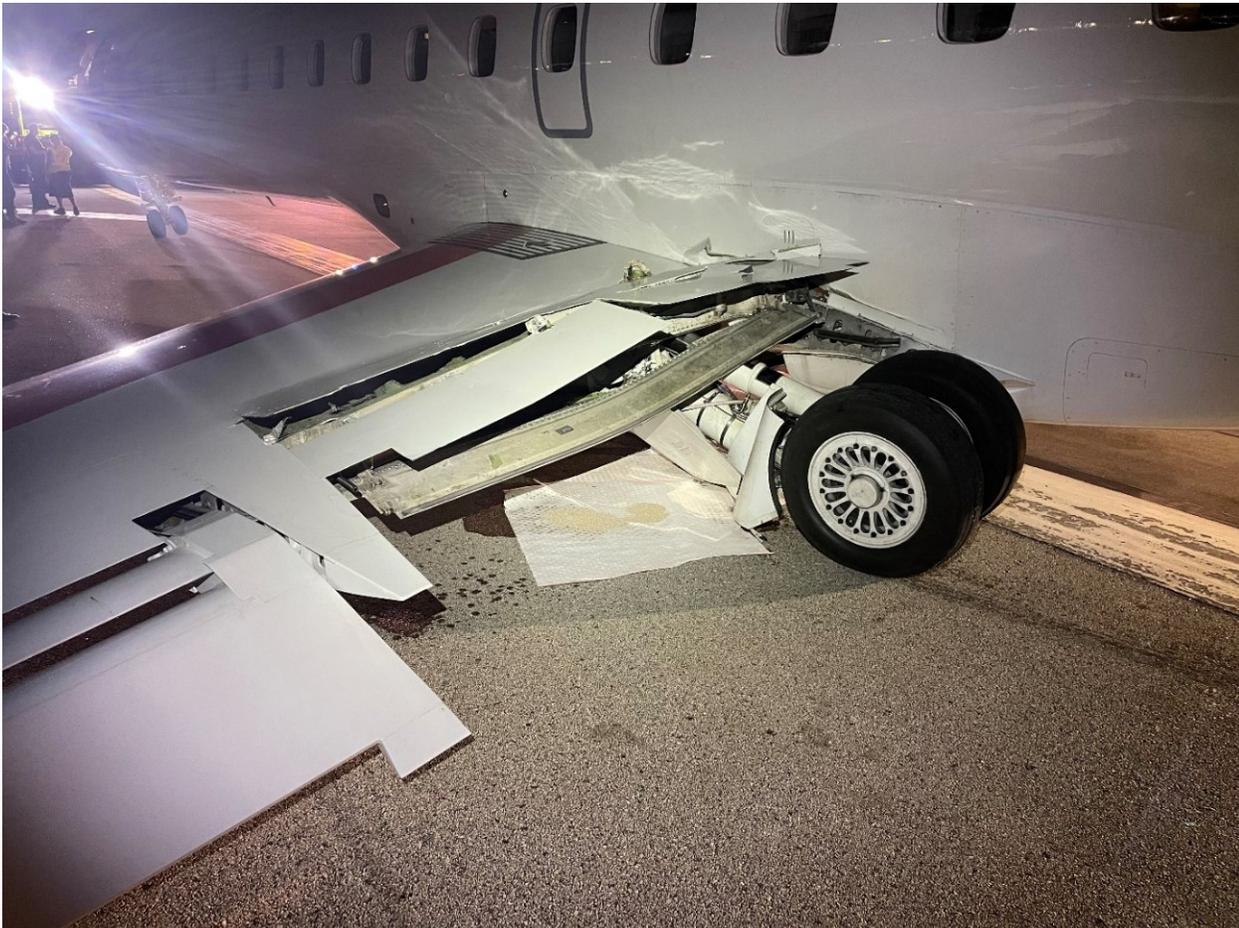
While the crew did not recall initiating the go-around, flight data showed an increase in throttle lever angle consistent with commanding go-around thrust that began shortly before impact. Flight data indicated that the vertical load factor during the touchdown was 3.9 gravitational constants (g). As the aircraft continued down the runway, the LMLG collapsed and punctured through the left-wing upper skin.

Visual inspection of the LMLG showed structural damage and deformation, in addition to hydraulic fluid leakage. The left wing spar III, a principal structural element, was bent and fractured through at 2 locations and partially fractured at 3 additional locations.

While there was damage to some of the left wing's structural components, the fuel tank was not compromised during the event. Most of the structural damage to the inboard section of the wing was consistent with a strong upward force from the LMLG. Damage to the outboard section of the wing was consistent with the wing scraping the runway surface and impacting runway lights.

Figure 1. Photograph of the accident aircraft showing the collapsed left landing gear. (Source: FAA)
