Aviation Investigation Preliminary Report

Location:	Franklin, TN	Accident Number:	ERA24FA217
Date & Time:	May 15, 2024, 12:02 Local	Registration:	N47WT
Aircraft:	Beech V35	Injuries:	3 Fatal
Flight Conducted Under:	Part 91: General aviation - Personal

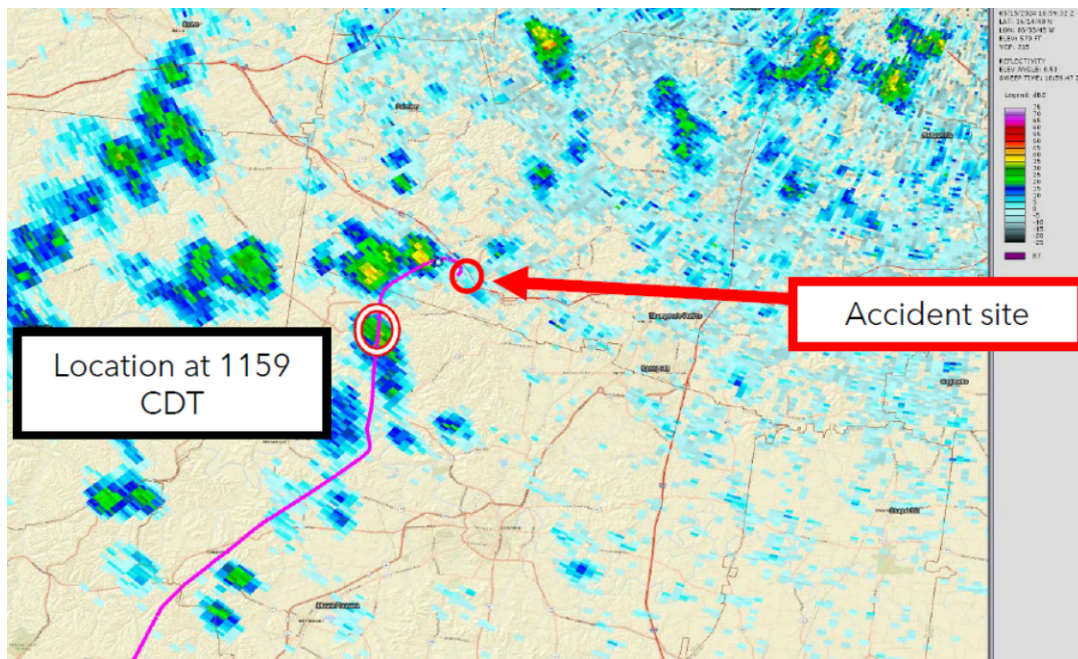
Preliminary weather data showed that while established on the 360° track, the airplane entered an area with depicted moderate to heavy precipitation (figure 1). The airplane momentarily descended to 8,900 feet, and then made a right turn to the northeast for several miles before initiating a right descending turn to a track of 213°. The groundspeed increased from 180 kts to 214 kts and the vertical speed decreased to a 4,000 fpm descent. The controller made several attempts to contact the pilot, which went unanswered and radar contact was lost shortly thereafter. ADS-B data for the final moments of the flight showed that as the airplane entered a 5,000 fpm rate of descent, the groundspeed rapidly decreased to 43 kts and the vertical speed then reached a descent rate of more than 15,000 fpm.

Figure 1 - Preliminary WSR-88D weather radar scan for 1159, with the airplane's flight track overlaid (magenta), along with annotations of the airplane's position at 1159 and the approximate location of the accident site.
