Aviation Investigation Preliminary Report

Location:	Auburn, WA	Accident Number:	WPR24FA182
Date & Time:	June 6, 2024, 11:59 Local	Registration:	N412JN
Aircraft:	VANS AIRCRAFT INC RV-12	Injuries:	1 Fatal
Flight Conducted Under:	Part 91: General aviation - Personal

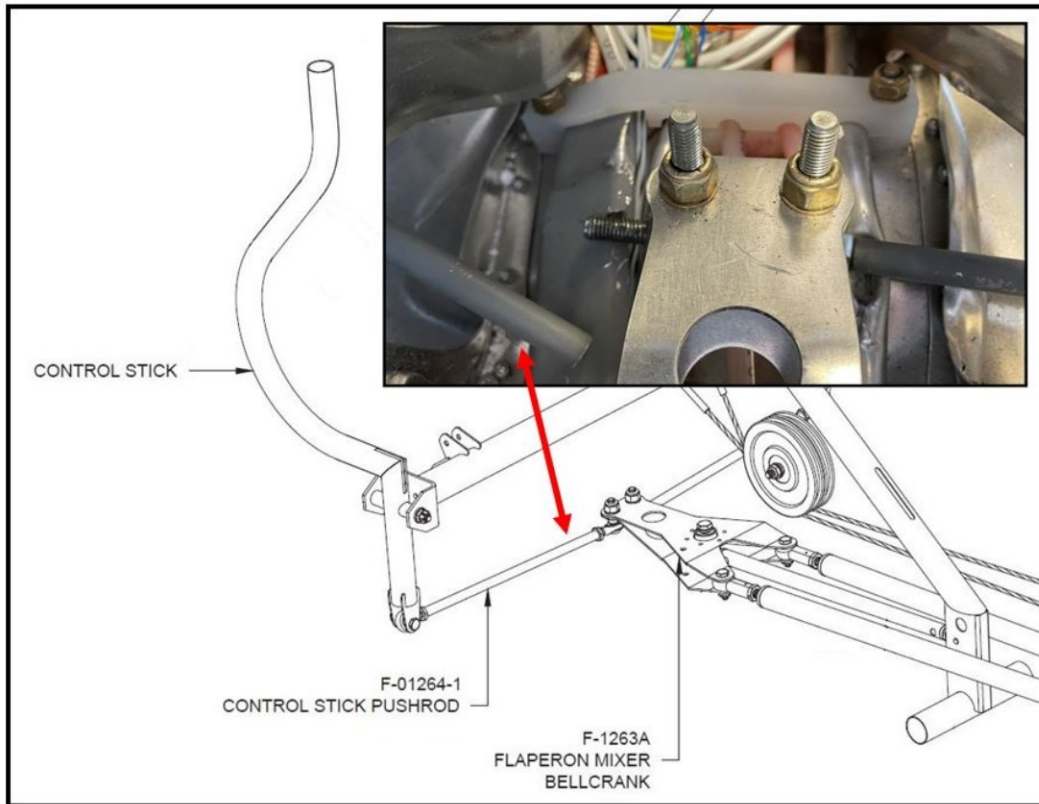
The airplane's roll control system consisted of full-length flaperons, connected to tandem control sticks through a series of pushrods, torque tubes, and a centrally mounted flaperon mixer bellcrank. Examination of the wreckage revealed that the left control stick pushrod (F-1264-1) was not connected to the inboard eyebolt bearing (CM-4MS) at the flaperon mixer bellcrank (see figure 1).

Figure 1 – Disconnected left control stick pushrod.

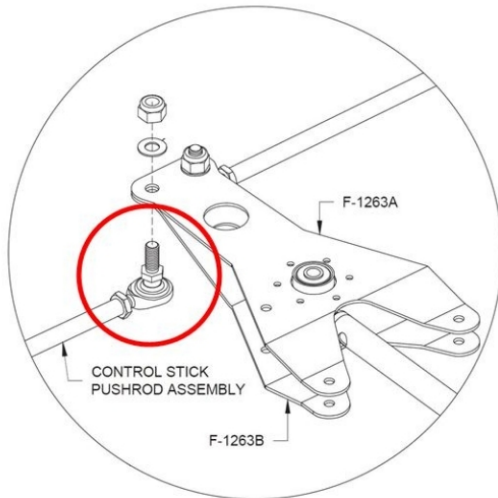
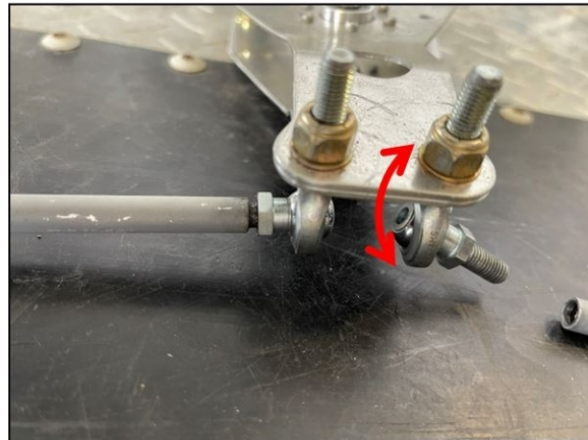
When compared with the airplane's plans, the inboard eyebolts were installed such that the eyebolt stud was connected to the pushrod, and its body to the mixing bellcrank, rather than the other way around (see figure 2). In this configuration, the stud end of the eyebolt was free to rotate within the threaded inboard section of pushrod.

Figure 2 – Installation of the CM-4MS eyebolt per plans on the left vs the installed eyebolt on the accident airplane as found on the right.
