Aviation Investigation Preliminary Report

Location:	Auburn, WA	Accident Number:	WPR24FA182
Date & Time:	June 6, 2024, 11:59 Local	Registration:	N412JN
Aircraft:	VANS AIRCRAFT INC RV-12	Injuries:	1 Fatal
Flight Conducted Under:	Part 91: General aviation - Personal

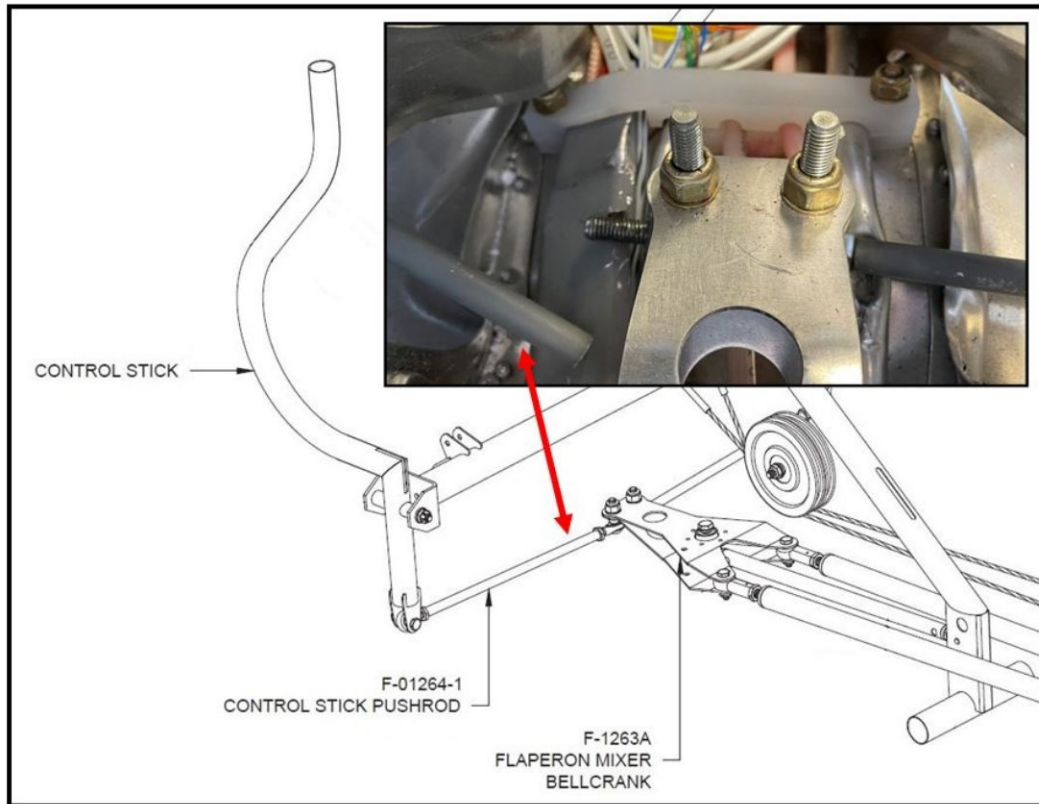
The airplane's roll control system consisted of full-length flaperons, connected to tandem control sticks through a series of pushrods, torque tubes, and a centrally mounted flaperon mixer bellcrank. Examination of the wreckage revealed that the left control stick pushrod (F-1264-1) was not connected to the inboard eyebolt bearing (CM-4MS) at the flaperon mixer bellcrank (see figure 1).

Figure 1 – Disconnected left control stick pushrod.

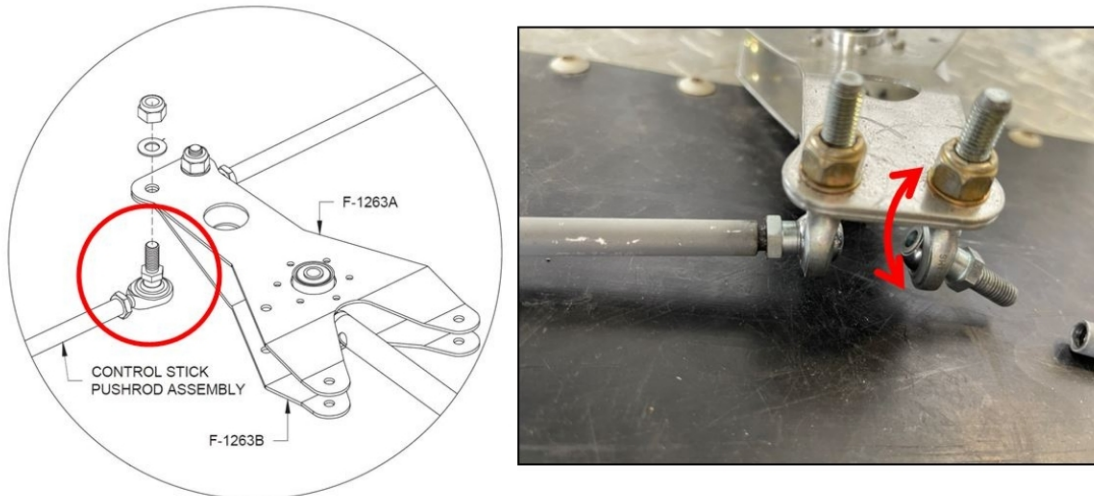
When compared with the airplane's plans, the inboard eyebolts were installed such that the eyebolt stud was connected to the pushrod, and its body to the mixing bellcrank, rather than the other way around (see figure 2). In this configuration, the stud end of the eyebolt was free to rotate within the threaded inboard section of pushrod.

Figure 2 – Installation of the CM-4MS eyebolt per plans on the left vs the installed eyebolt on the accident airplane as found on the right.
