# Aviation Investigation Preliminary Report

<b>Location:</b>	Oakland, CA	<b>Incident Number:</b>	DCA24LA206
<b>Date &amp; Time:</b>	May 25, 2024, 07:44 Local	<b>Registration:</b>	N8825Q
<b>Aircraft:</b>	Boeing 737-8	<b>Injuries:</b>	181 None
<b>Flight Conducted Under:</b>	Part 121: Air carrier - Scheduled

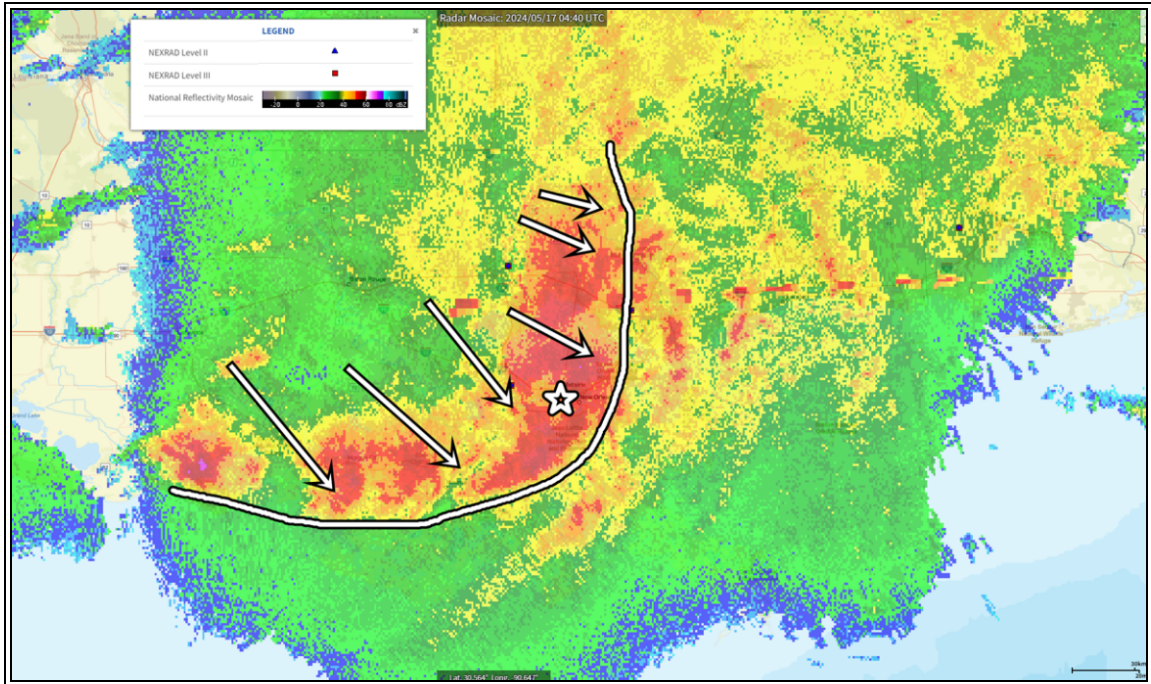
During the evening of May 16, 2024, the KMSY area was impacted with a squall line of thunderstorms which resulted in strong gusting winds up to 73 knots, heavy rain, and a wind shift. The peak gust of 73 knots was recorded at 2336 CDT (0436Z May 17, 2024). A National Weather Service (NWS) Composite Radar Mosaic depicted a bowing segment associated with the squall line around that time (figure 1). The NWS had a Convective Significant Meteorological (SIGMET) current for an area of severe thunderstorms moving from 250 degrees at 35 knots, with tops above 45,000 ft, the NWS also had a tornado watch current for the area at the time. Thunderstorms began at 2212 CDT on May 16th and continued through 0234 CDT on May 17<sup>th</sup> with a total of 1.37 inches of rainfall.

**Figure 1.** NWS Composite Radar Mosaic depicted a bowing segment associated with the squall line at 2340 CDT.

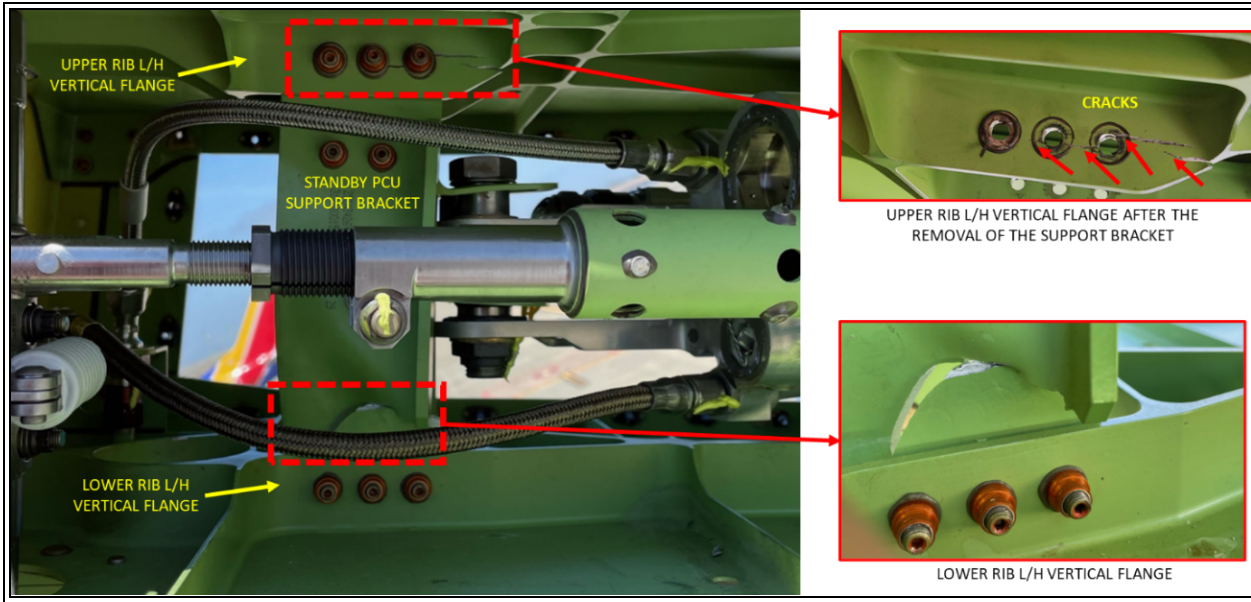
After arriving at the gate, the aircraft was met by SWA maintenance, and the airplane was removed from service. Post-incident troubleshooting and inspection of the airplane was accomplished by SWA maintenance. The examination revealed damage to the vertical stabilizer trailing edge ribs above and below the standby rudder power control unit (PCU). The damage to the stabilizer ribs adversely affects the structural strength of the fitting and is considered substantial damage. As part of the investigation, a timeline of events was created.

After the May 25, 2024, rudder system anomaly event, SWA maintenance replaced the main rudder PCU as part of their troubleshooting procedures. During the replacement and functional testing of the PCU, maintenance found a damaged bearing in the forward end of the upper input control rod. A new control rod was installed and during the rigging/adjustment of the main rudder PCU, maintenance identified additional structural damage to the rudder system in the area surrounding the standby rudder PCU. The standby rudder PCU was removed and was retained, along with the main rudder PCU, for further examination and testing by the NTSB systems group. Damage was observed on the standby rudder PCU forward support bracket and anti-rotation bushing. The vertical stabilizer trailing edge rib above the standby PCU was also fractured through and adjacent to two of the three holes where the left standby PCU support bracket was attached (figure 2). The vertical stabilizer trailing edge rib below the standby PCU was dented/deformed up to about 0.065" forward of the location where the standby PCU forward support brackets are attached. The damaged structural components were removed for further examination by the NTSB structures group.

**Figure 2.** View of damage to the standby rudder PCU support bracket and ribs. (Source: Southwest Airlines)

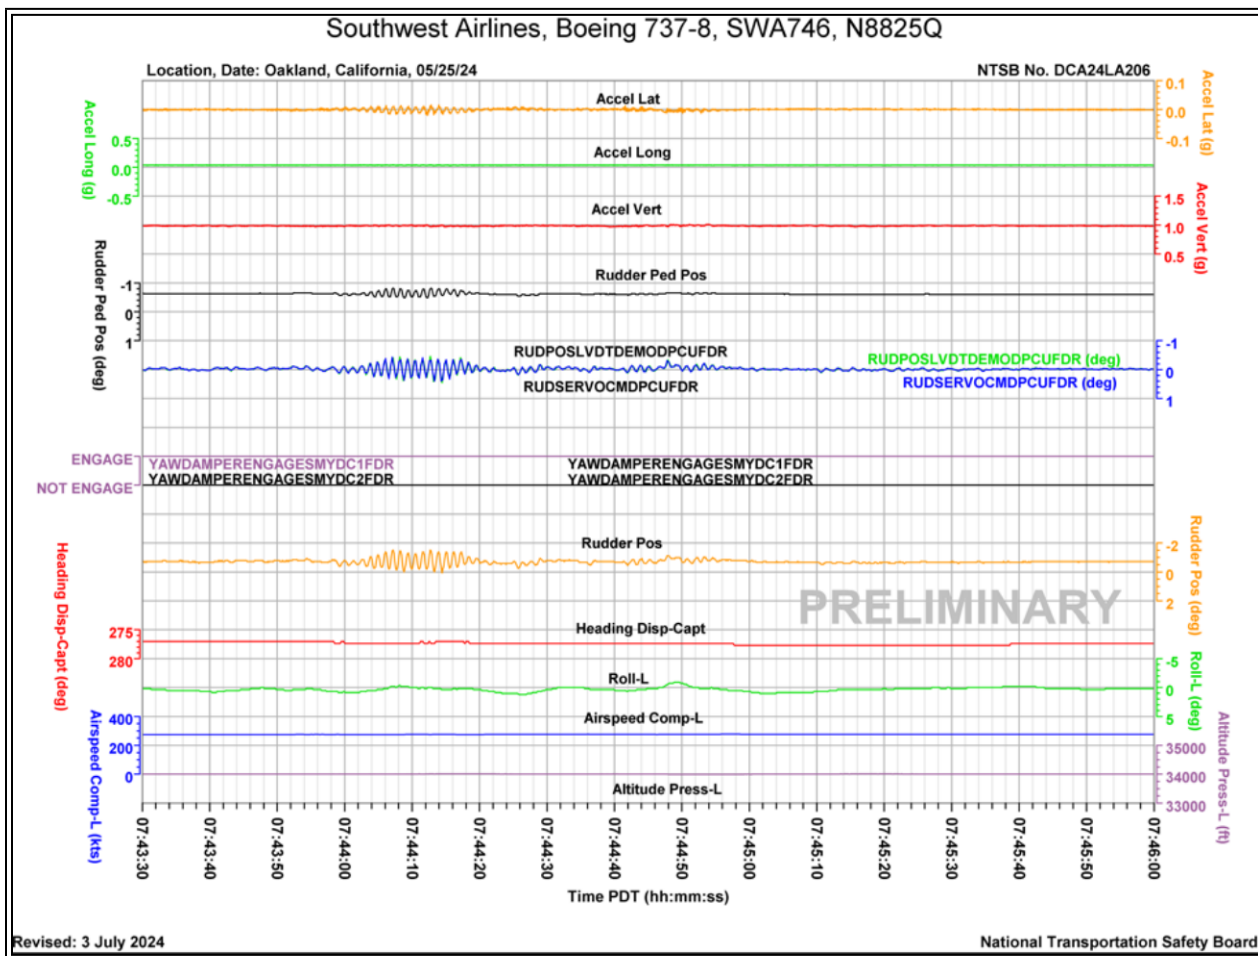
Data from the digital flight data recorder (DFDR) was sent to the NTSB's Vehicle Recorder Laboratory in Washington, DC, for analysis. A preliminary review of the data has been completed and a plot showing the rudder system parameters for the event flight is shown in figure 3. A review of the data corroborated the flight crew's statements regarding the anomalous behavior of the rudder system during cruise at 34,000 feet. Data showed periodic oscillations, lasting about 20 seconds, in rudder deflection, rudder pedal position, and yaw damper command. These oscillations had a frequency of approximately 0.9 Hz, and an amplitude of about  $\pm 0.75$  degrees of rudder surface movement. This motion resulted in  $\pm 0.03$

G oscillations in lateral acceleration at the same frequency, but no significant changes or oscillations in airplane heading or bank angle.

A review of the data also showed that the anomalous behavior of the rudder system began on the first flight after a scheduled maintenance on May 23, 2024. Before the maintenance, yaw damper commands did not correspond to rudder pedal movements. However, after scheduled maintenance was performed on the airplane, rudder pedal movements were noted when the yaw damper was engaged. All occurrences of these oscillations occurred with the yaw damper engaged; when the yaw damper was disengaged in-flight, or when the airplane was dispatched with the yaw damper on the minimum equipment list (MEL), the anomalous behavior was not observed.

Figure 3. Plot of the FDR data from the event flight.
