Aviation Investigation Preliminary Report

Location:	Oakland, CA	Incident Number:	DCA24LA206
Date & Time:	May 25, 2024, 07:44 Local	Registration:	N8825Q
Aircraft:	Boeing 737-8	Injuries:	181 None
Flight Conducted Under:	Part 121: Air carrier - Scheduled

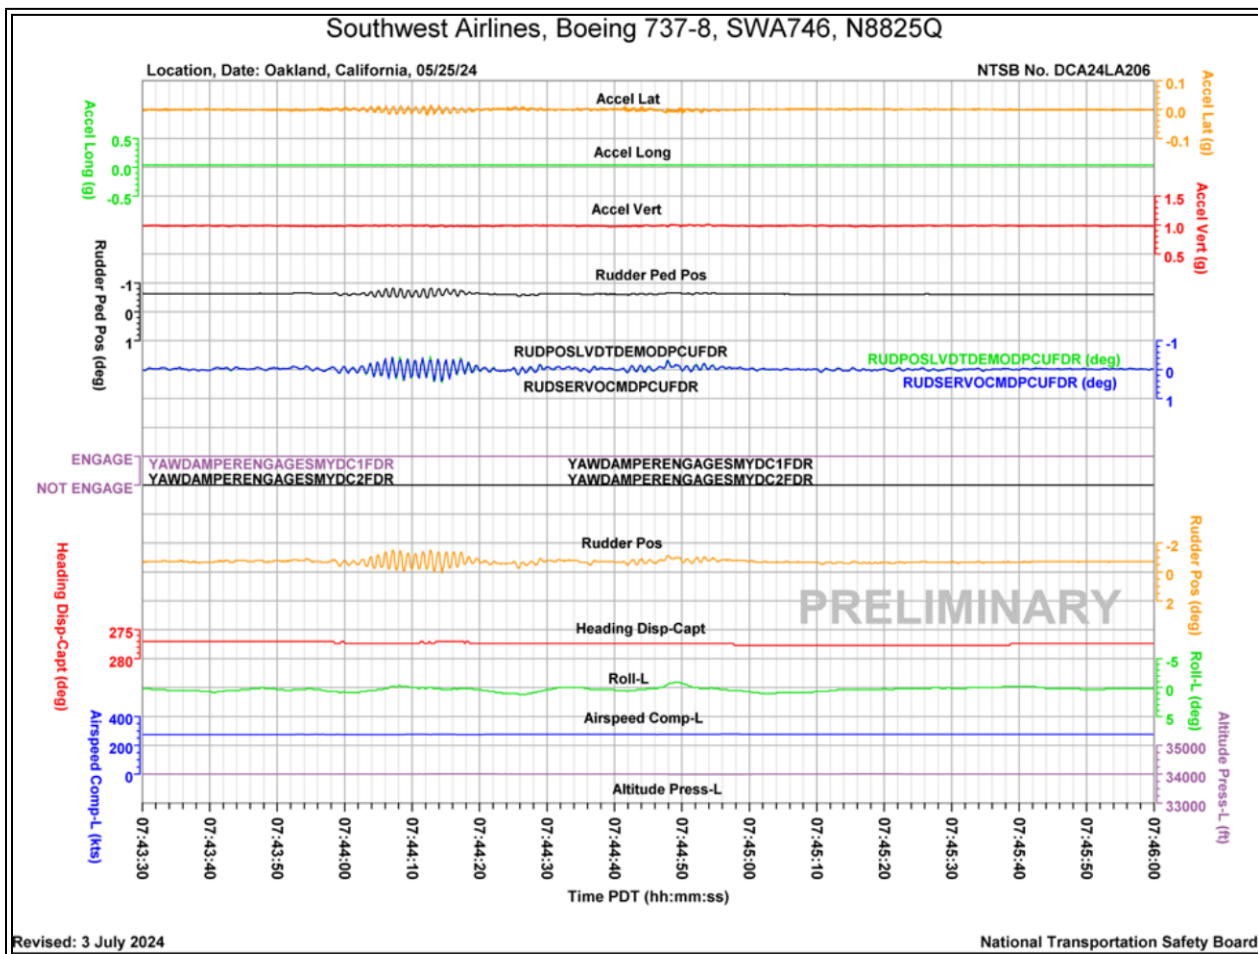
Data from the digital flight data recorder (DFDR) was sent to the NTSB's Vehicle Recorder Laboratory in Washington, DC, for analysis. A preliminary review of the data has been completed and a plot showing the rudder system parameters for the event flight is shown in figure 3. A review of the data corroborated the flight crew's statements regarding the anomalous behavior of the rudder system during cruise at 34,000 feet. Data showed periodic oscillations, lasting about 20 seconds, in rudder deflection, rudder pedal position, and yaw damper command. These oscillations had a frequency of approximately 0.9 Hz, and an amplitude of about ± 0.75 degrees of rudder surface movement. This motion resulted in ± 0.03

G oscillations in lateral acceleration at the same frequency, but no significant changes or oscillations in airplane heading or bank angle.

A review of the data also showed that the anomalous behavior of the rudder system began on the first flight after a scheduled maintenance on May 23, 2024. Before the maintenance, yaw damper commands did not correspond to rudder pedal movements. However, after scheduled maintenance was performed on the airplane, rudder pedal movements were noted when the yaw damper was engaged. All occurrences of these oscillations occurred with the yaw damper engaged; when the yaw damper was disengaged in-flight, or when the airplane was dispatched with the yaw damper on the minimum equipment list (MEL), the anomalous behavior was not observed.

Figure 3. Plot of the FDR data from the event flight.
