Aviation Investigation Preliminary Report

Location:	Clinton, MI	Accident Number:	CEN24FA215
Date & Time:	June 10, 2024, 13:11 Local	Registration:	N1039X
Aircraft:	Piper PA28	Injuries:	1 Fatal, 1 Serious
Flight Conducted Under:	Part 91: General aviation - Instructional

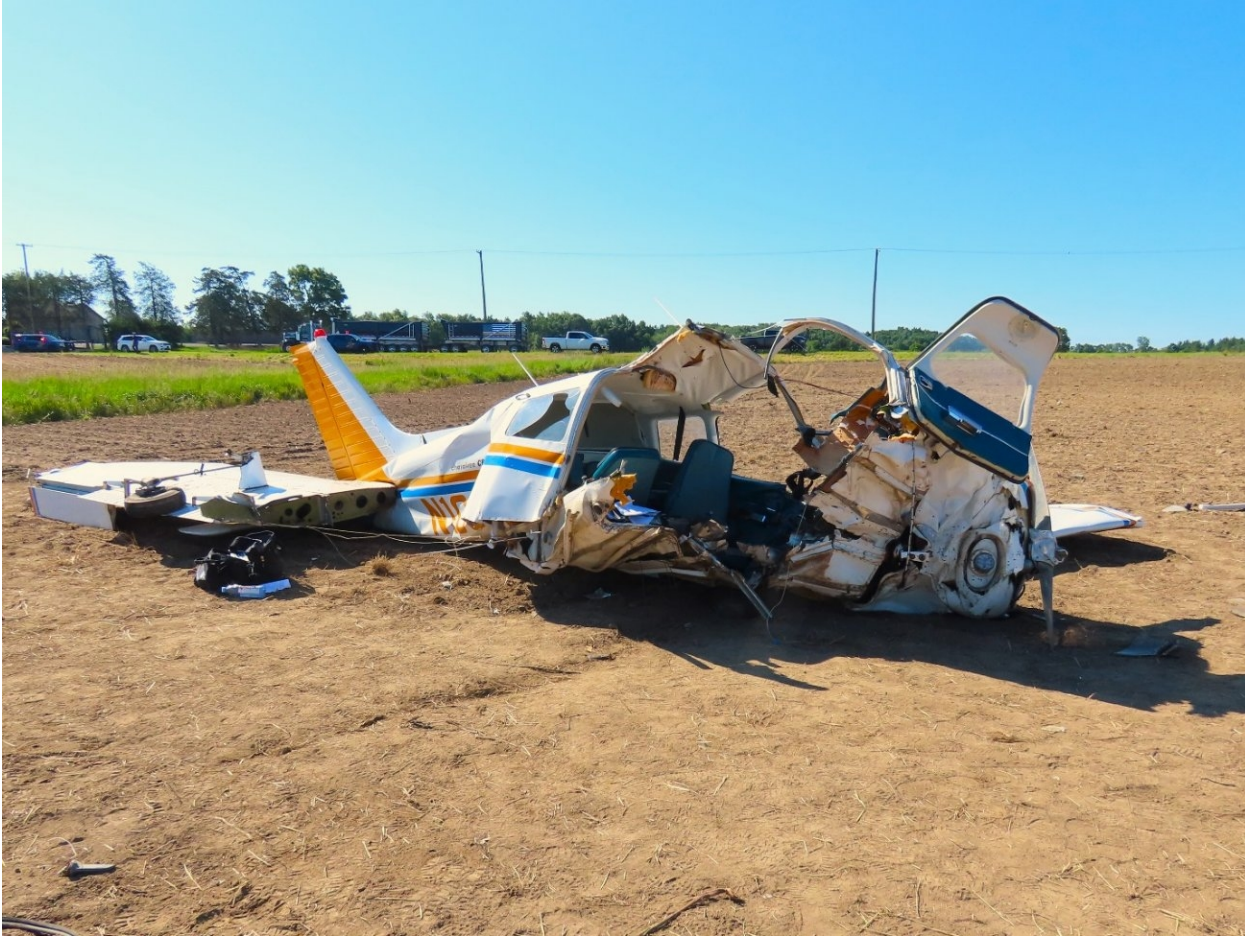
The airplane impacted a field about 13 nautical miles southwest of ARB at an elevation of 910 ft msl. The first point of impact was located about 35 ft north of the main wreckage, with pieces of the right wingtip located in a shallow ground scar. The main wreckage came to rest on a true heading of 270°. All major structural components of the airplane were located at the accident site; the right wing was separated from the fuselage, and the forward fuselage was partially separated forward of the cabin door frame (See Figure 1.)

Figure 1. Wreckage with the separated right wing and partially separated forward fuselage.

Ground scars at the accident site and damage to the airplane were consistent with the airplane impacting terrain in a steep nose-down, right wing low attitude.
