Aviation Investigation Preliminary Report

Location:	Siler City, NC	Accident Number:	ERA24FA261
Date & Time:	June 14, 2024, 12:48 Local	Registration:	N515DH
Aircraft:	Piper PA28	Injuries:	2 Fatal
Flight Conducted Under:	Part 91: General aviation - Instructional

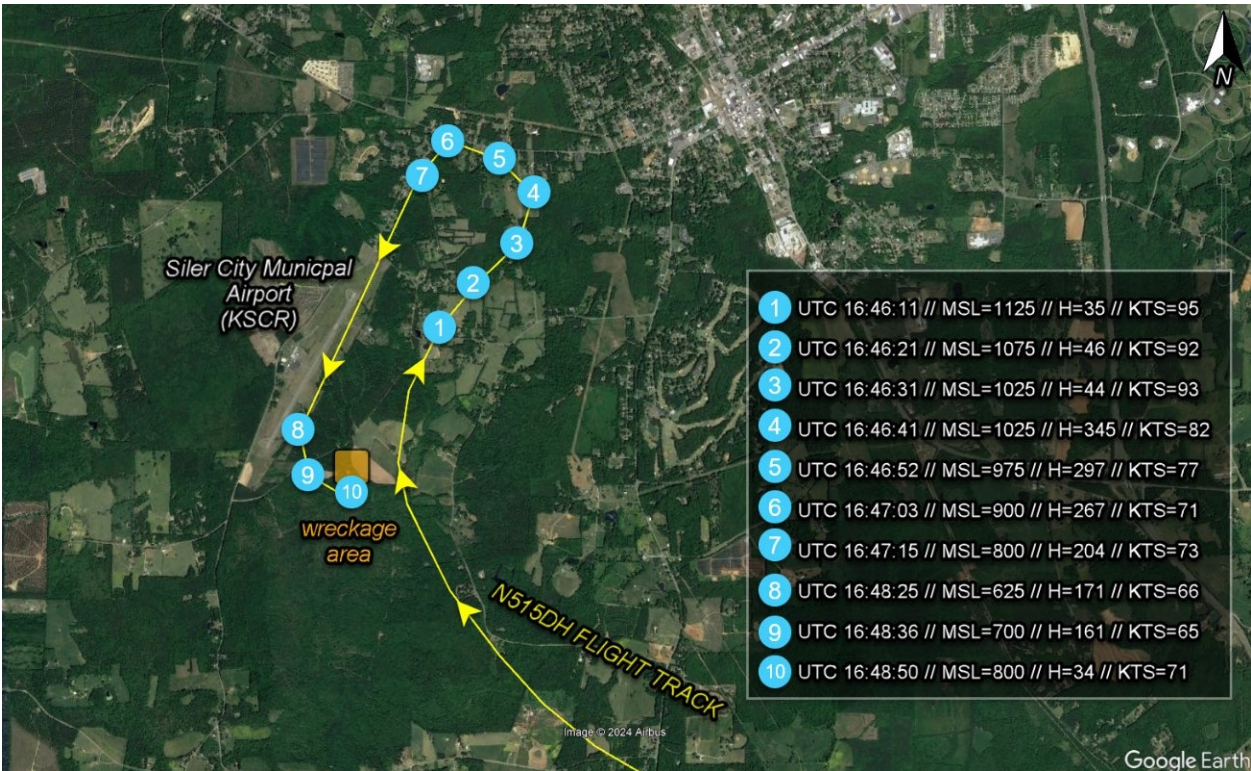
Preliminary ADS-B track data depicted the accident airplane’s traffic pattern entry, and its flight on the downwind leg about 1,100 ft mean sea level (msl) around 90 knots (kts) groundspeed. The airplane turned and slowed on the left base leg to the low 80-kt range, and then entered the final approach leg, slowing into the low 70-kt range before the ADS-B track data was lost.

About 1 minute later, the track data resumed in the vicinity of the runway’s departure end at 625 ft msl and 66 kts ground speed. Over the next 25 seconds, a 90° left turn was depicted. The final two targets displayed 700 ft and 65 knots, and 800 ft and 71 knots; respectively, before track data ended. (see figure 1.)

Figure 1: Preliminary ADS-B Flight Track Data. Times are reported as coordinated universal time (UTC) (NTSB)
