# Aviation Investigation Final Report

<b>Location:</b>	Humboldt Bay, California	<b>Accident Number:</b>	WPR24LA210
<b>Date &amp; Time:</b>	June 20, 2024, 10:31 Local	<b>Registration:</b>	N141PB
<b>Aircraft:</b>	LANCAIR COMPANY LC42-550FG	<b>Aircraft Damage:</b>	Substantial
<b>Defining Event:</b>	Powerplant sys/comp malf/fail	<b>Injuries:</b>	1 None
<b>Flight Conducted Under:</b>	Part 91: General aviation - Personal

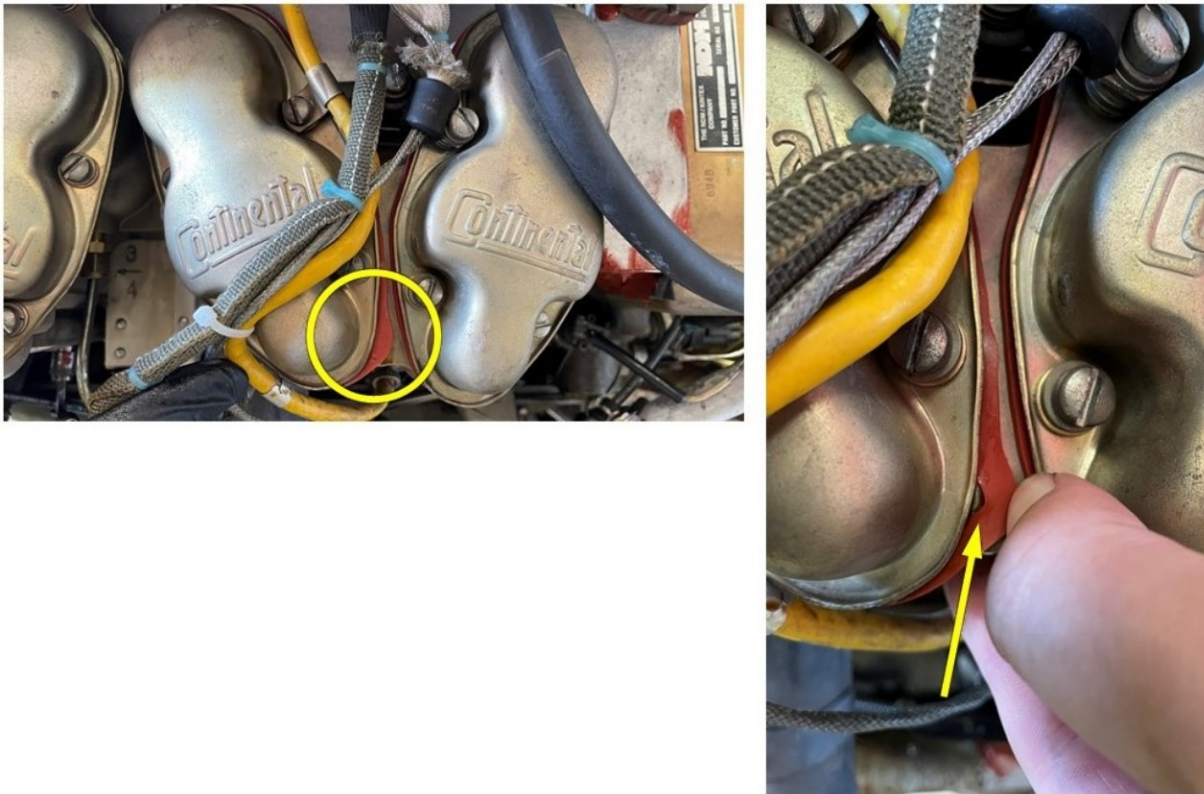
Postaccident examination of the engine revealed that a rocker cover gasket was misaligned before the accident. The gasket was unable to maintain an adequate seal and opened during the accident flight. Oil was then ejected out of the gap between the rocker cover and cylinder head, which resulted in oil exhaustion.

Maintenance personnel's incorrect installation of an engine rocker cover gasket, which resulted in oil exhaustion and subsequent loss of engine power during the initial climb.

Examination of the rocker covers revealed that the gasket for the exhaust rocker for cylinder No. 2 (on the left aft side of the engine) was misaligned in its lower right corner, such that a gap between the rocker cover and cylinder head was present (figure 1).

Figure 1. Misaligned gasket (left); gap in the gasket seal (right).

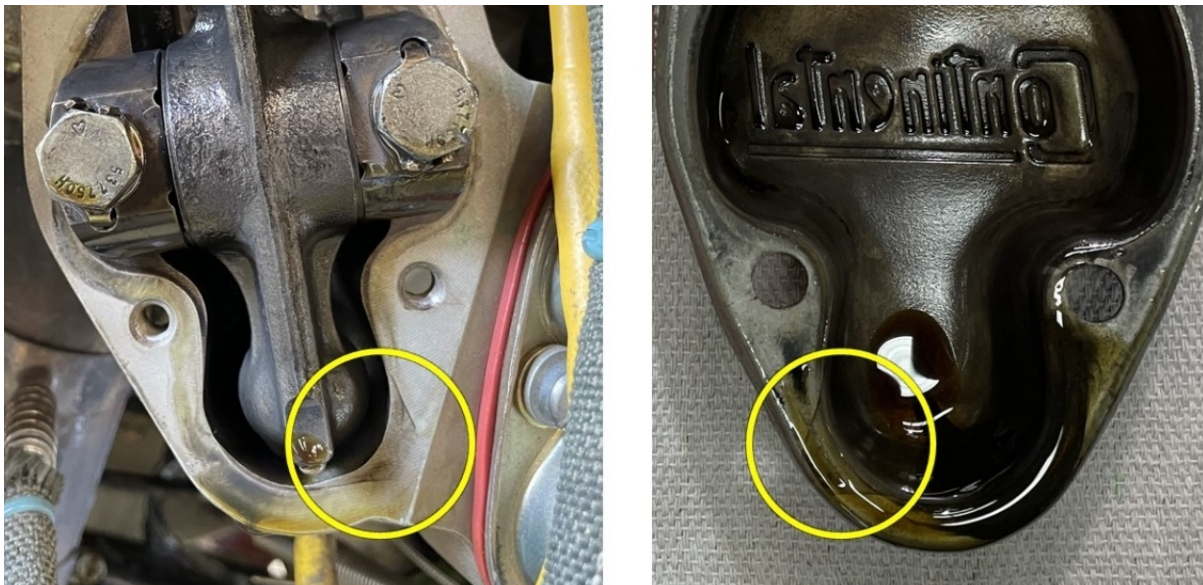
The cover was removed, and a dark stain was present on the face of the gasket mating surface, which mirrored the misalignment of the gasket (figure 2).

Figure 2. Witness marks showing pre-existing misaligned gasket on rocker (left) and cover (right).
