Aviation Investigation Preliminary Report

Location:	Portland, ME	Incident Number:	DCA24LA219
Date & Time:	June 25, 2024, 05:43 Local	Registration:	N7861J
Aircraft:	Boeing 737-79P	Injuries:	136 None
Flight Conducted Under:	Part 121: Air carrier - Scheduled

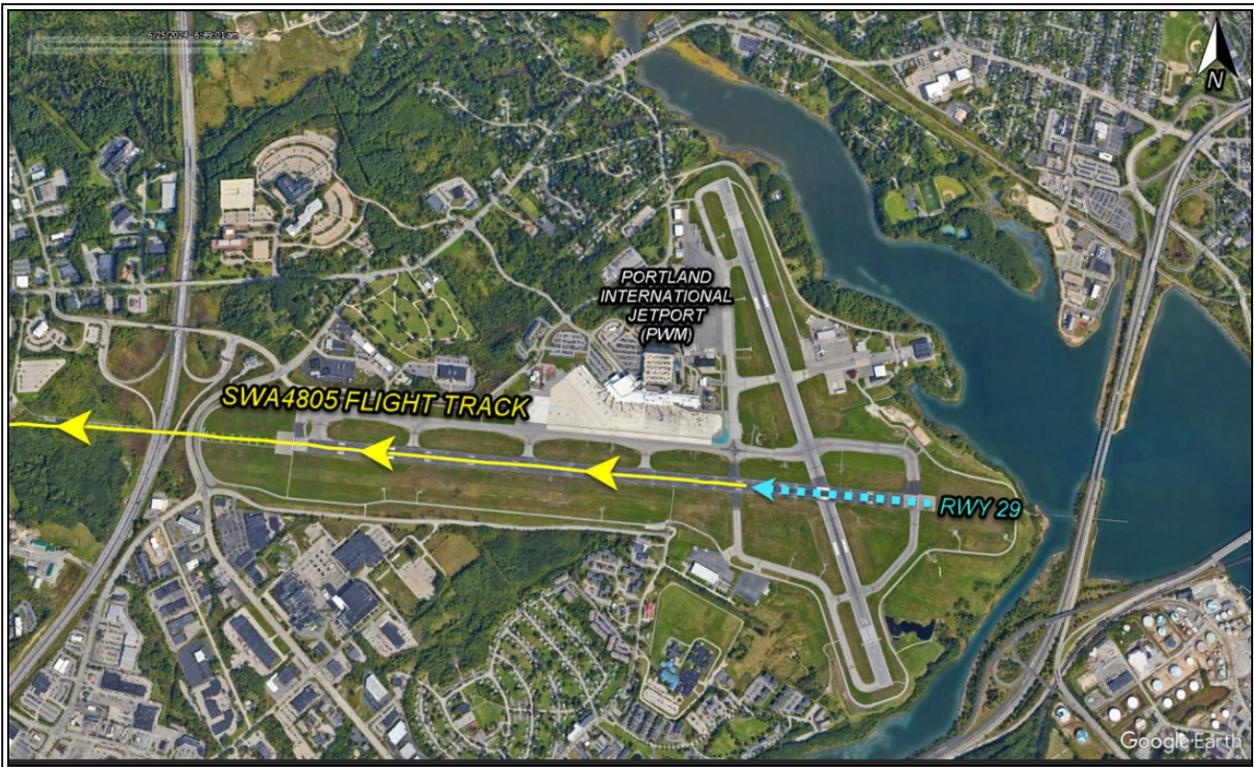
The airplane turned onto runway 29, and the FO announced on UNICOM that the airplane would be departing from runway 29. After a visual check of the runway, the flight crew verified the runway and that it was clear of all objects. The flight crew did not observe any equipment, markings, visual closed runway lighted "Xs" designations, or any other sign indicating that the runway was closed, and all equipment and people were clear of the runway. No other traffic or communication was heard on the UNICOM frequency. The flight departed runway 29 (figure 1) and continued to BWI uneventfully.

Figure 1. SWA flight 4805 departure from runway 29 overlaid on a Google Earth image.

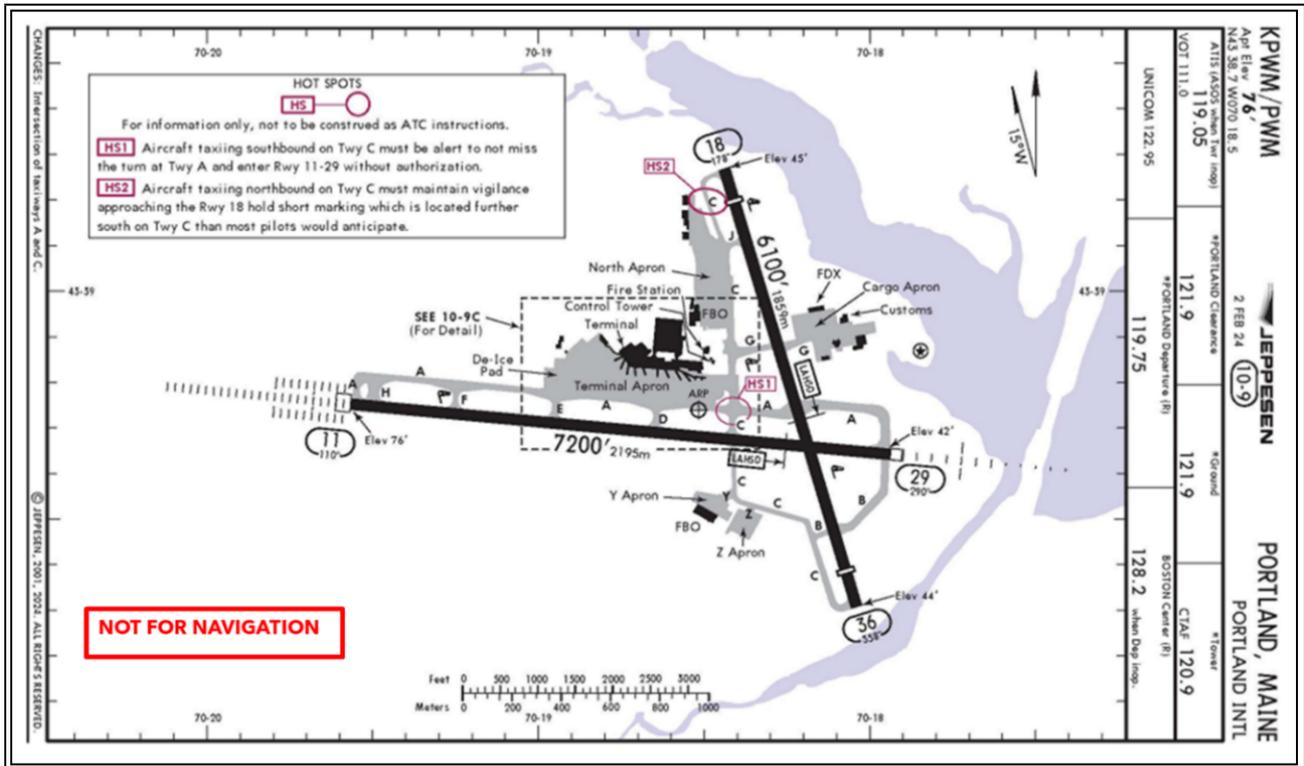
The airport was equipped with two separate frequencies with which pilots could communicate when the tower was not operating. Those frequencies were listed as the common traffic advisory frequency (CTAF) and UNICOM (see figure 2).

Figure 2. Jeppesen airport diagram for PWM.
