# Aviation Investigation Preliminary Report

<b>Location:</b>	Portland, ME	<b>Incident Number:</b>	DCA24LA219
<b>Date &amp; Time:</b>	June 25, 2024, 05:43 Local	<b>Registration:</b>	N7861J
<b>Aircraft:</b>	Boeing 737-79P	<b>Injuries:</b>	136 None
<b>Flight Conducted Under:</b>	Part 121: Air carrier - Scheduled

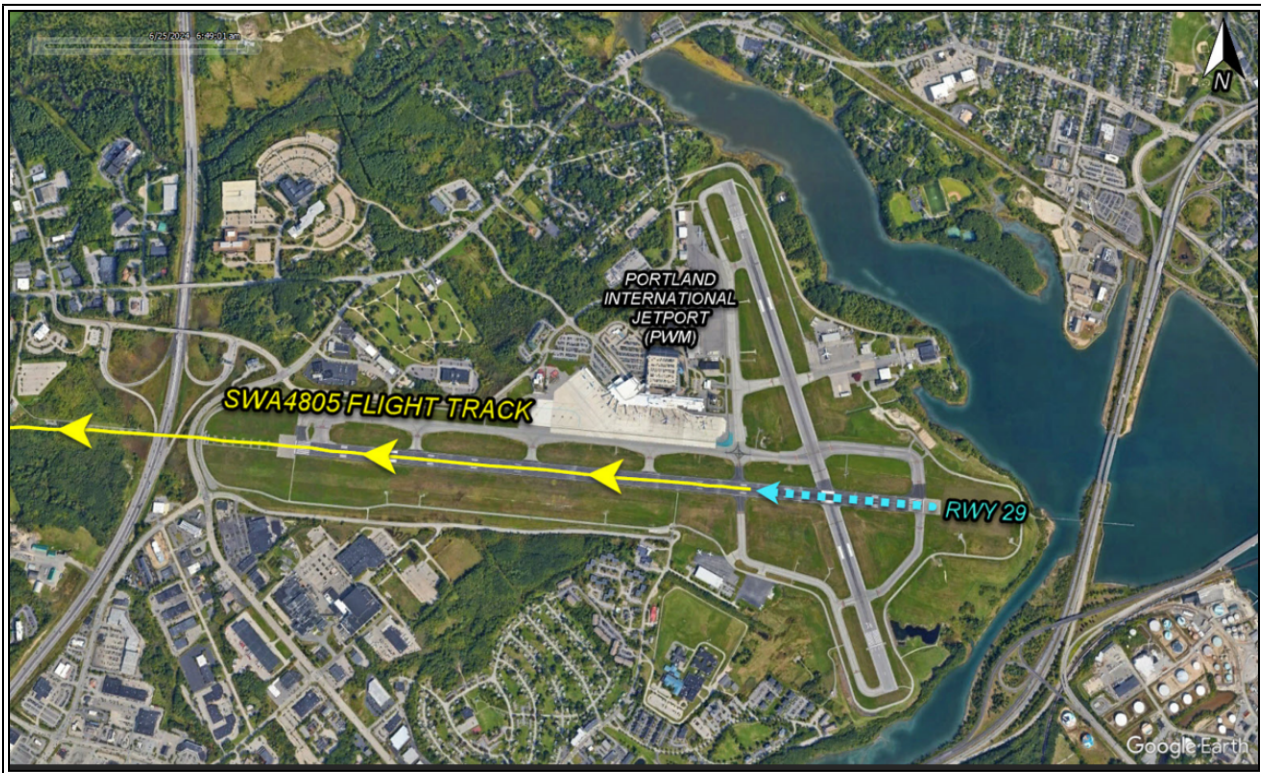
The airplane turned onto runway 29, and the FO announced on UNICOM that the airplane would be departing from runway 29. After a visual check of the runway, the flight crew verified the runway and that it was clear of all objects. The flight crew did not observe any equipment, markings, visual closed runway lighted "Xs" designations, or any other sign indicating that the runway was closed, and all equipment and people were clear of the runway. No other traffic or communication was heard on the UNICOM frequency. The flight departed runway 29 (figure 1) and continued to BWI uneventfully.

**Figure 1.** SWA flight 4805 departure from runway 29 overlaid on a Google Earth image.

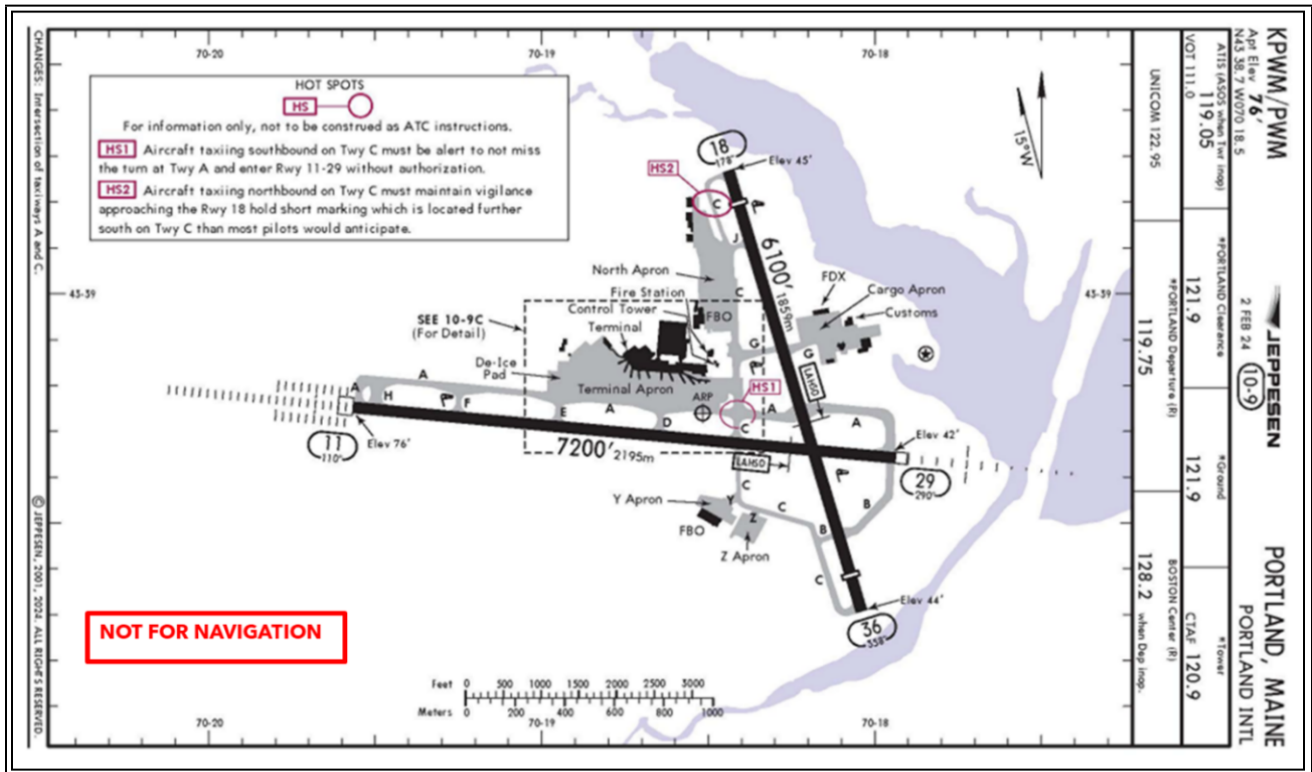
The airport was equipped with two separate frequencies with which pilots could communicate when the tower was not operating. Those frequencies were listed as the common traffic advisory frequency (CTAF) and UNICOM (see figure 2).

Figure 2. Jeppesen airport diagram for PWM.
