# **Aviation Investigation Preliminary Report**

**Location**: Kekaha, HI **Accident Number**: ANC24FA063

Date & Time: July 11, 2024, 13:05 Local Registration: N144KW

Aircraft: ROBINSON HELICOPTER R44 Injuries: 3 Fatal

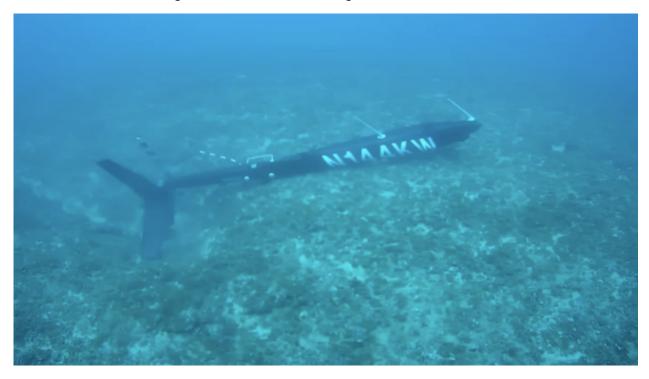
operated vehicle (ROV) on the three most probable targets. During the ROV search, the Coast Guard was able to locate the severed tail boom section of the helicopter in about 77 ft of water, but the main fuselage was not found. See figure 1

Figure 1. Robinson R44, N144KW, tail boom assembly (US Coast Guard Photo)
