Aviation Investigation Preliminary Report

Location:	Youngstown, NY	Accident Number:	ERA24FA309
Date & Time:	July 20, 2024, 11:40 Local	Registration:	N1259K
Aircraft:	Cessna 208	Injuries:	1 Fatal
Flight Conducted Under:	Part 91: General aviation - Skydiving

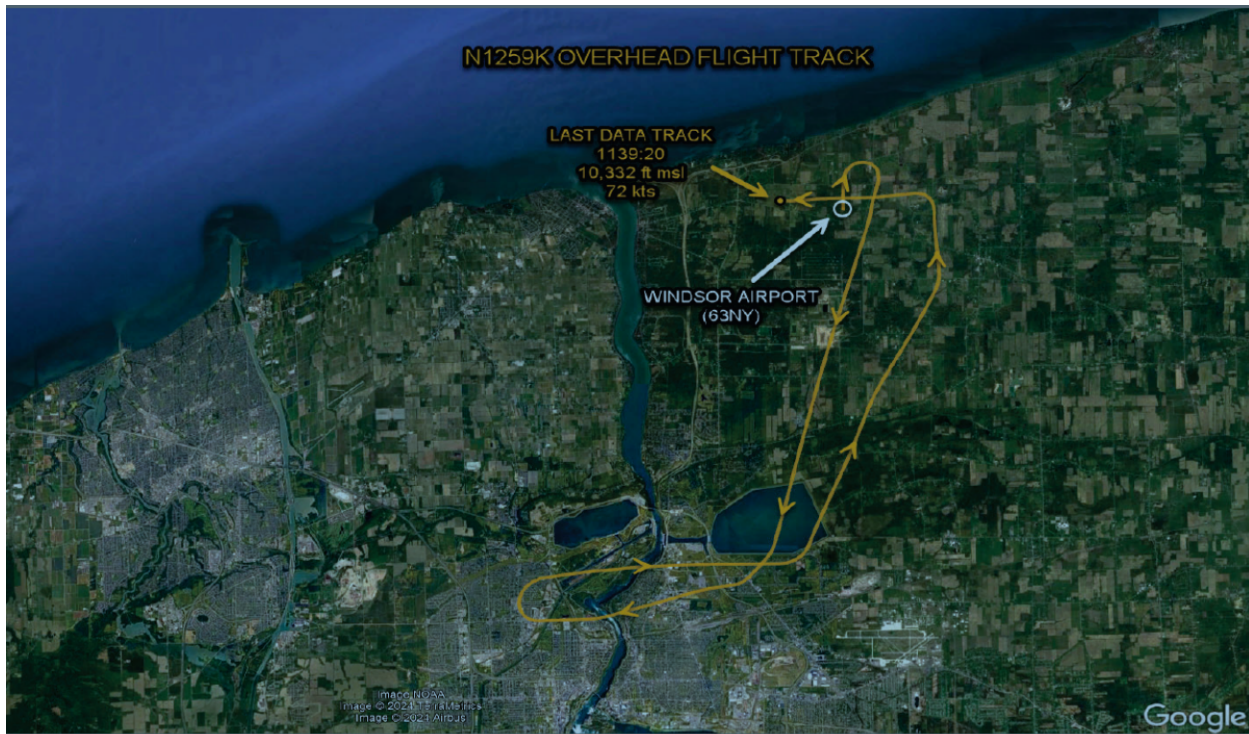
Review of preliminary ATC track data indicated that the airplane departed 63NY from runway 36, turned south and climbed to an altitude of 12,000 ft msl. The airplane subsequently made a jump pass from east to west over the airport. The track data ended near the west side of the airport, at 1139:20 at an altitude of 10,332 ft, an airspeed of 72 kts and a heading of 267° (see figure 1).

Figure 1.Overhead flight track of accident airplane (N1259K).
