Aviation Investigation Preliminary Report

Location:	Geneva, OH	Accident Number:	ERA24FA310
Date & Time:	July 21, 2024, 17:54 Local	Registration:	N751TX
Aircraft:	WILLIAMS JOHN TITAN T-51 MUSTANG	Injuries:	1 Fatal
Flight Conducted Under:	Part 91: General aviation - Personal

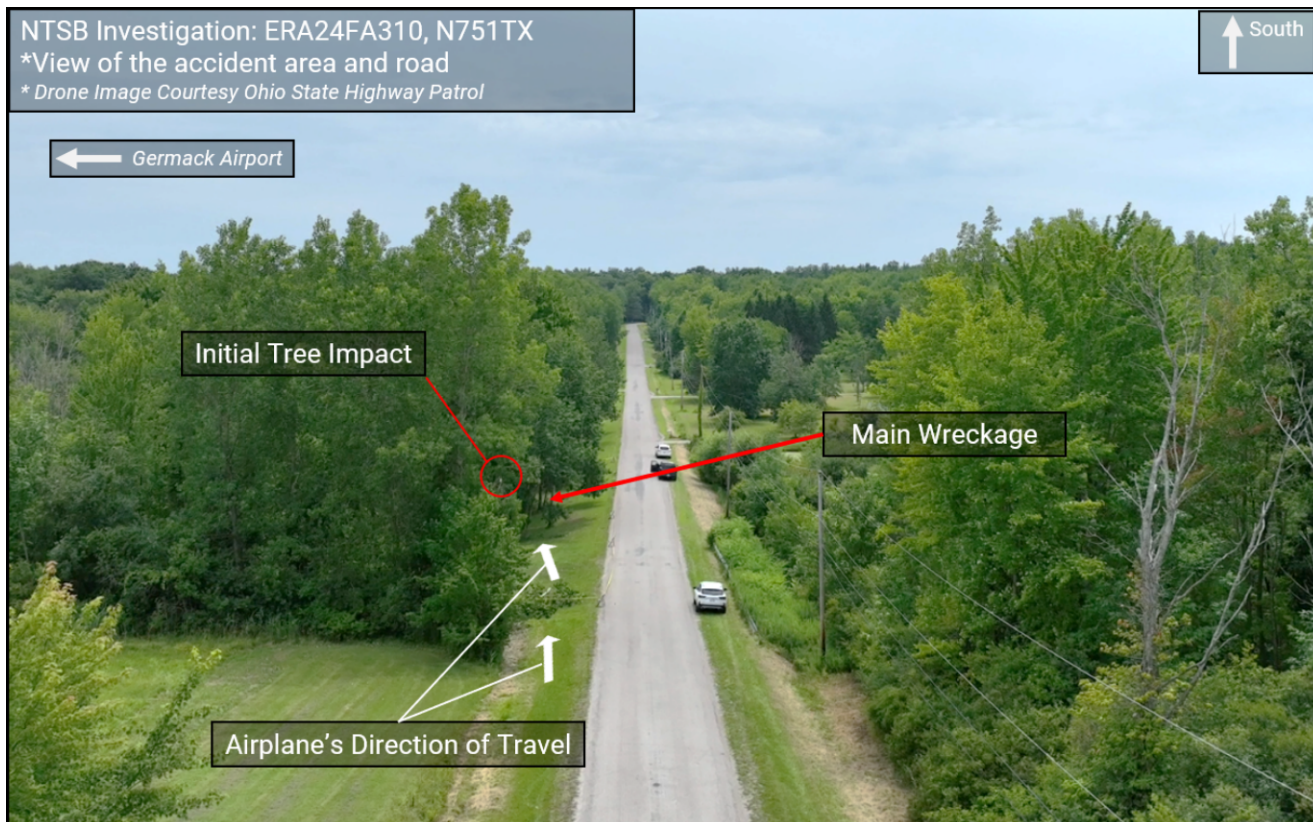
The main wreckage came to rest inverted in a wooded area about 30 ft east of a county road. The initial impact point coincided with elevated tree branches about 250 ft north of the main wreckage. All major portions of the airframe were located in the debris path. There was no evidence of fire. Three propeller blades were located a few hundred feet north of runway 1, and one blade fell onto runway 1. Fragments of engine cowling were located on and north of runway 1.

Figure 2: View of the accident site area and initial tree impact as viewed looking toward the South, which was the reported direction of the airplane's glide path.
