Aviation Investigation Preliminary Report

Location:	Geneva, OH	Accident Number:	ERA24FA310
Date & Time:	July 21, 2024, 17:54 Local	Registration:	N751TX
Aircraft:	WILLIAMS JOHN TITAN T-51 MUSTANG	Injuries:	1 Fatal
Flight Conducted Under:	Part 91: General aviation - Personal

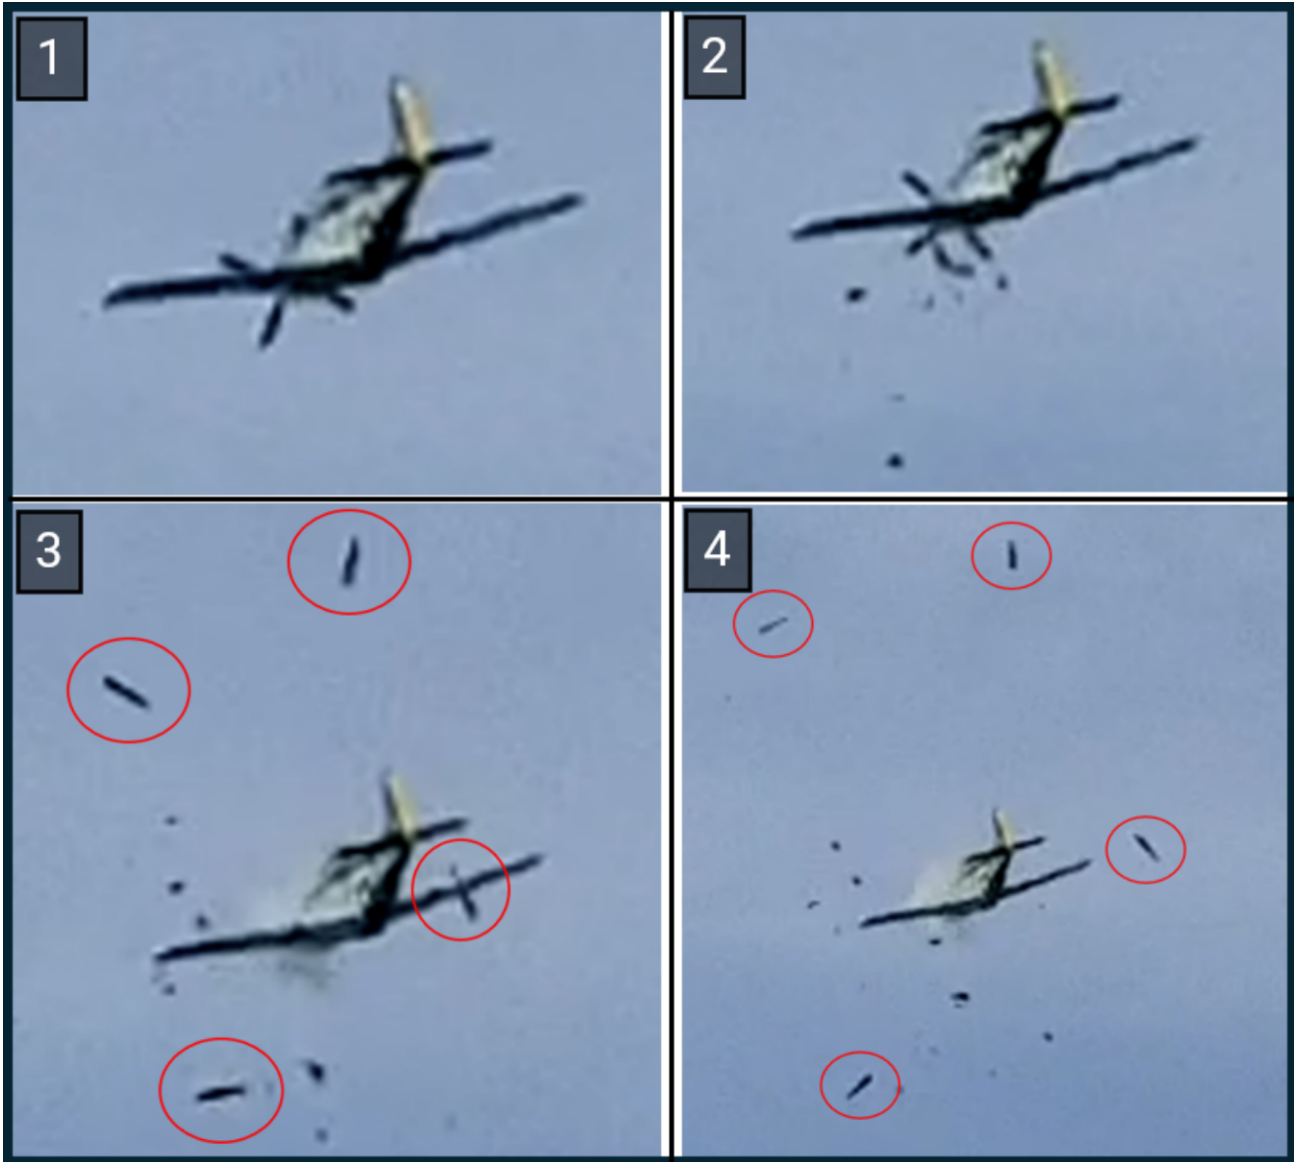
The private pilot located at the airport recorded a video of the pilot’s runway fly over. The video recorded the airplane approaching runway 1 a few hundred feet above ground level. The engine sound increased during the pull up, the airplane then entered a shallow left bank, and an explosion is seen and heard originating from the forward engine cowling area. Figure 1 shows the video frame by frame during the parts separation and the red circles outline the four propellers separated from the propeller hub.

Figure 1: Frame by frame view of the parts separation (the red circles outline the four propellers).
