Aviation Investigation Preliminary Report

Location:	Jamestown, NY	Accident Number:	ERA24FA338
Date & Time:	August 5, 2024, 10:11 Local	Registration:	N750GB
Aircraft:	Cessna 750	Injuries:	1 Serious, 1 Minor
Flight Conducted Under:	Part 91: General aviation - Business

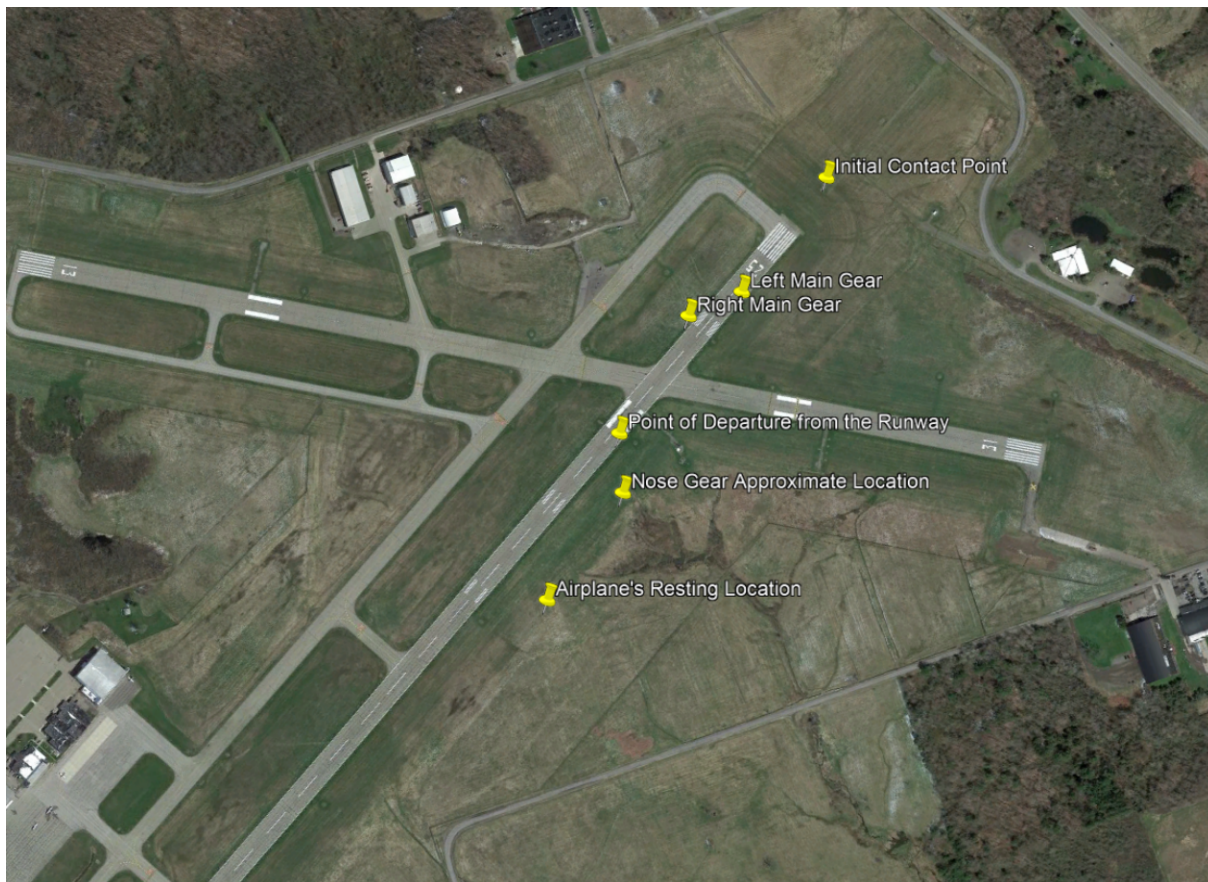
The airplane initially impacted terrain and runway lighting 200 ft before the approach end of runway 25. The airplane continued along the runway centerline, beyond the runway 13/31 intersection, continued off the left side of runway 25, and came to rest about 225 ft from the runway's left edge and about 2,150 ft beyond the initial impact point (figure 2).

Figure 2 – Wreckage path plots.

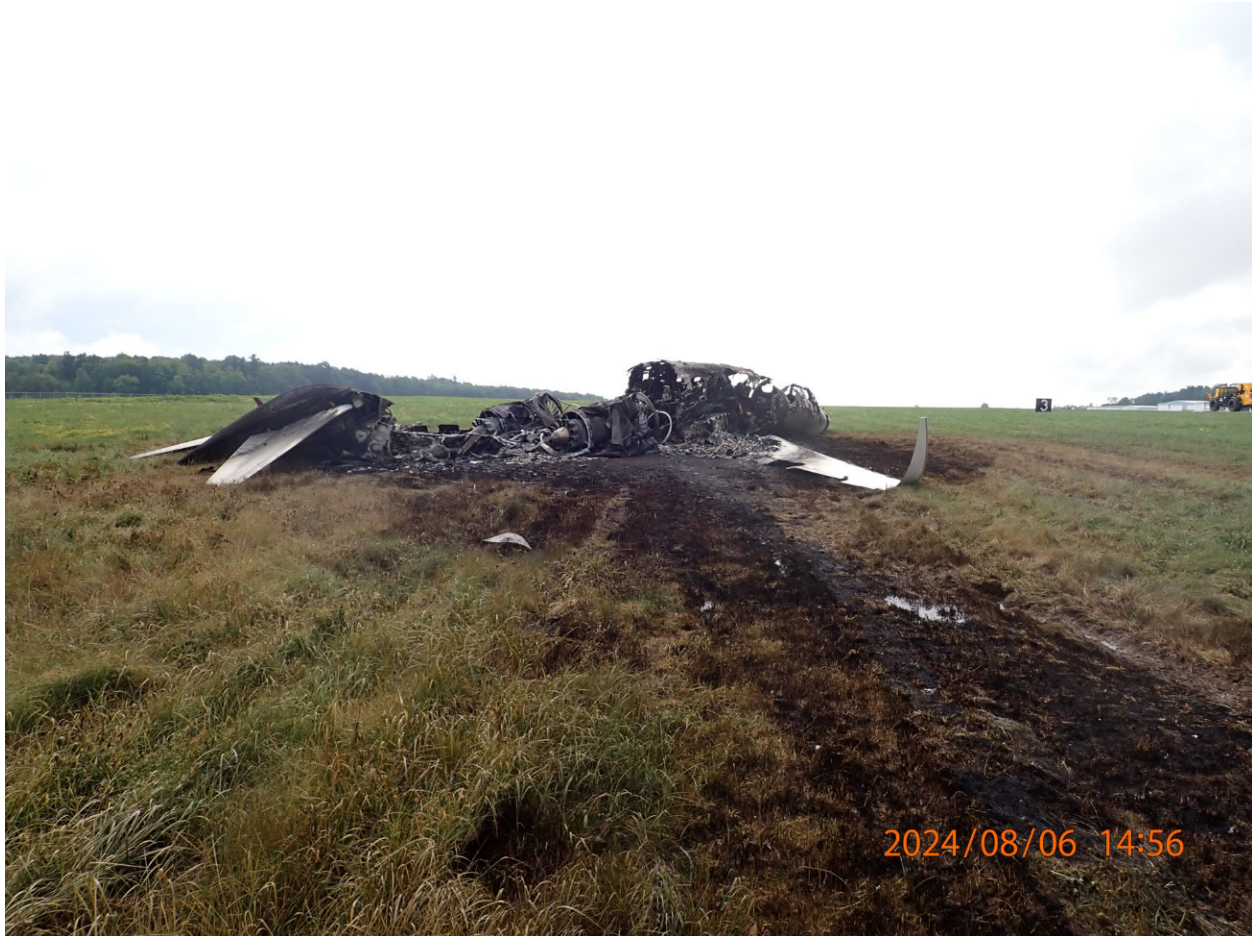
The airplane came to rest facing about 300° magnetic. The cockpit, cabin area, inboard sections of both wings, empennage, and the root section of the vertical stabilizer were consumed by post-impact fire. The upper portion of the vertical stabilizer and the horizontal stabilizers were intact (figure 3).

Figure 3 – View of main wreckage facing direction of travel.
