Aviation Investigation Preliminary Report

Location:	Jamestown, NY	Accident Number:	ERA24FA338
Date & Time:	August 5, 2024, 10:11 Local	Registration:	N750GB
Aircraft:	Cessna 750	Injuries:	1 Serious, 1 Minor
Flight Conducted Under:	Part 91: General aviation - Business

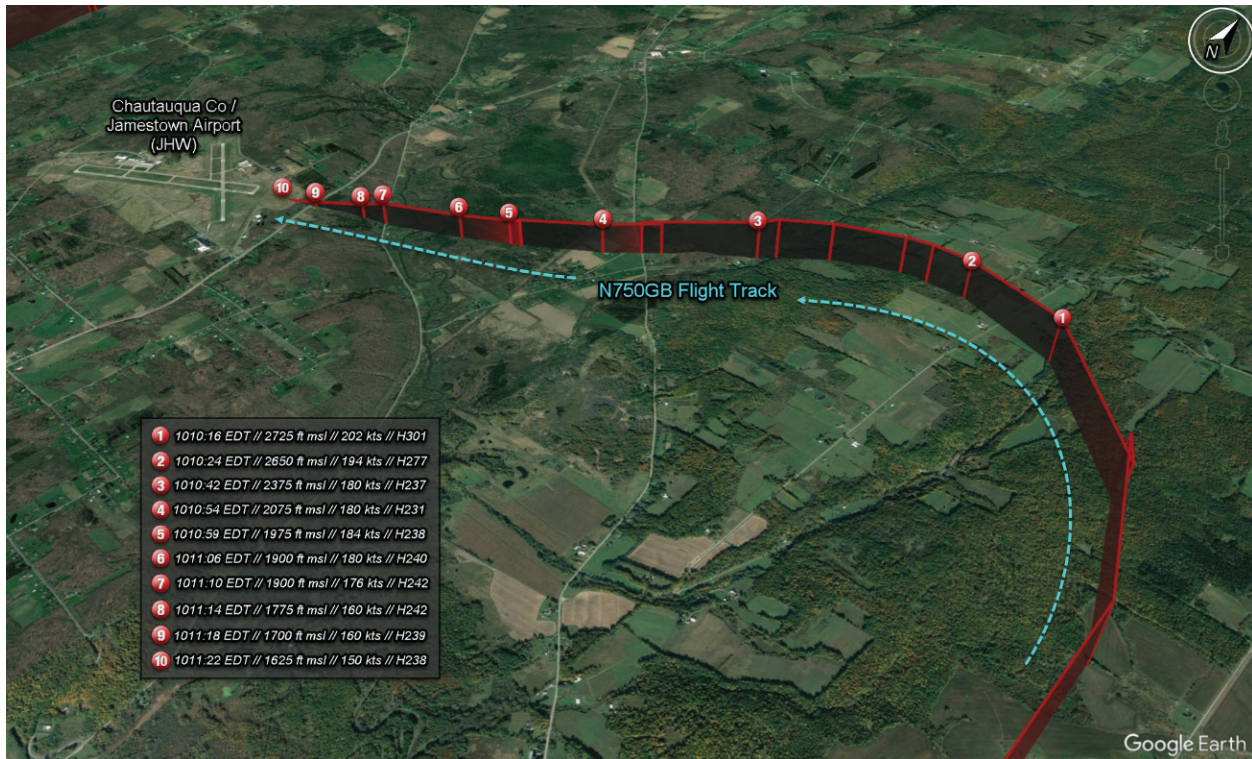
Figure 1 – ADS-B track data depicting the final minute of the accident flight

a left, descending, decelerating, 270°-degree turn to align with runway 25 (figure 1). The final target showed the airplane aligned with the runway at 1,625 ft and 150 kts. The airplane impacted the ground in a flat attitude about 200 ft before the approach end of runway 25 at JHW, which was located at an elevation of 1,723 ft.

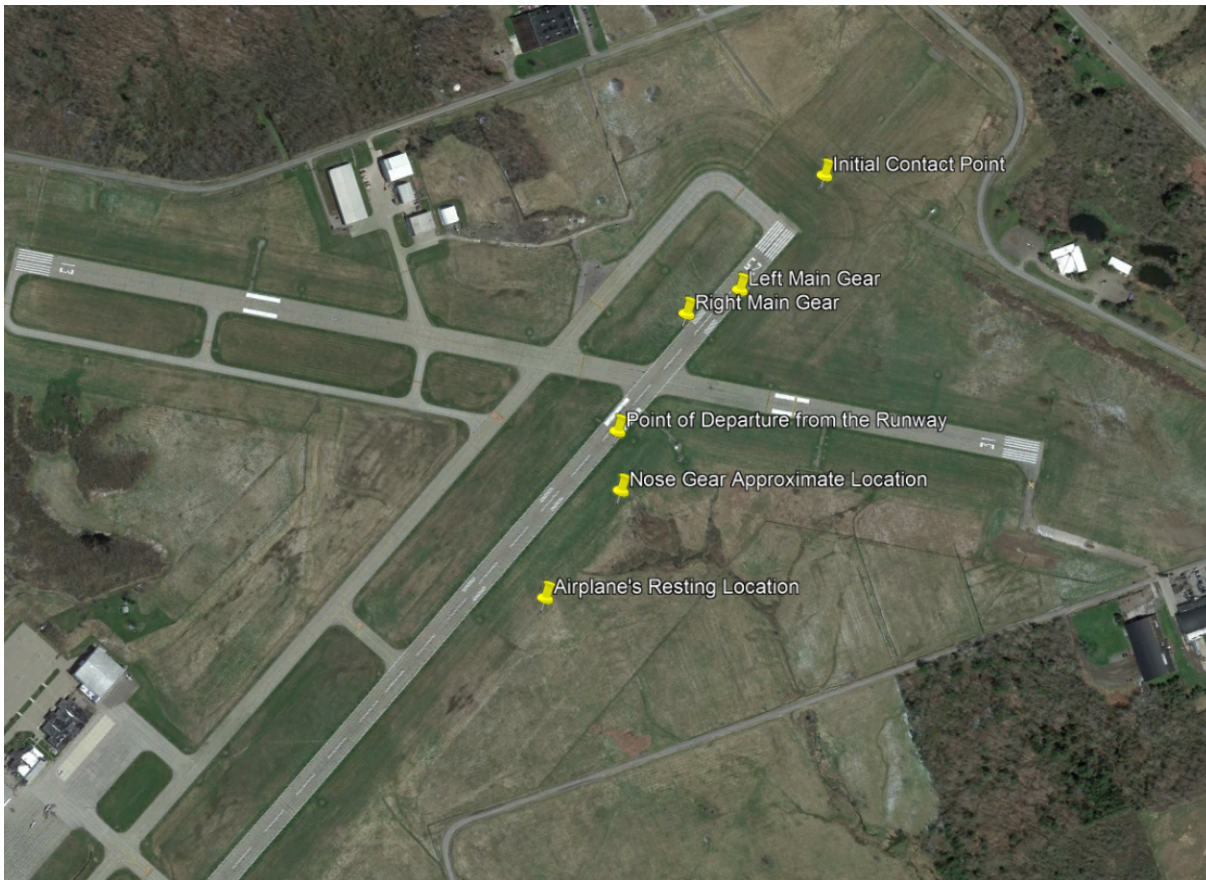
Figure 2 – Wreckage path plots.

The airplane initially impacted terrain and runway lighting 200 ft before the approach end of runway 25. The airplane continued along the runway centerline, beyond the runway 13/31 intersection, continued off the left side of runway 25, and came to rest about 225 ft from the runway's left edge and about 2,150 ft beyond the initial impact point (figure 2).
