# Aviation Investigation Final Report

<b>Location:</b>	Guthrie, Oklahoma	<b>Accident Number:</b>	CEN24LA317
<b>Date &amp; Time:</b>	August 14, 2024, 20:21 Local	<b>Registration:</b>	N184DC
<b>Aircraft:</b>	Vans RV8	<b>Aircraft Damage:</b>	Substantial
<b>Defining Event:</b>	Loss of engine power (total)	<b>Injuries:</b>	1 None
<b>Flight Conducted Under:</b>	Part 91: General aviation - Personal

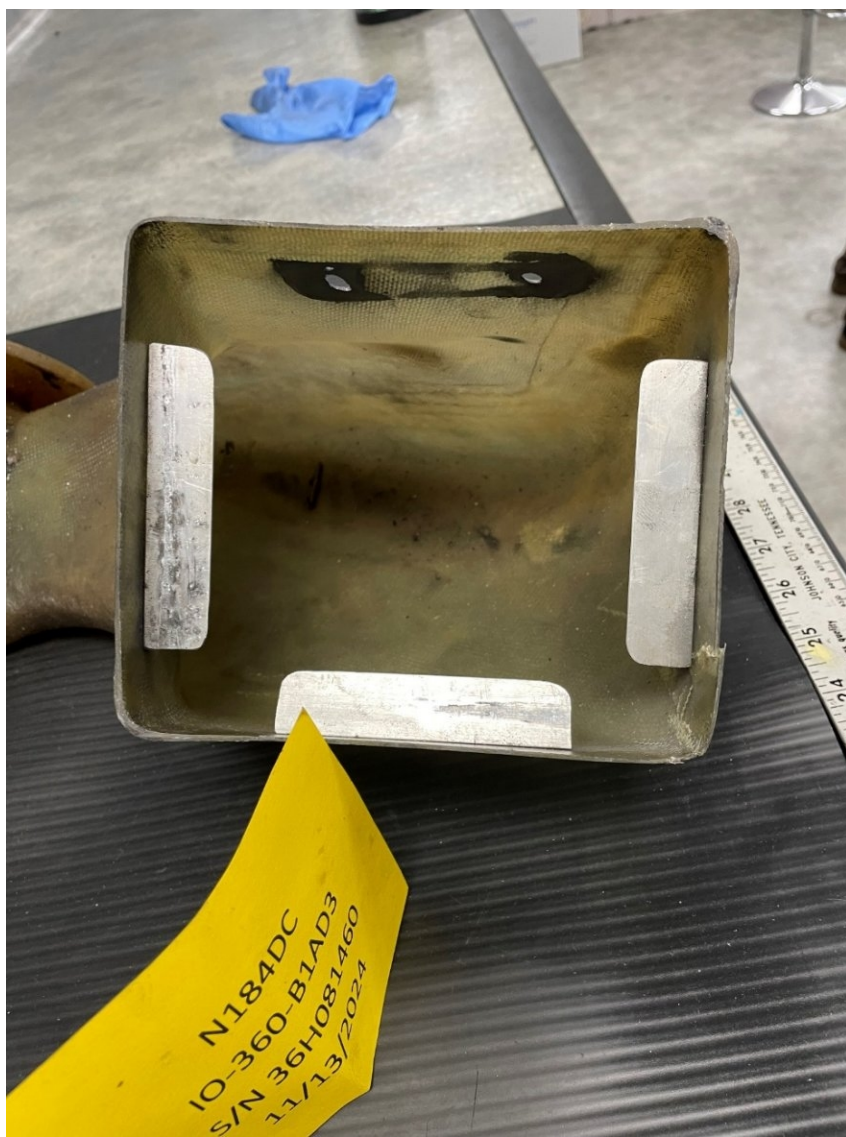
Postaccident examination of the engine revealed an air filter retaining bracket that was fastened to a fiberglass air snorkel/box had separated and was ingested into the No. 2 cylinder. The separated bracket then jammed the intake valve into the open position, resulting in a loss of engine power. Elongation was noted on the fiberglass where the rivets secured the fabricated retaining bracket.

Postaccident examination of the engine revealed no compression was noted on the No. 2 cylinder. The air filter was removed from the fiberglass air snorkel/box, and one of the four fabricated retaining brackets was separated and missing (see Figure 1). Elongation was noted on the fiberglass where the rivets secured the fabricated retaining bracket.

Figure 1. Air filter retaining brackets; one bracket separated and missing.

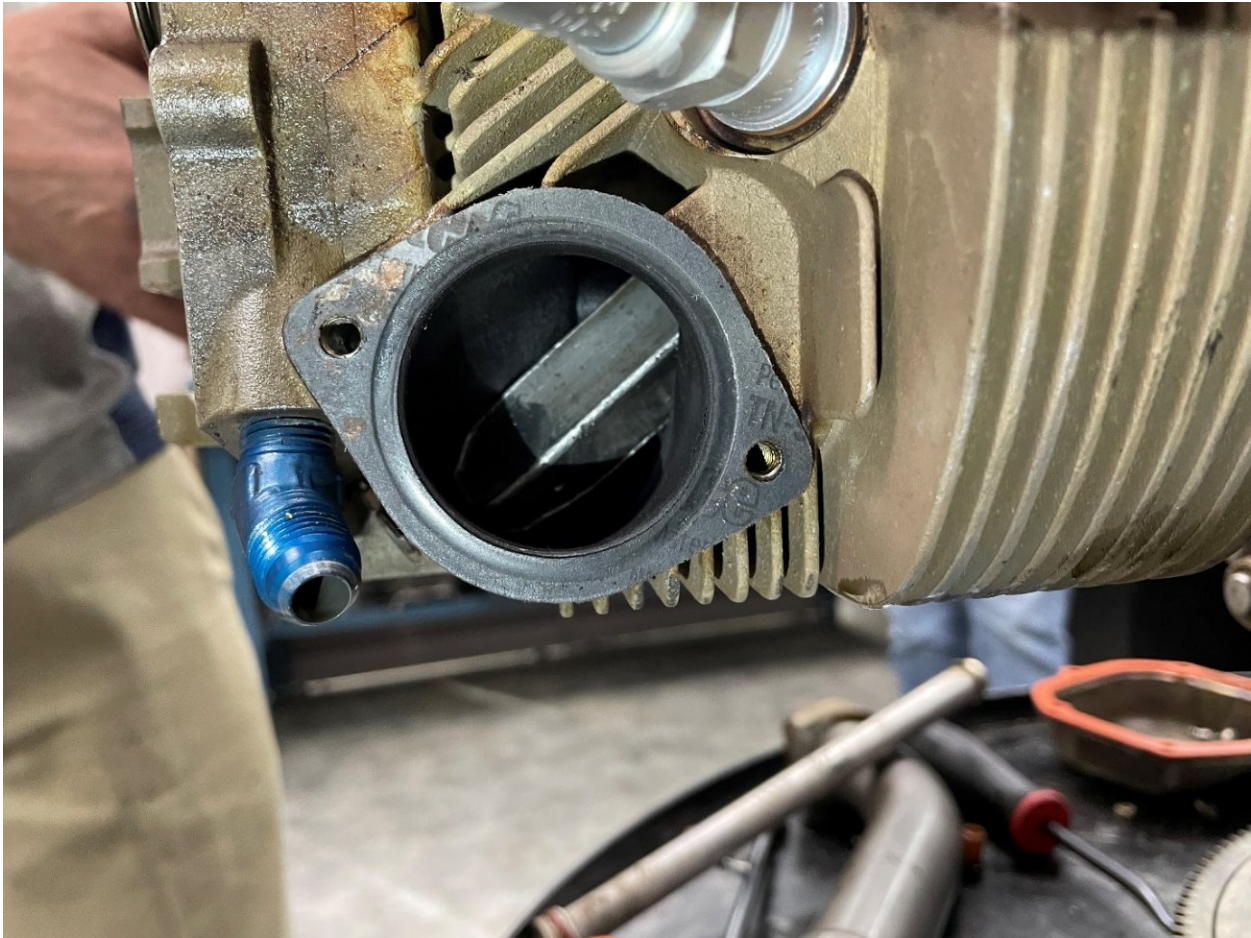
The No. 2 cylinder intake tube was removed, and a foreign metal piece, consistent with the separated retaining bracket, was observed within the cylinder. The bracket was jammed in the cylinder and under the intake valve seat. The intake valve and retaining bracket were removed from the cylinder and photo documented (see Figures 2 and 3).

Figure 2. No 2. cylinder intake and separated retaining bracket.

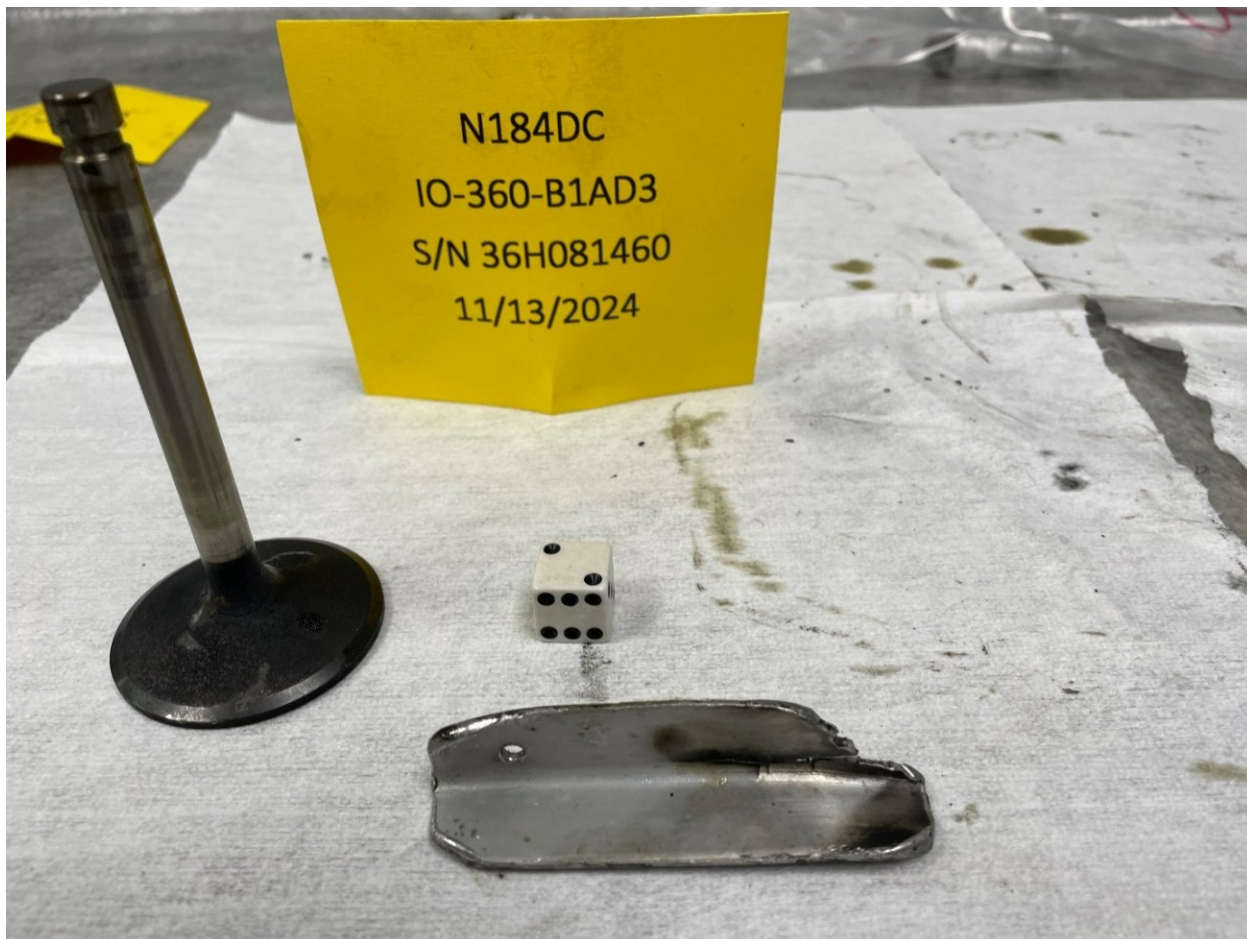
A loss of engine power due to the separation and ingestion of an air filter retaining bracket into the engine cylinder.

Figure 3. Separated air filter retaining bracket located in the No. 2 cylinder intake.
