Aviation Investigation Preliminary Report

Location: College Park, GA Accident Number: DCA24FA299

Date & Time:
 September 10, 2024, 10:07 Local
 Registration:
 N503DN (A1); N302PQ (A2)

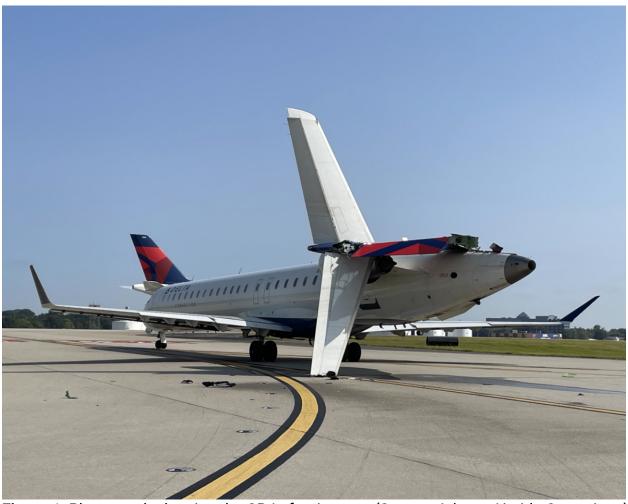
Figure 1. Photograph showing the CRJ after impact. (Source: Atlanta Airside Operations)

At that time, the right wingtip of the A350 impacted the vertical stabilizer of the CRJ, which was holding short of runway 8R at taxiway H. Following the collision, the captain stopped the A350 and set the parking brake. After airport rescue and firefighting (ARFF) examined the exterior of the A350, the crew was given clearance for the airplane to return to the gate.

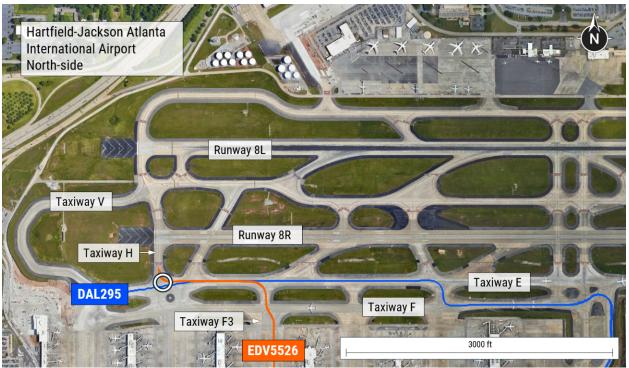
Figure 2 is a Google Earth screenshot that is overlaid with the ground tracks of the A350 (DAL295, the blue line) and the CRJ (EDV5526, the orange line). The white circle shows the location of the collision at the intersection of taxiways E and H.

Figure 2. Ground position tracks for DAL295 (A350) and EDV5526 (CRJ) in relation to taxiways E and H.

The FAA provided the NTSB with certified ADS-B latitude and longitude data. Analysis of the ADS-B and preliminary FDR data showed the airplanes collided at 10:07:46. The CRJ was stationary, and the A350 was taxiing at a groundspeed of about 12 knots. The CRJ sustained lateral accelerations of 0.5 G left followed by 0.55 G right, and the CRJ's heading was rotated about 9° clockwise.

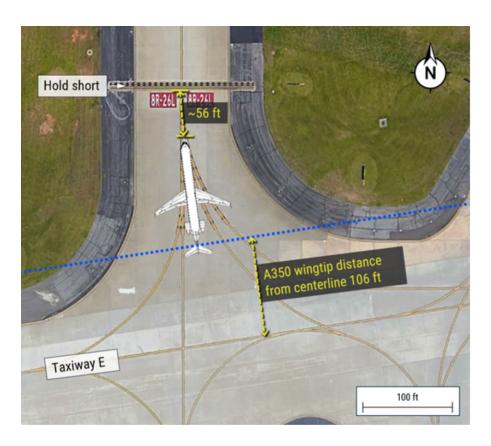
On September 13, the operations group met at the Delta Air Lines general offices in ATL to interview the flight crews. The airworthiness group examined the accident airplane from September 11 to 13, 2024, in ATL. According to Endeavor, the distance from the hold short line to the nose landing gear of the CRJ was approximately 56 feet (figure 3). The A350 was examined at the Delta Tech Ops facility, and the CRJ was examined at the Endeavor Air facility.

Figure 3. Image showing the distance from the hold short line to the nose landing gear of the CRJ.
