# Aviation Investigation Preliminary Report

<b>Location:</b>	College Park, GA	<b>Accident Number:</b>	DCA24FA299
<b>Date &amp; Time:</b>	September 10, 2024, 10:07 Local	<b>Registration:</b>	N503DN (A1); N302PQ (A2)
<b>Aircraft:</b>	Airbus A350-941 (A1); Mitsubishi Heavy Industries (MHI)/Bombardier CL600 2D24-900 (A2)	<b>Injuries:</b>	236 None (A1); 1 Minor, 59 None (A2)
<b>Flight Conducted Under:</b>	Part 121: Air carrier - Scheduled (A1); Part 121: Air carrier - Scheduled (A2)

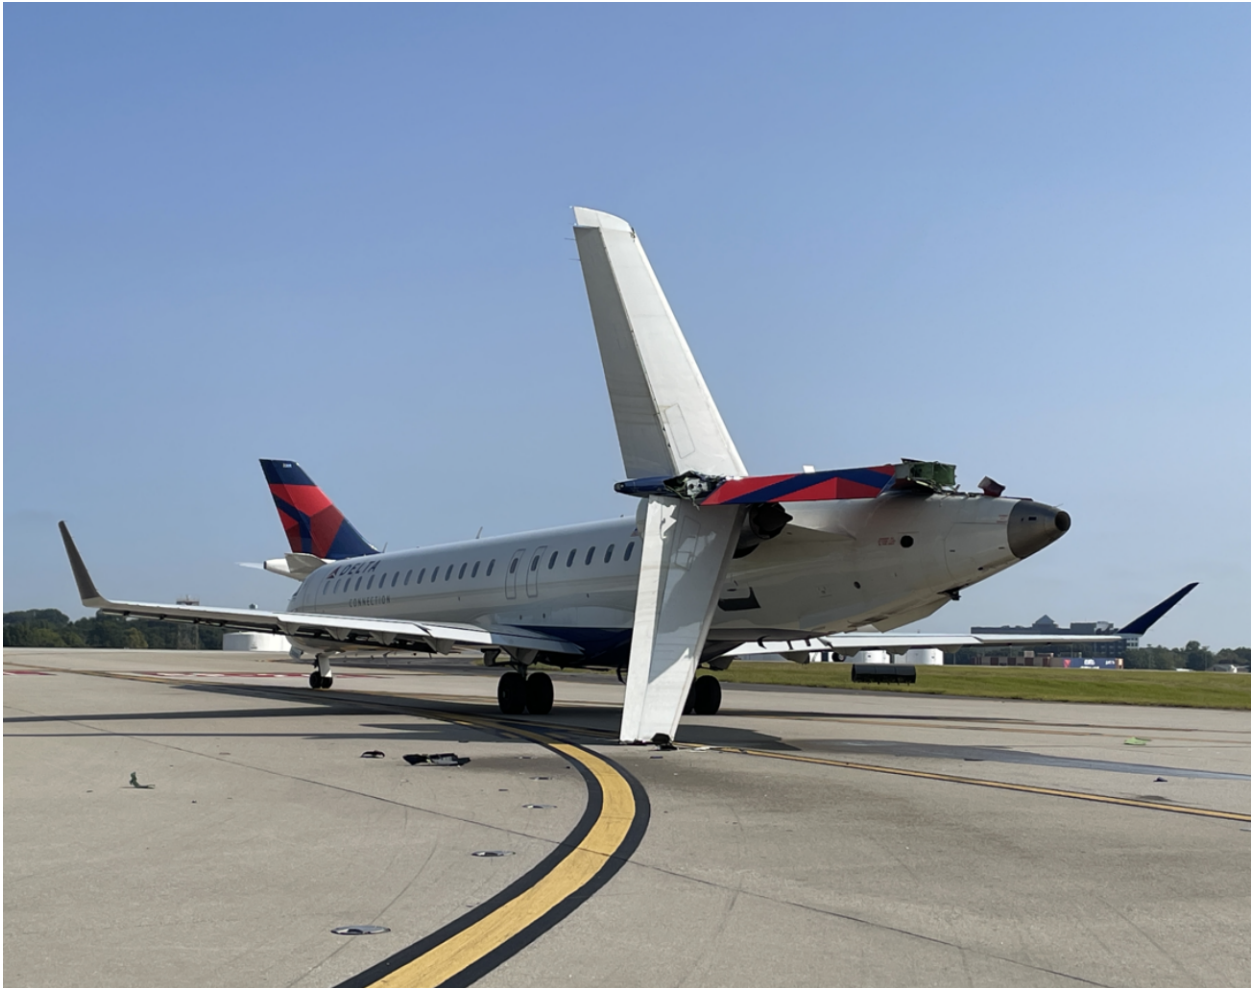
**Figure 1.** Photograph showing the CRJ after impact. (Source: Atlanta Airside Operations)

At that time, the right wingtip of the A350 impacted the vertical stabilizer of the CRJ, which was holding short of runway 8R at taxiway H. Following the collision, the captain stopped the A350 and set the parking brake. After airport rescue and firefighting (ARFF) examined the exterior of the A350, the crew was given clearance for the airplane to return to the gate.

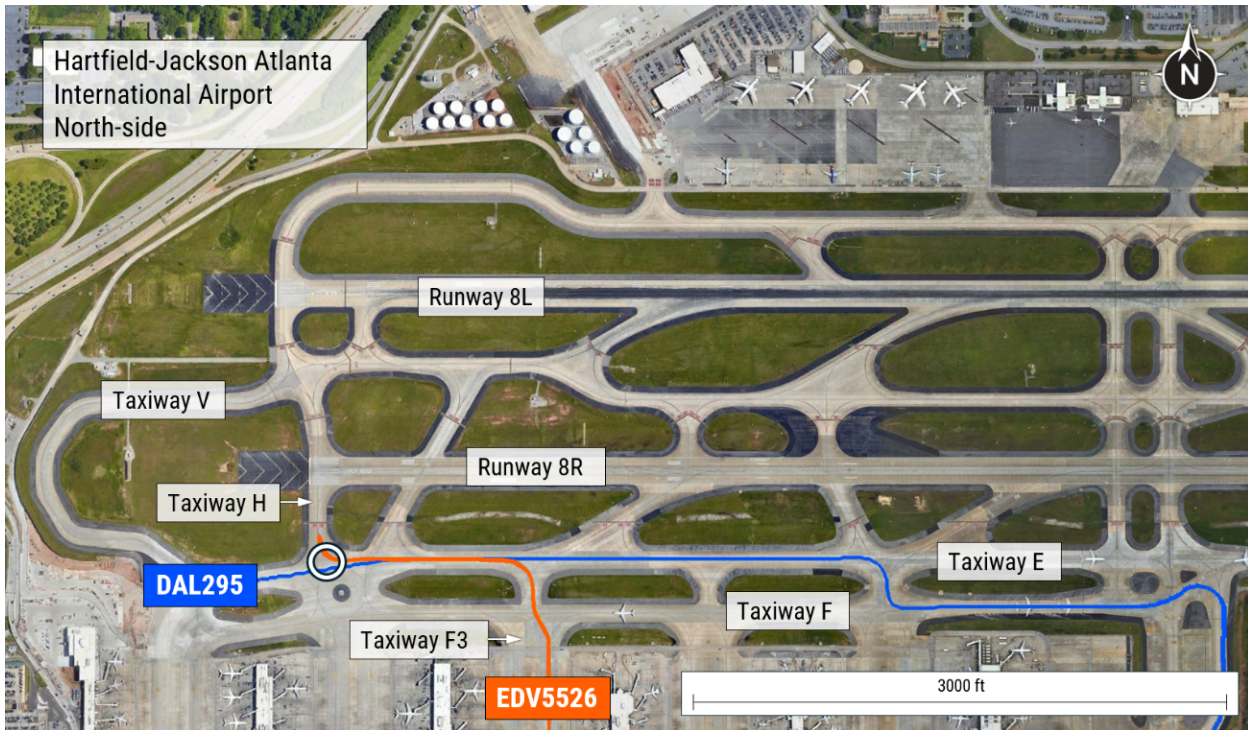
Figure 2 is a Google Earth screenshot that is overlaid with the ground tracks of the A350 (DAL295, the blue line) and the CRJ (EDV5526, the orange line). The white circle shows the location of the collision at the intersection of taxiways E and H.

**Figure 2.** Ground position tracks for DAL295 (A350) and EDV5526 (CRJ) in relation to taxiways E and H.

The FAA provided the NTSB with certified ADS-B latitude and longitude data. Analysis of the ADS-B and preliminary FDR data showed the airplanes collided at 10:07:46. The CRJ was stationary, and the A350 was taxiing at a groundspeed of about 12 knots. The CRJ sustained lateral accelerations of 0.5 G left followed by 0.55 G right, and the CRJ's heading was rotated about 9° clockwise.

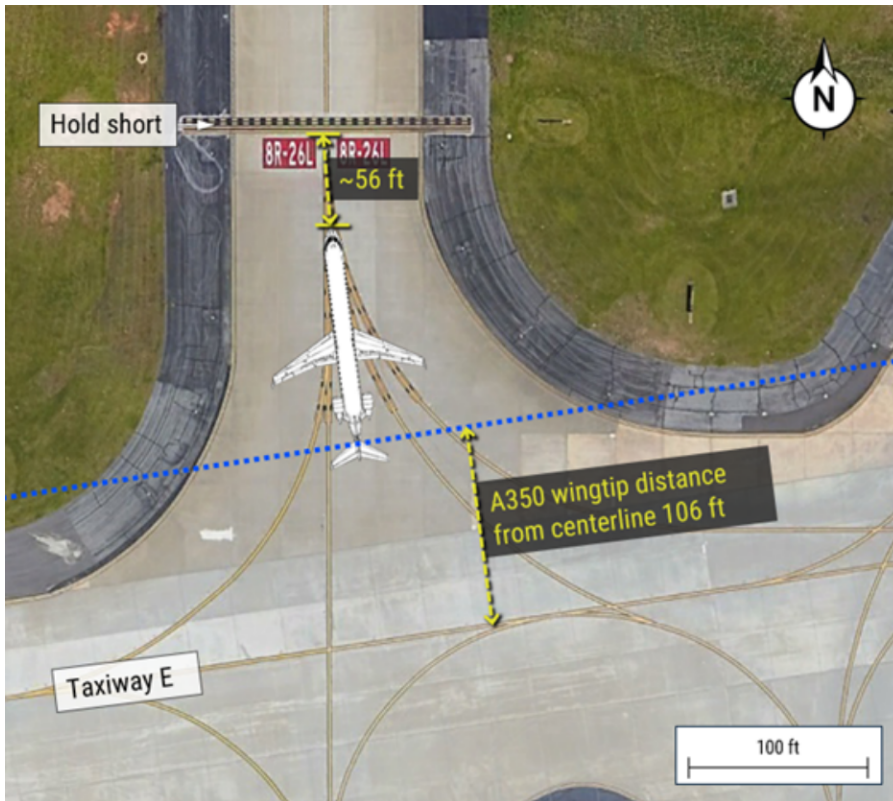
On September 13, the operations group met at the Delta Air Lines general offices in ATL to interview the flight crews. The airworthiness group examined the accident airplane from September 11 to 13, 2024, in ATL. According to Endeavor, the distance from the hold short line to the nose landing gear of the CRJ was approximately 56 feet (figure 3). The A350 was examined at the Delta Tech Ops facility, and the CRJ was examined at the Endeavor Air facility.

**Figure 3.** Image showing the distance from the hold short line to the nose landing gear of the CRJ.
