Aviation Investigation Preliminary Report

Location:	Saint Mary's, AK	Accident Number:	ANC24FA094
Date & Time:	September 15, 2024, 22:04 Local	Registration:	N90193
Aircraft:	Cessna 207	Injuries:	4 Fatal
Flight Conducted Under:	Part 91: General aviation - Personal

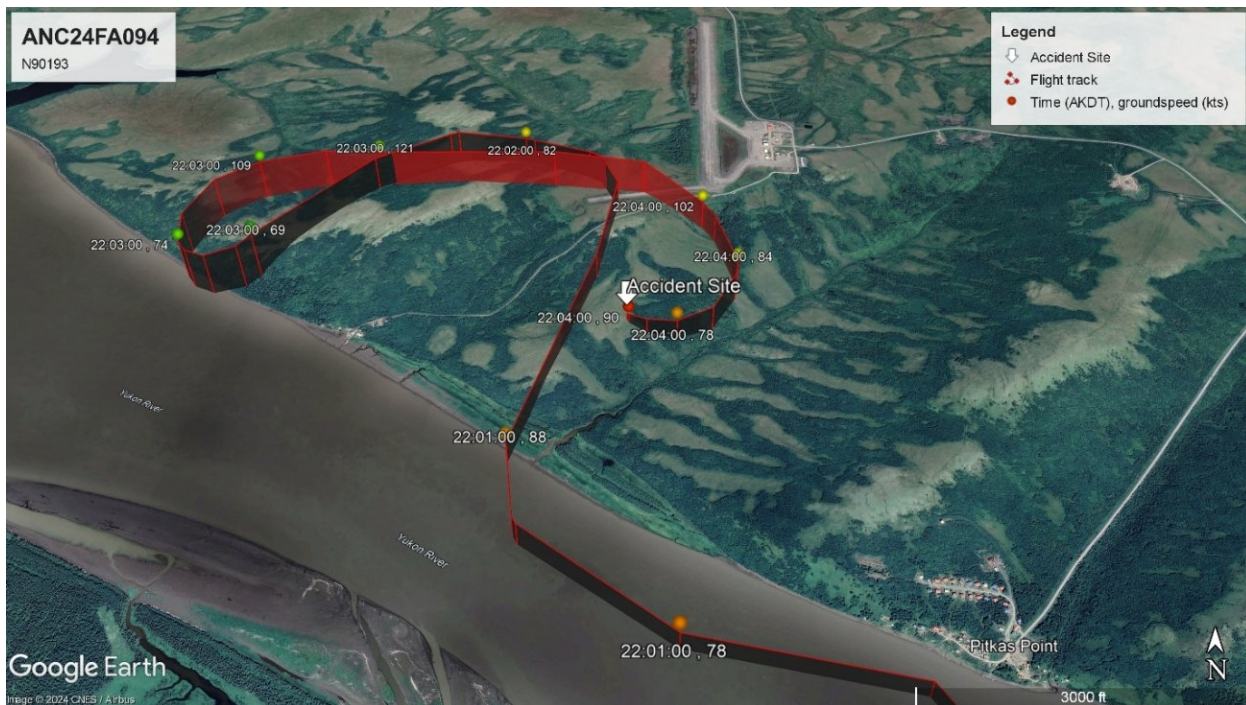
According to the flight tracking service used by the operator, the airplane departed BET about 2108 and proceeded to the northwest to KSM between 500 and 800 ft above ground level (agl). At 2159, the airplane was about 4 nautical miles southeast of the KSM airport and about 180 ft agl over the Yukon River. The airplane continued north toward the airport, overflew the west side of runway 6/24, then maneuvered to the west of the airport. The airplane then made a left 180° turn and overflew runway 6/24 about 200 ft agl. The airplane turned right and proceeded south, then made a steep right descending turn toward the ground. The final recorded point was above the accident site (See figure 1).

Figure 1. Accident flight track near St. Mary's Airport overlaid on Google Earth.

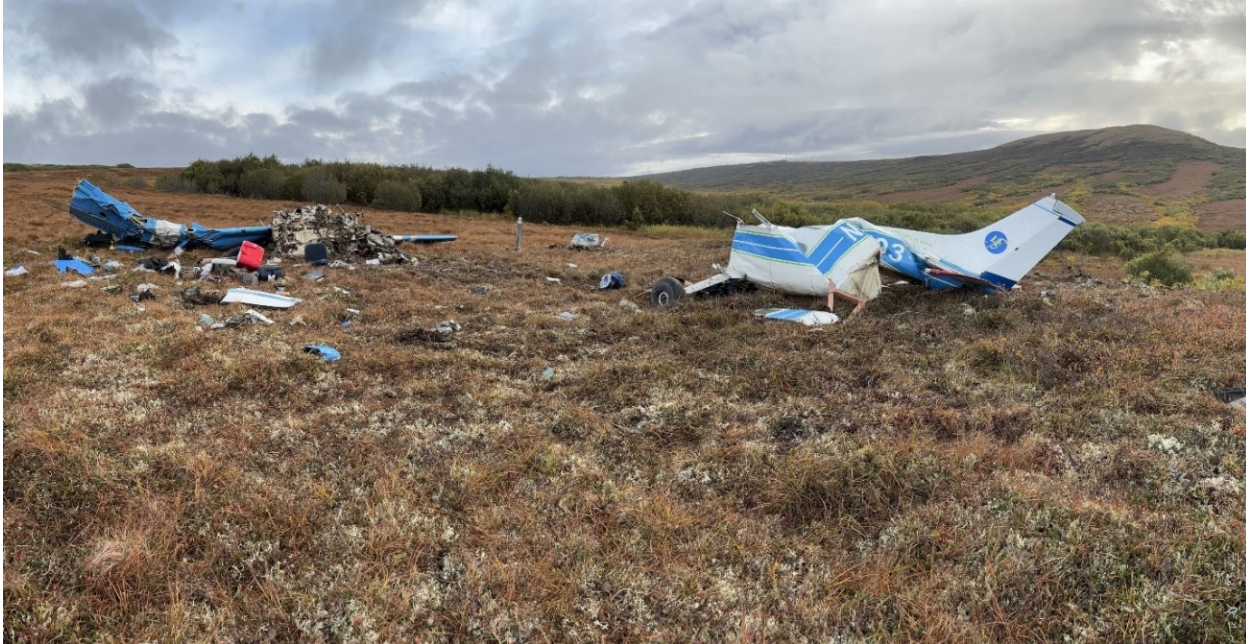
The NTSB on-scene wreckage examination revealed that the airplane impacted rising terrain in a right wing low and nose low attitude on a northwest heading. The highly fragmented debris path was about 150 ft long and contained all major components of the airplane (See figure 2).

Figure 2. A view of the airplane wreckage at the accident site facing north (Courtesy of FAA).
The airplane wreckage was recovered for the accident site and transported to Wasilla, Alaska, and a detailed NTSB examination is pending.
