Aviation Investigation Preliminary Report

Location:	Saint Mary's, AK	Accident Number:	ANC24FA094
Date & Time:	September 15, 2024, 22:04 Local	Registration:	N90193
Aircraft:	Cessna 207	Injuries:	4 Fatal
Flight Conducted Under:	Part 91: General aviation - Personal

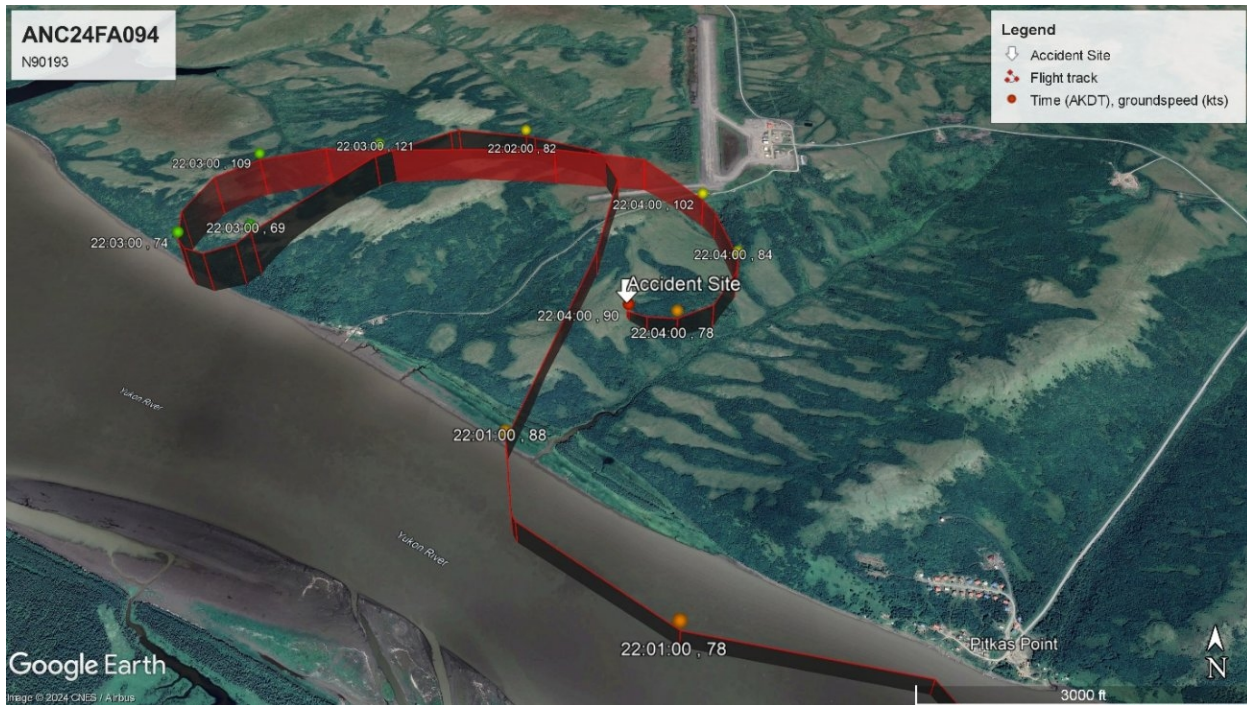
According to the flight tracking service used by the operator, the airplane departed BET about 2108 and proceeded to the northwest to KSM between 500 and 800 ft above ground level (agl). At 2159, the airplane was about 4 nautical miles southeast of the KSM airport and about 180 ft agl over the Yukon River. The airplane continued north toward the airport, overflew the west side of runway 6/24, then maneuvered to the west of the airport. The airplane then made a left 180° turn and overflew runway 6/24 about 200 ft agl. The airplane turned right and proceeded south, then made a steep right descending turn toward the ground. The final recorded point was above the accident site (See figure 1).

Figure 1. Accident flight track near St. Mary's Airport overlaid on Google Earth.
