Aviation Investigation Preliminary Report

Location:	Saint Mary's, AK	Accident Number:	ANC24FA094
Date & Time:	September 15, 2024, 22:04 Local	Registration:	N90193
Aircraft:	Cessna 207	Injuries:	4 Fatal
Flight Conducted Under:	Part 91: General aviation - Personal

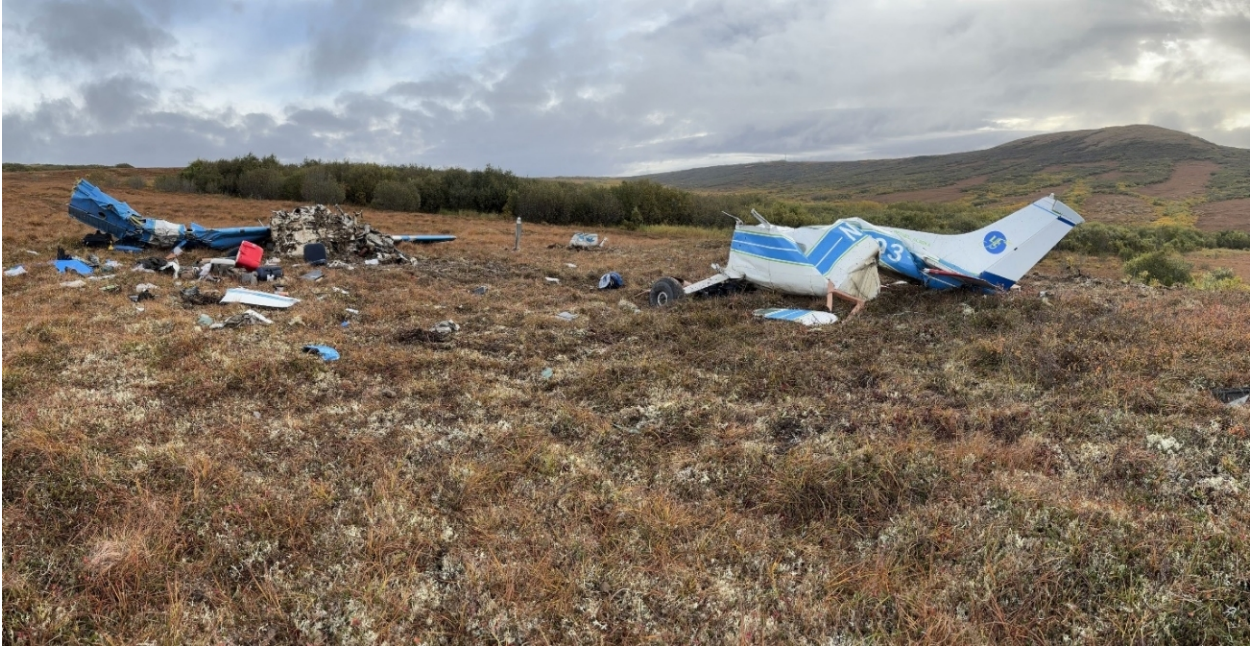
The NTSB on-scene wreckage examination revealed that the airplane impacted rising terrain in a right wing low and nose low attitude on a northwest heading. The highly fragmented debris path was about 150 ft long and contained all major components of the airplane (See figure 2).

Figure 2. A view of the airplane wreckage at the accident site facing north (Courtesy of FAA).
