Aviation Investigation Preliminary Report

Location:	Las Vegas, NV	Incident Number:	DCA25LA001
Date & Time:	October 5, 2024, 15:10 Local	Registration:	N701FR
Aircraft:	Airbus A321-211	Injuries:	197 None
Flight Conducted Under:	Part 121: Air carrier - Scheduled

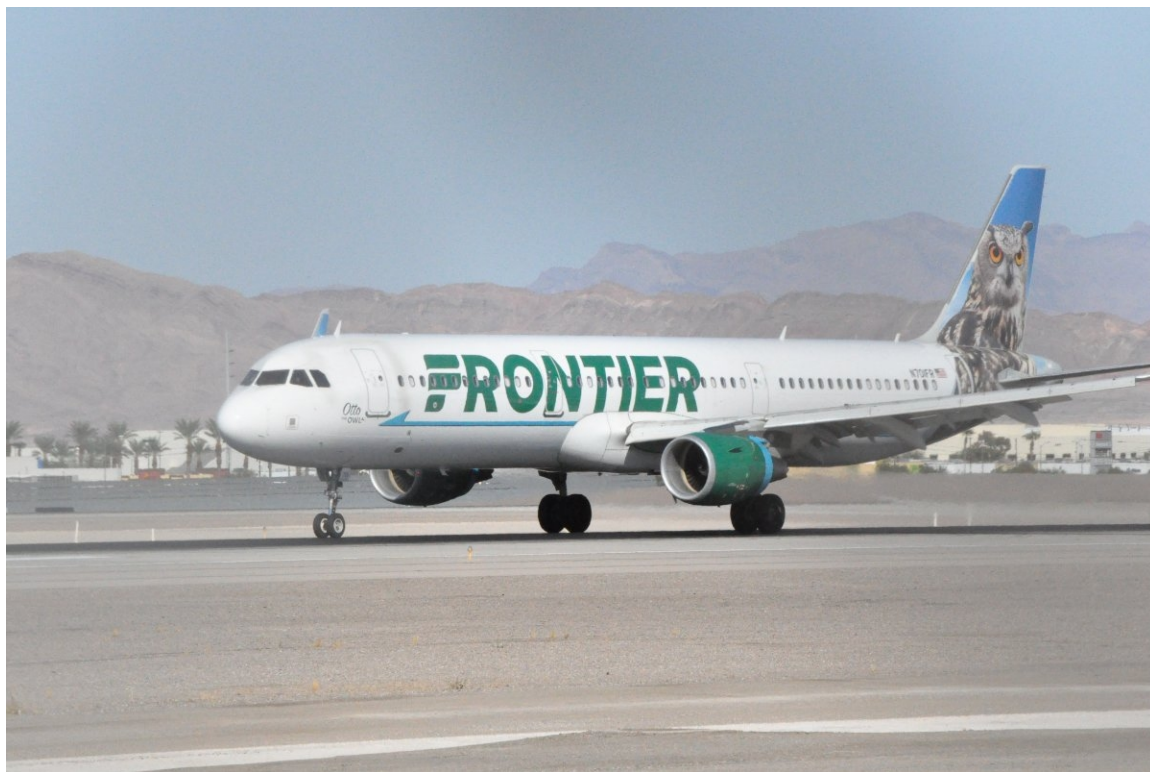
Witness photographs, (see figures 1 through 3), and video recordings showed that shortly after touchdown, smoke began trailing behind both main landing gear before flames were visible from the same area. The flames appeared to extinguish shortly before the airplane came to a stop. Airport firefighting personnel and equipment arrived shortly thereafter and dispensed fire extinguishing agent around the landing gear and engines.

Figure 1. N701FR at touchdown (Source: Owen Denning).

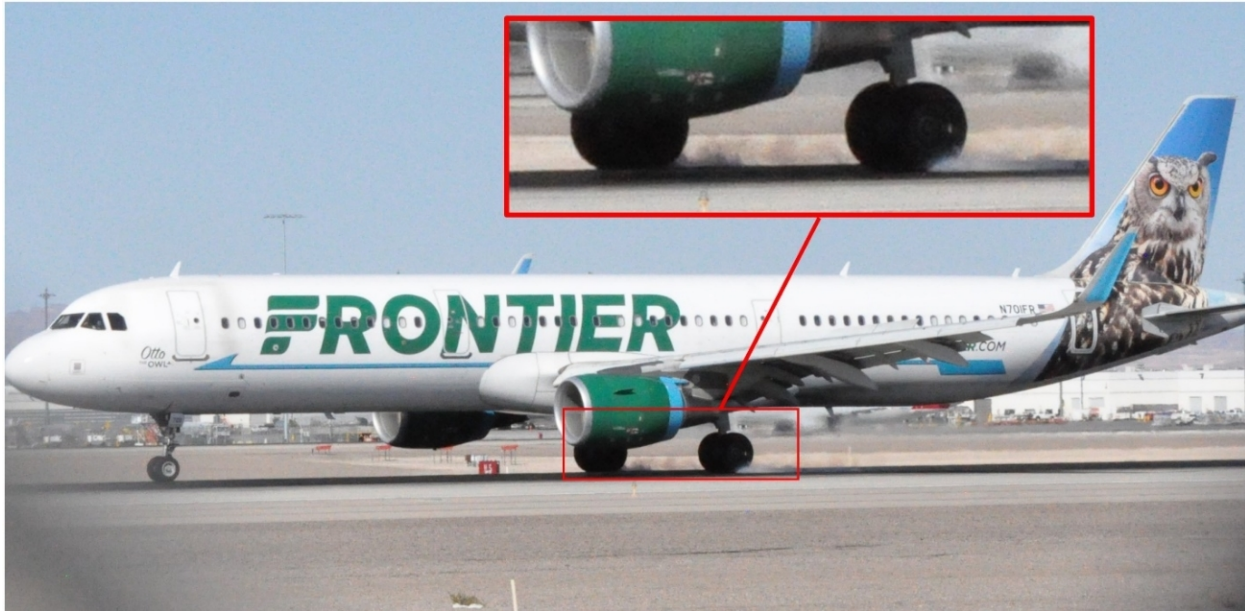
Figure 2. Photograph showing smoke trailing behind N701FR's main landing gear (Source: Owen Denning).

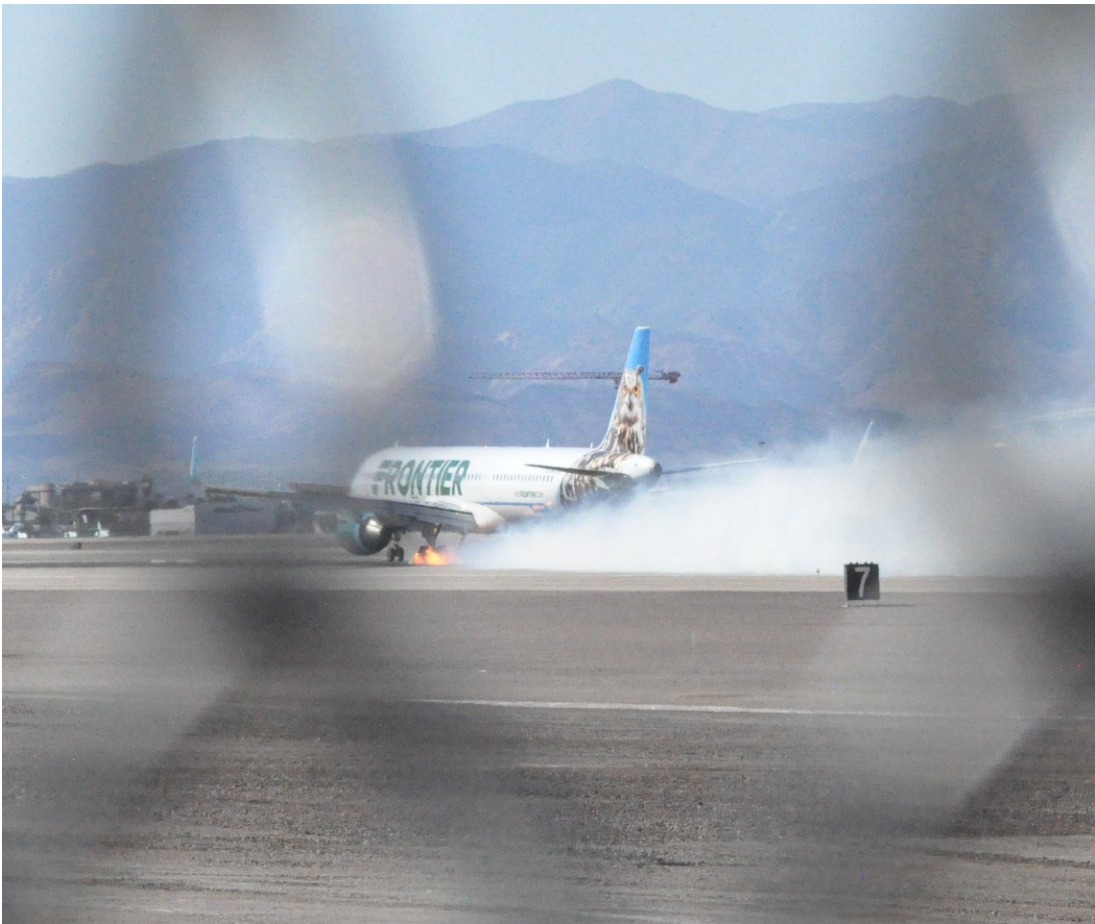
Figure 3. Photograph showing flames behind N701FR's left main landing gear (Source: Owen Denning).
