Aviation Investigation Preliminary Report

Location:	Las Vegas, NV	Incident Number:	DCA25LA001
Date & Time:	October 5, 2024, 15:10 Local	Registration:	N701FR
Aircraft:	Airbus A321-211	Injuries:	197 None
Flight Conducted Under:	Part 121: Air carrier - Scheduled

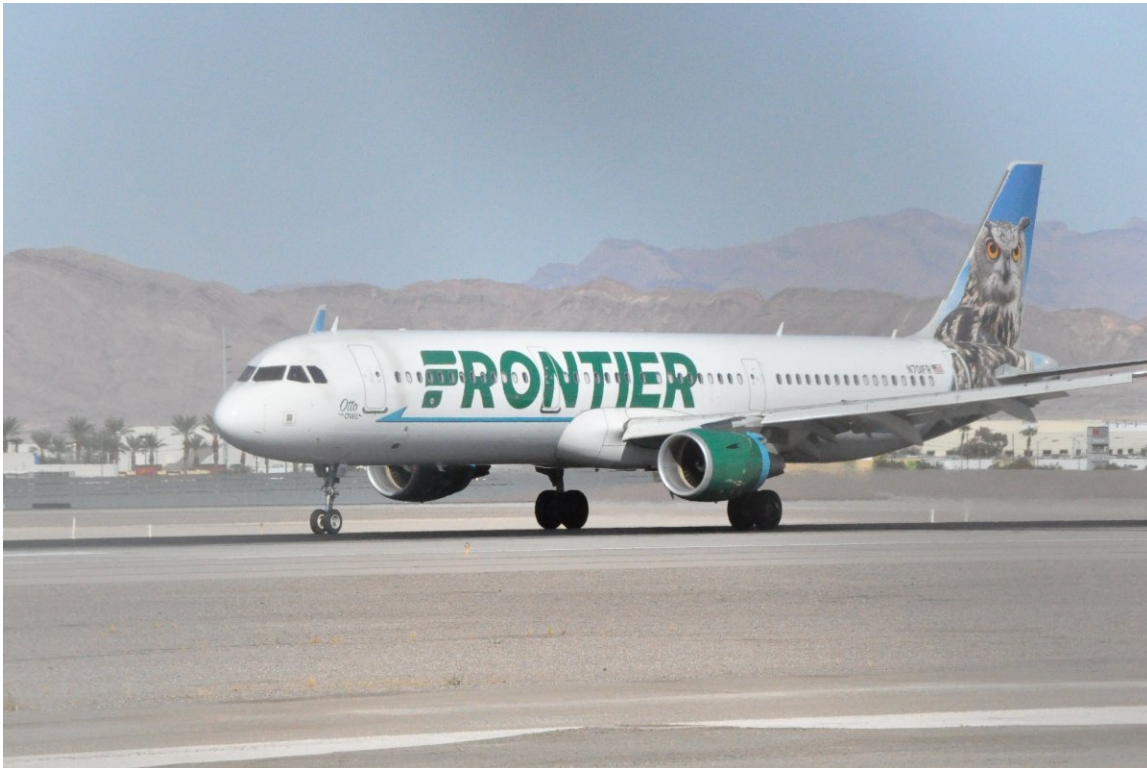
Witness photographs, (see figures 1 through 3), and video recordings showed that shortly after touchdown, smoke began trailing behind both main landing gear before flames were visible from the same area. The flames appeared to extinguish shortly before the airplane came to a stop. Airport firefighting personnel and equipment arrived shortly thereafter and dispensed fire extinguishing agent around the landing gear and engines.

Figure 1. N701FR at touchdown (Source: Owen Denning).

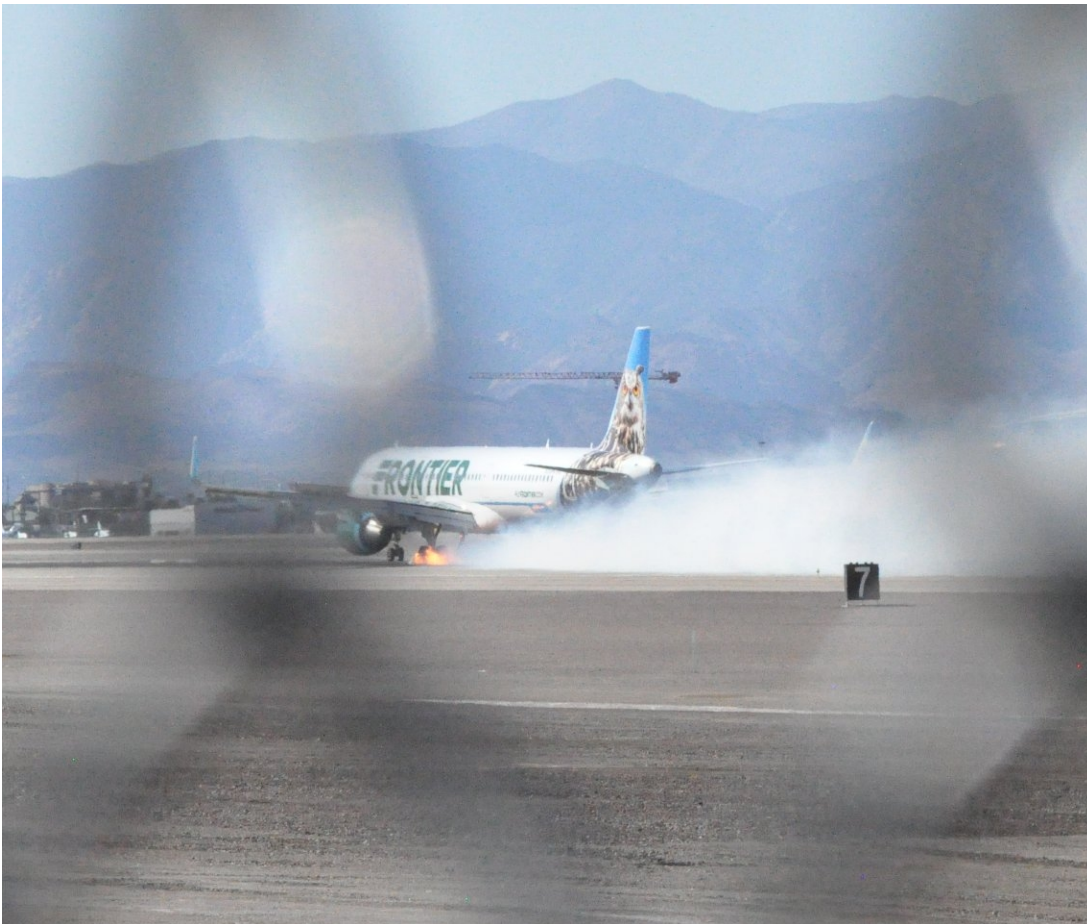
Figure 3. Photograph showing flames behind N701FR's left main landing gear (Source: Owen Denning).
