Aviation Investigation Preliminary Report

Location:	Long Beach, CA	Incident Number:	OPS25LA005
Date & Time:	October 19, 2024, 21:50 UTC	Registration:	N250WN (A1); N895AM (A2)
Aircraft:	Boeing 737-7H4 (A1); DIAMOND AIRCRAFT IND INC DA 40 (A2)	Injuries:	
Flight Conducted Under:	Part 121: Air carrier - Scheduled (A1); Part 91: General aviation - Personal (A2)

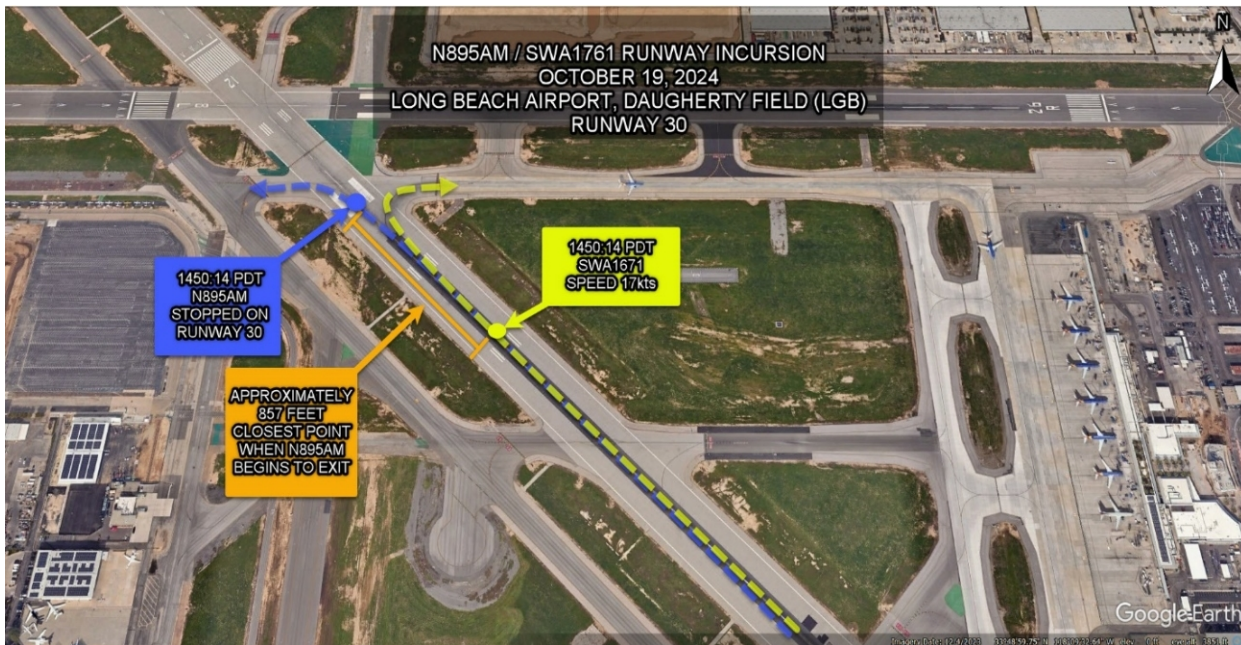
At 1450:05, as SWA1671 was completing their landing roll out on runway 30, the crew of SWA1671 advised the LC1 controller that there was an aircraft on runway 30.

Figure 1 shows the ground tracks of N895AM (indicated by the blue track) and SWA1671 (indicated by the yellow track) overlaid on satellite imagery in Google Earth. The illustration depicts the direction of travel for each airplane as well as their closest estimated proximity.

Figure 1. Overhead view of the flight tracks of N895AM and SWA1671 with the area of closest proximity.
