# Aviation Investigation Final Report

| <b>Location:</b> | Ogallala, Nebraska | <b>Accident Number:</b> | CEN25LA029 |
| <b>Date &amp; Time:</b> | October 27, 2024, 12:15 Local | <b>Registration:</b> | N257ST |
| <b>Aircraft:</b> | Cub Crafters Carbon Cub | <b>Aircraft Damage:</b> | Destroyed |

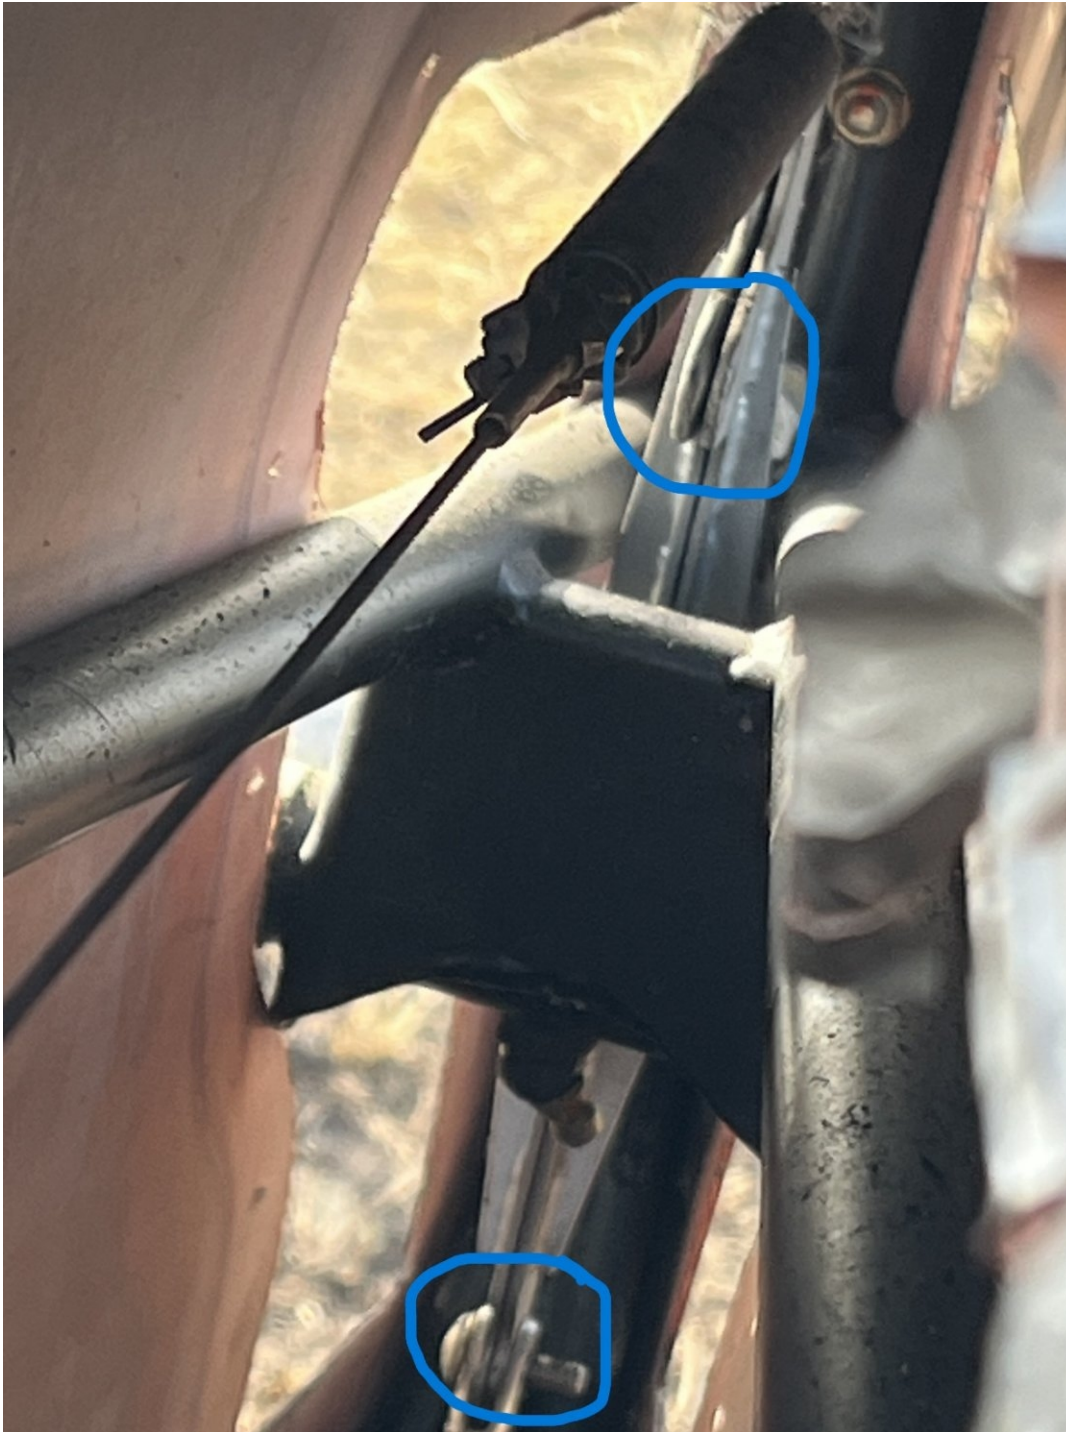
A postaccident examination of the airplane found that the top elevator control cable was not attached to the elevator horn. The securing bolt, nut, and cotter pin were not located. The lower elevator control cable remained attached via its bolt, but the securing nut and cotter pin were not located. A review of maintenance information about the airplane revealed that the airplane was originally assembled about three years before the accident, and had undergone several condition inspections, including one by a mechanic who was different than the owner/builder. The most recent condition inspection was performed by the owner/builder about nine months before the accident, and would have included inspection of all flight control surfaces. There was no logbook record of any recent maintenance to the elevator, nor did the pilot recall any. Based on the available information, it is likely that the elevator control cable was improperly secured during maintenance; however, when the maintenance occurred could not be determined.

The improper installation of the elevator control cable hardware, which resulted in the separation of the elevator control cable and a loss of pitch control in flight.

A postaccident examination of the airplane found that top elevator control cable was not attached to the elevator horn (see figure 1). The securing bolt and nut were not located. The lower elevator control cable remained attached via its bolt, but the securing nut was not located.

Figure 1. Elevator Control Connections (FAA Photo)
