Aviation Investigation Final Report

Location:	Kenner, Louisiana	Incident Number:	DCA24LA330
Date & Time:	December 20, 2023, 14:14 Local	Registration:	N8830Q
Aircraft:	Boeing 737-8	Aircraft Damage:	Minor
Defining Event:	Birdstrike	Injuries:	
Flight Conducted Under:	Part 121: Air carrier - Scheduled

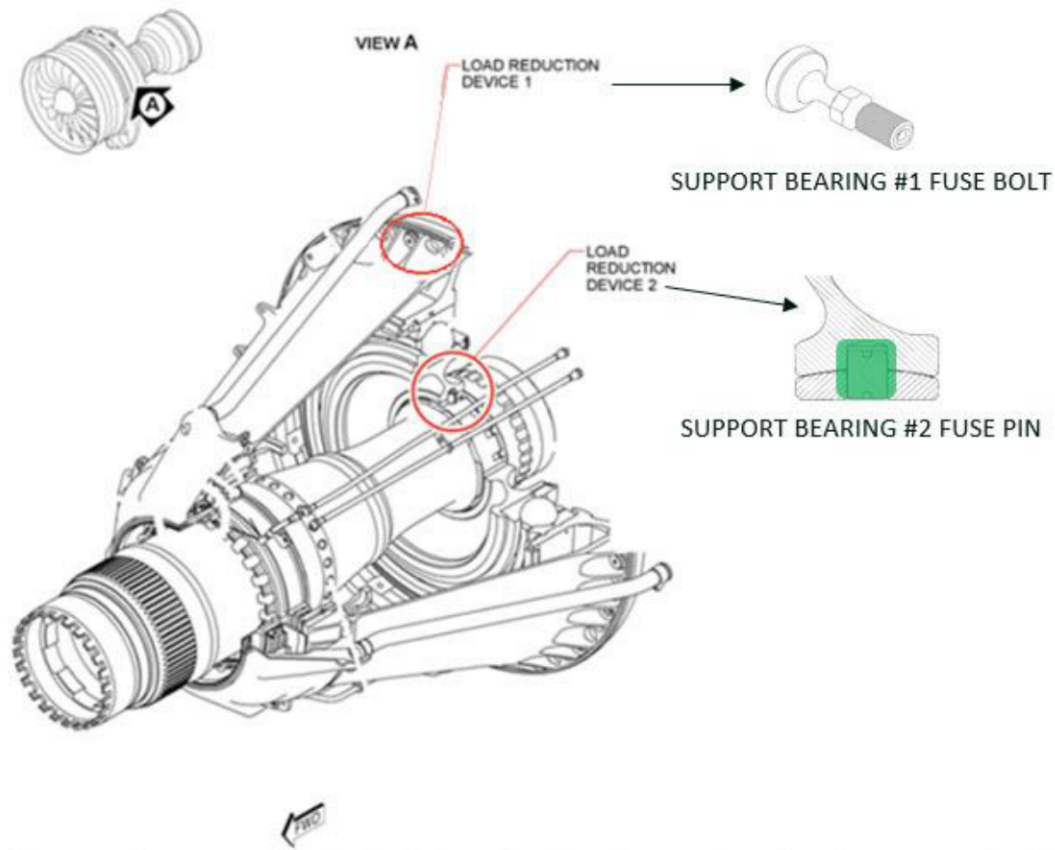
Figure 1. The location of the LRD on the LEAP-1B engine. (Source: CFM)

The airplane was equipped with two CFM International LEAP-1B engines, which incorporate an LRD designed to minimize aircraft and engine damage during a significant fan imbalance. The design was intended to enable the fan to be mechanically disconnected from the turbomachinery, thus reducing the severity of the vibration that is transmitted into the airframe. LRD devices are a mechanical design feature and do not require any pilot intervention (see figure 1).

Postincident examination found that the No. 1 engine LRD was activated in this event, causing tubes supplying oil to the engine sump to become dislodged and the flange from the sump area to open. The open flange allowed oil to enter the core compressor upstream of the pneumatic bleed ports that supply bleed air to the cabin and cockpit. The oil was exposed to high temperatures and resulted in smoke and fumes that were then fed into the cockpit.

The NTSB is aware that CFM International, in collaboration with Boeing, has begun work on an engine software design update that they anticipate completing in the first quarter of 2026. The update will mitigate the presence of smoke or fumes in the cockpit or airplane cabin by closing the PRSOV when the LRD activates. This update will be entirely software-based and made available through a service bulletin upon certification.

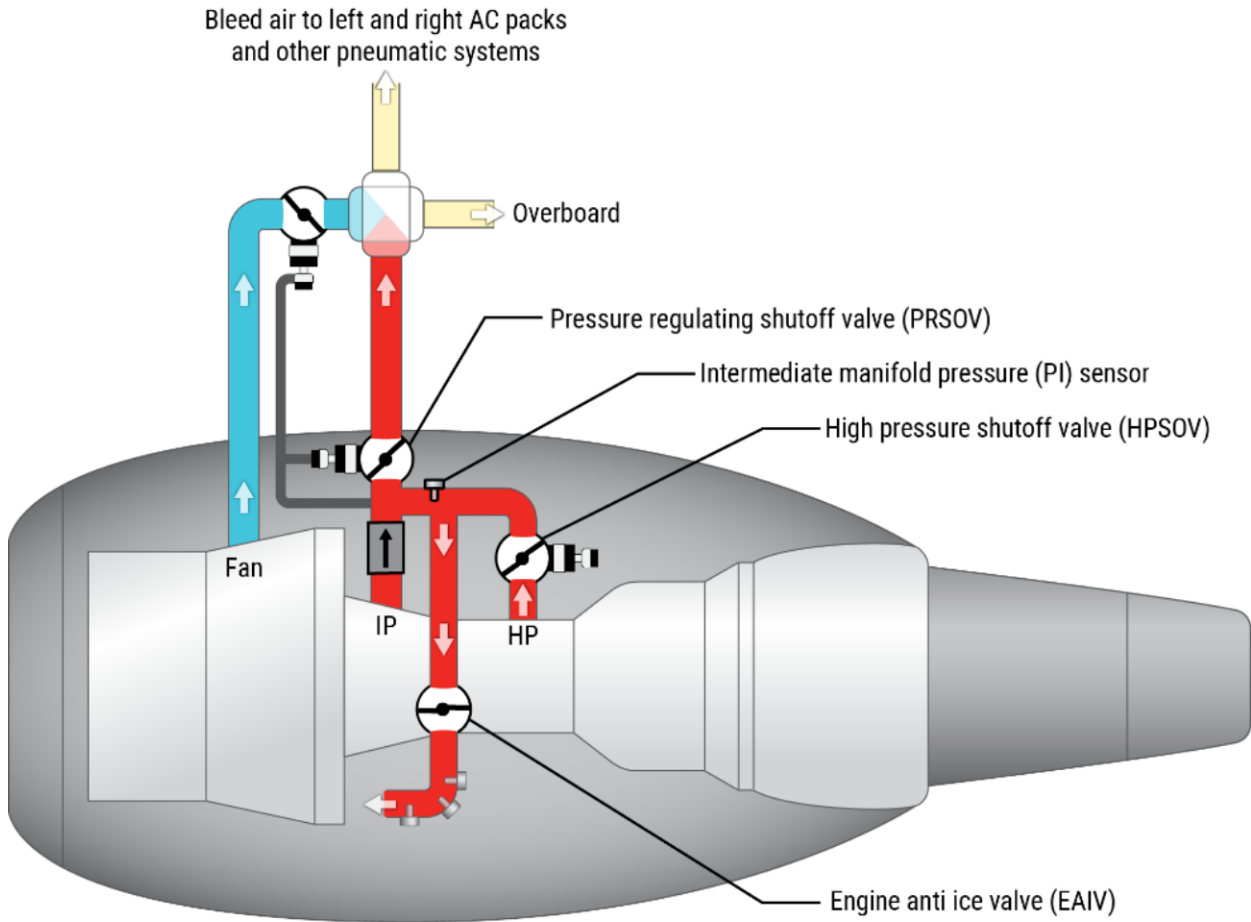
Figure 2. Simplified engine bleed air diagram with PRSOV depicted. (Image Copyright © Boeing. Reprinted with permission.)

the left engine's fan blades from the turbomachinery. When the LRD activated, tubes supplying oil to the engine sump became dislodged and the flange from the sump area opened, allowing engine oil to enter the core compressor upstream of the pneumatic bleed ports that supply bleed air to the cabin and cockpit. The oil was exposed to high temperatures and resulted in smoke and fumes that were then fed into the cockpit. About 15 seconds after the bird ingestion, the left engine's core speed (N2) was below 62% rpm, which would have de-energized the engine's running relay and subsequently closed the pressure regulating shutoff valve (PRSOV). Following the closure of the PRSOV, which was the point of access into the cockpit, the smoke and fumes would have quickly dissipated.

Each engine has a PRSOV that, when closed, prevents bleed air from entering the airplane (see figure 2). Pulling the engine fire switch, causes the PRSOV to automatically close.

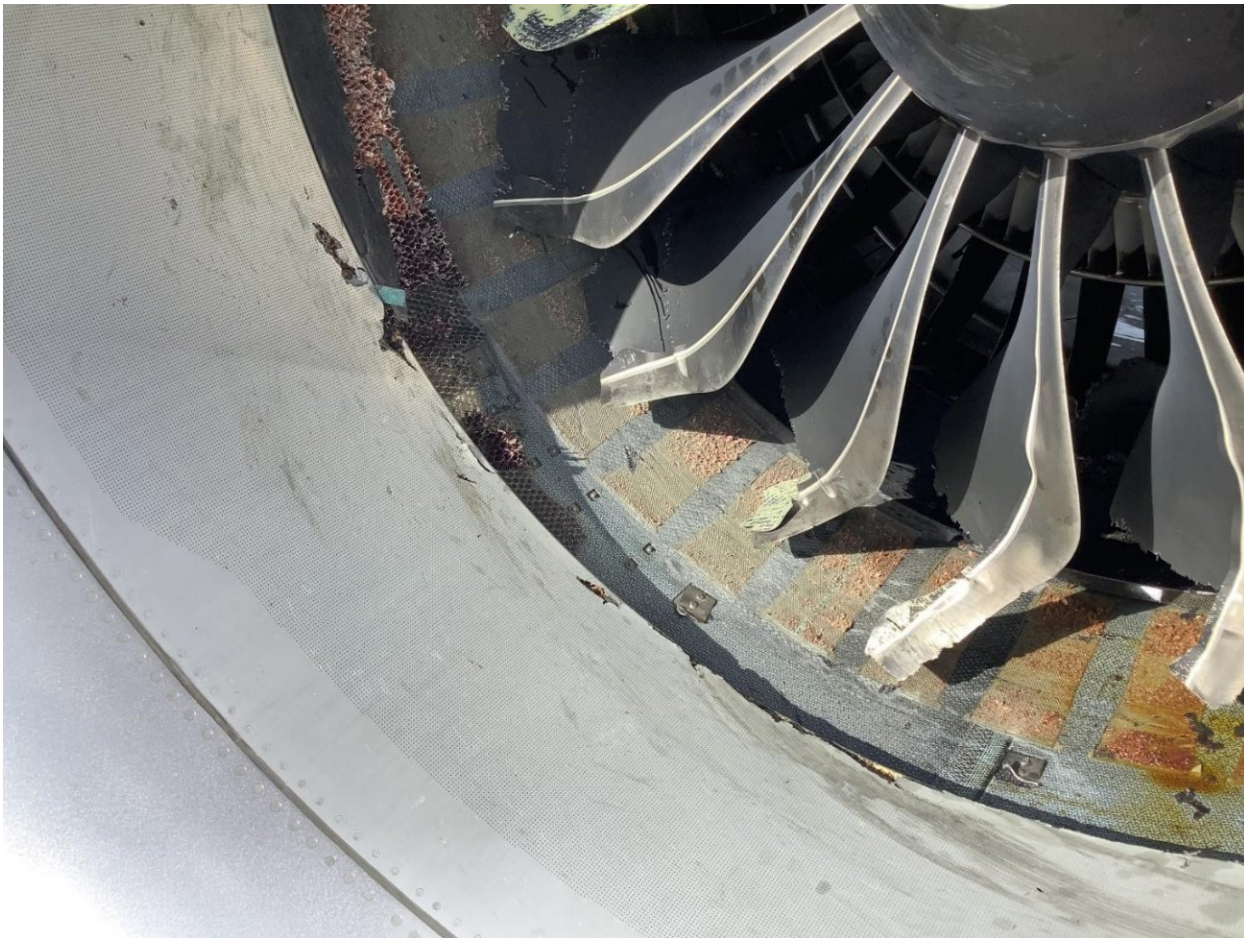
Postincident examination of the airplane found damage to the left engine fan blades consistent with a bird ingestion (see figure 3).

Figure 3. Close-up photo of damage to the left engine. (Source: Southwest Airlines)
