Aviation Investigation Preliminary Report

| Location: | Kenner, LA | Incident Number: | DCA24LA330 |
| Date & Time: | December 20, 2023, 14:14 Local | Registration: | N8830Q |
| Aircraft: | Boeing 737-8 | Injuries: | |

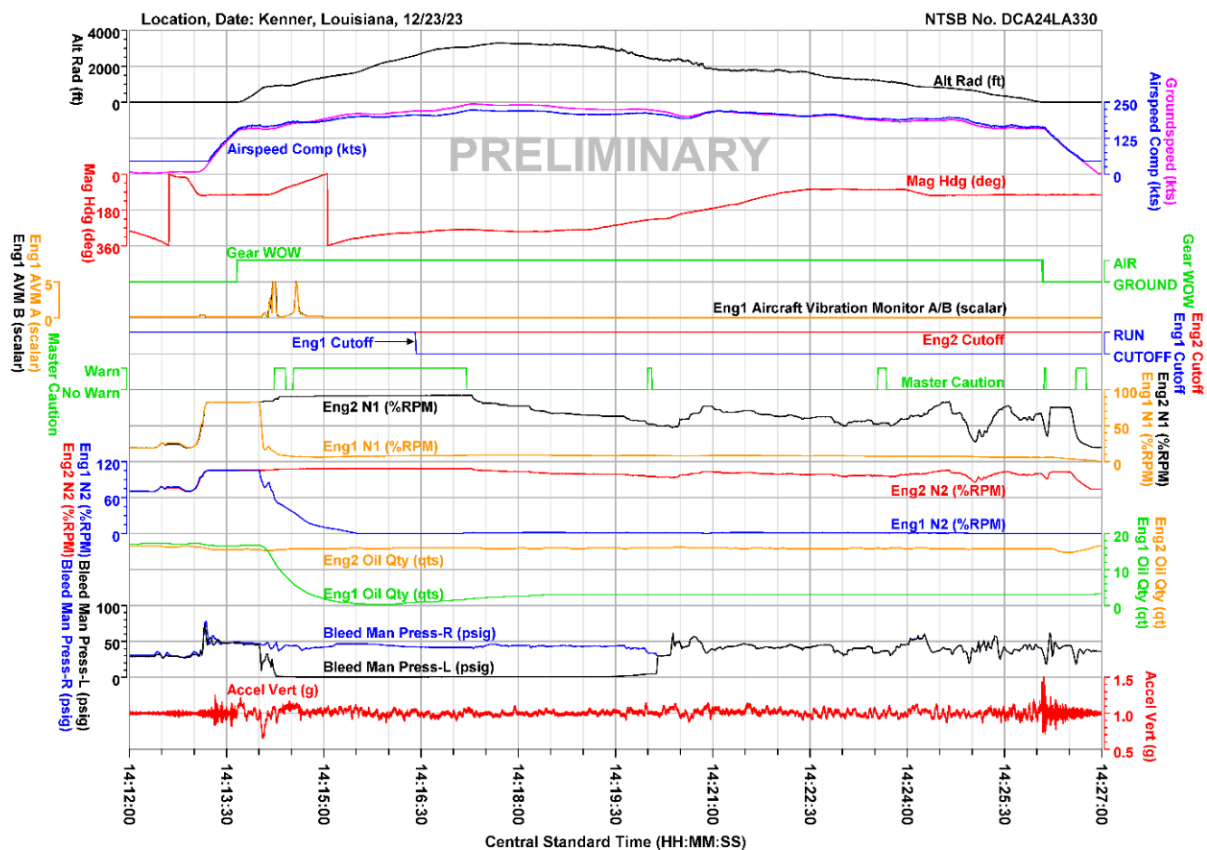
Figure 1. FDR data from the accident landing.

The data showed that, after takeoff, while the airplane was climbing through about 600 ft, both the left and right engine fan speed (N1) values were about 83 percent rpm. About 2 seconds later, the left engine's N1 decreased to 75 percent rpm. Subsequently, the airborne vibration monitor (AVM) began to increase, and the left engine's oil tank quantity began to decrease from 16.25 quarts. About 15 seconds after the bird ingestion, the left engine's core speed (N2) was below 62 percent rpm which would have de-energized the engine's running relay and subsequently closed the pressure regulating shutoff valve (PRSOV). About 28 seconds later, the left engine's N1 stabilized at 6 percent rpm with an oil tank quantity of 3.5 quarts.

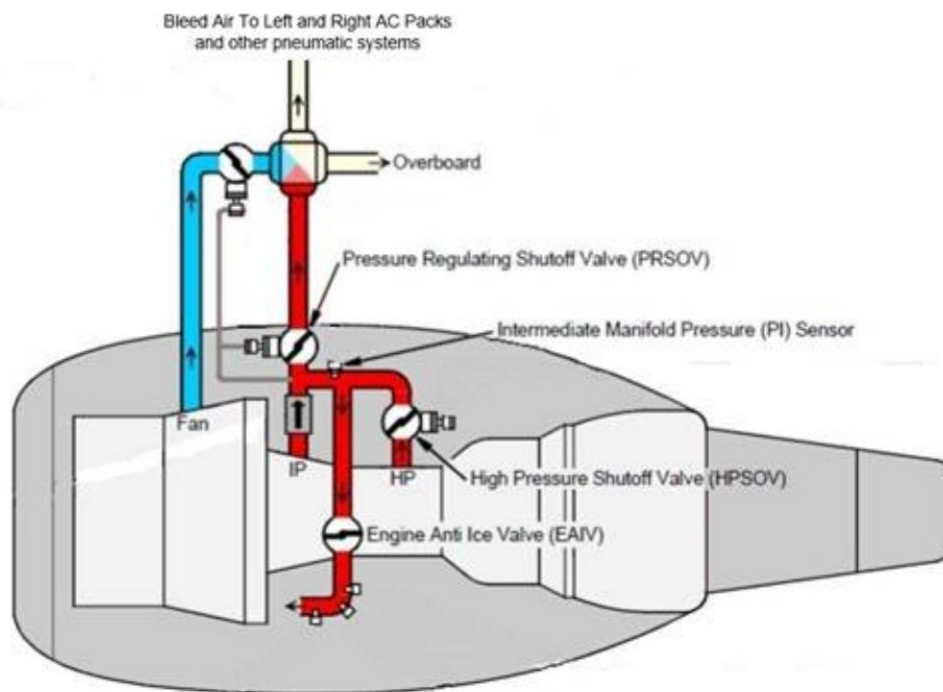
Figure 2. Simplified engine bleed air diagram with PRSOV depicted. (Copyright © Boeing. Reprinted with permission of Boeing.)

The airplane was equipped with two CFM International LEAP-1B engines, which incorporate a load reduction device (LRD) designed to minimize aircraft and engine damage during a significant fan imbalance. The design was intended to enable the fan to be mechanically disconnected from the turbomachinery, thus reducing the severity of the vibration that is transmitted into the airframe. LRD devices are a mechanical design feature and do not require any pilot intervention. When the LRD activates due to excessive vibration, engine oil enters the

compressor upstream of the pneumatic bleed ports, which supply bleed air to the cabin and flight deck.

Engine bleed air from the high-pressure compressor travels from the engine to the pressure regulating shutoff valve (PRSOV, see figure 2) and then to the left and right air conditioning packs. When closed, the PRSOV prevents bleed air from the affected engine from entering the airplane. The valve closes automatically if the engine running relay is de-energized (the affected engine spools down below 62% minimum N₂), the engine start switch is moved to cutoff, or the engine fire switch is pulled.

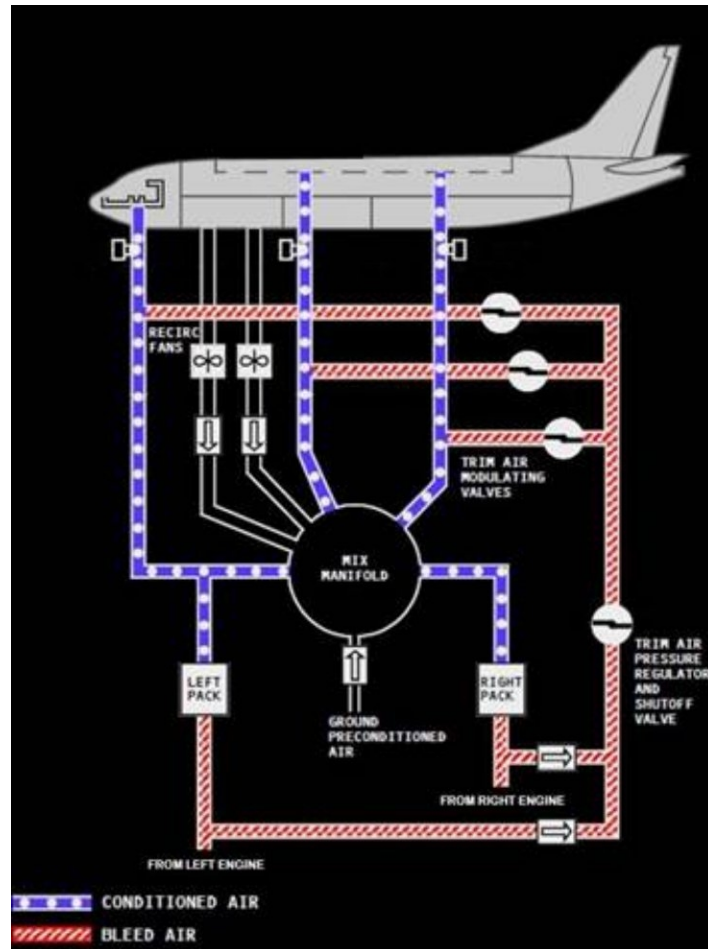
Figure 3. The air conditioning graphic referenced is a simplified system description. (Copyright © Boeing. Reprinted with permission of Boeing.)

Conditioned air from the left air conditioning pack (supplied by left engine) is normally distributed to the flight deck. Conditioned air from the right air conditioning pack (supplied by right engine) and excess air from the left air conditioning pack, and recirculated air are combined in the mixing manifold and is normally distributed to the cabin (see figure 3).
