# Aviation Investigation Preliminary Report

<b>Location:</b>	Windham, NY	<b>Accident Number:</b>	ERA25FA058
<b>Date &amp; Time:</b>	November 24, 2024, 18:09 Local	<b>Registration:</b>	N58156
<b>Aircraft:</b>	Mooney M20J	<b>Injuries:</b>	1 Fatal
<b>Flight Conducted Under:</b>	Part 91: General aviation - Personal

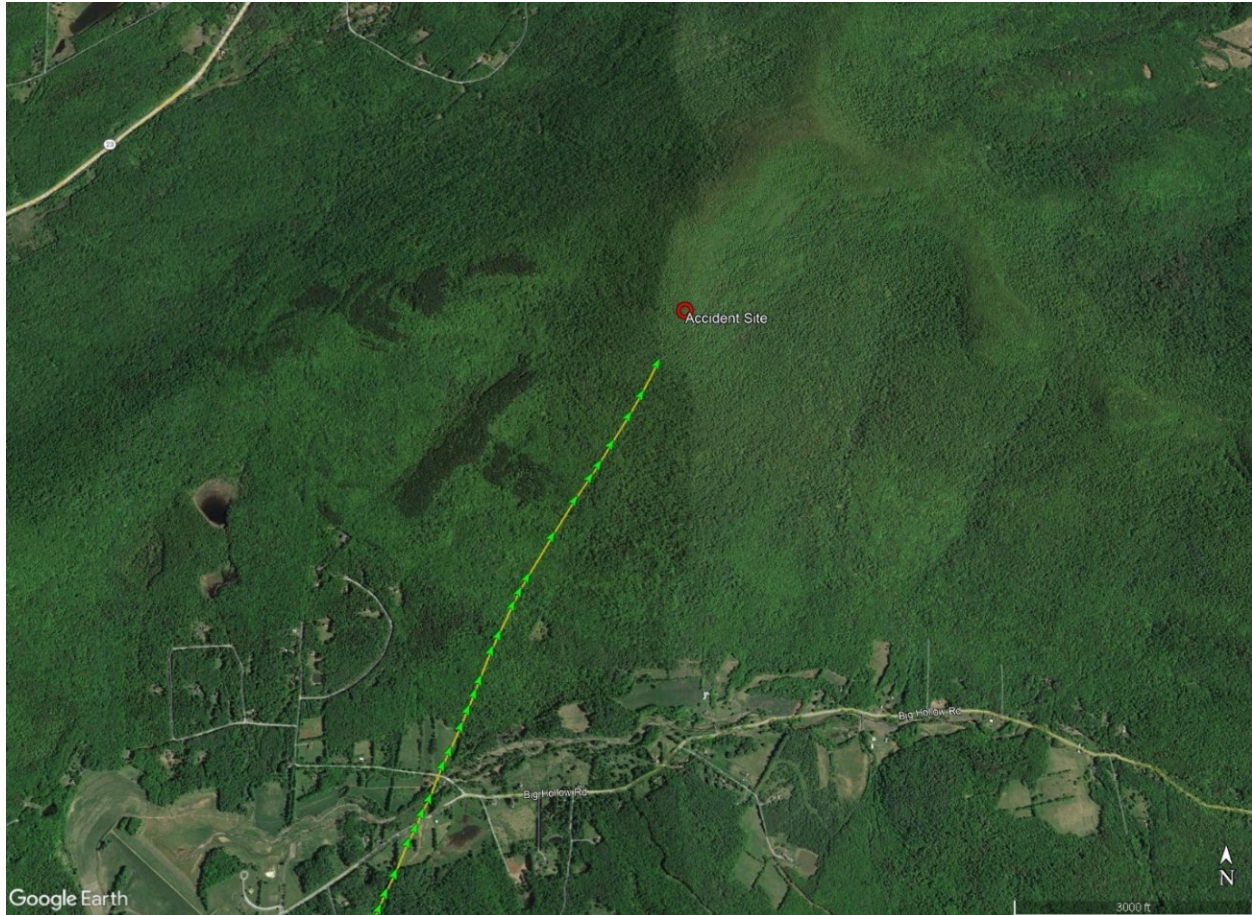
Figure 1 – The accident airplane’s ADS-B flight track (green arrows) and the annotated location of the accident site (red circle).
