Aviation Investigation Preliminary Report

Location:	Fort Blackmore, VA	Accident Number:	ERA25FA065
Date & Time:	December 4, 2024, 14:51 Local	Registration:	N627TT
Aircraft:	TRUITT JAMES B VANS RV-8A	Injuries:	1 Fatal
Flight Conducted Under:	Part 91: General aviation - Business

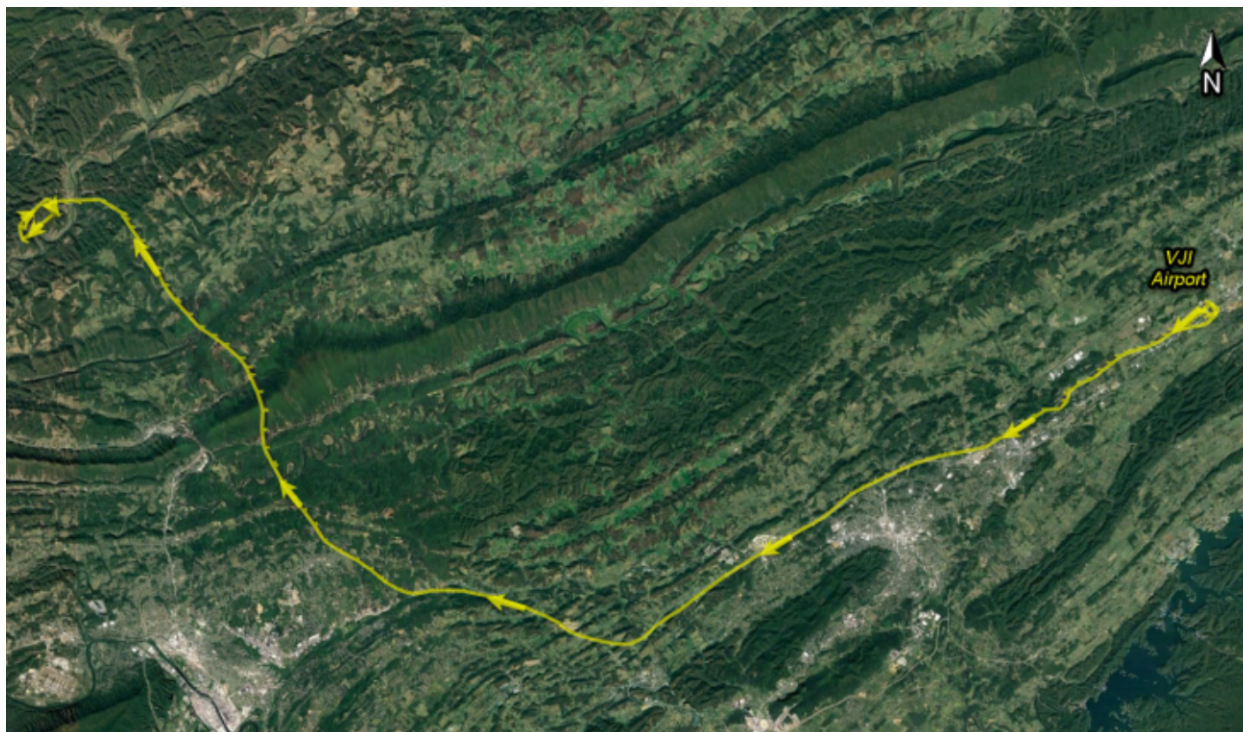
Preliminary Automatic Dependent Surveillance-Broadcast (ADS-B) track data revealed that the airplane departed from runway 24 at VJI at 1426. The airplane then flew in the vicinity of the airport consistent with the operations manager’s description before proceeding to the southwest (see figure 1). The airplane maintained the southwest ground track for approximately 20 miles before turning to the west, then northwest. The track data showed altitude variations from approximately 2,100 ft to 3,700 ft mean sea level (msl) along the route of flight. About 1444, at an altitude of 2,725 ft msl, the airplane began a left turn to the west, followed by a sharp left turn and a climb of 200 ft. The airplane then began a right turn and climbed to 2,825 ft, descended to 2,600 ft, climbed again to 2,875 ft, followed by a decent to 2,450 ft. The last track data, recorded at 1447, indicated that the airplane’s last recorded altitude was 2,150 ft.

Figure 1 – The accident airplane’s ADS-B flight track (yellow line and arrows) from the departure airport, VJI, to the location of the accident site.

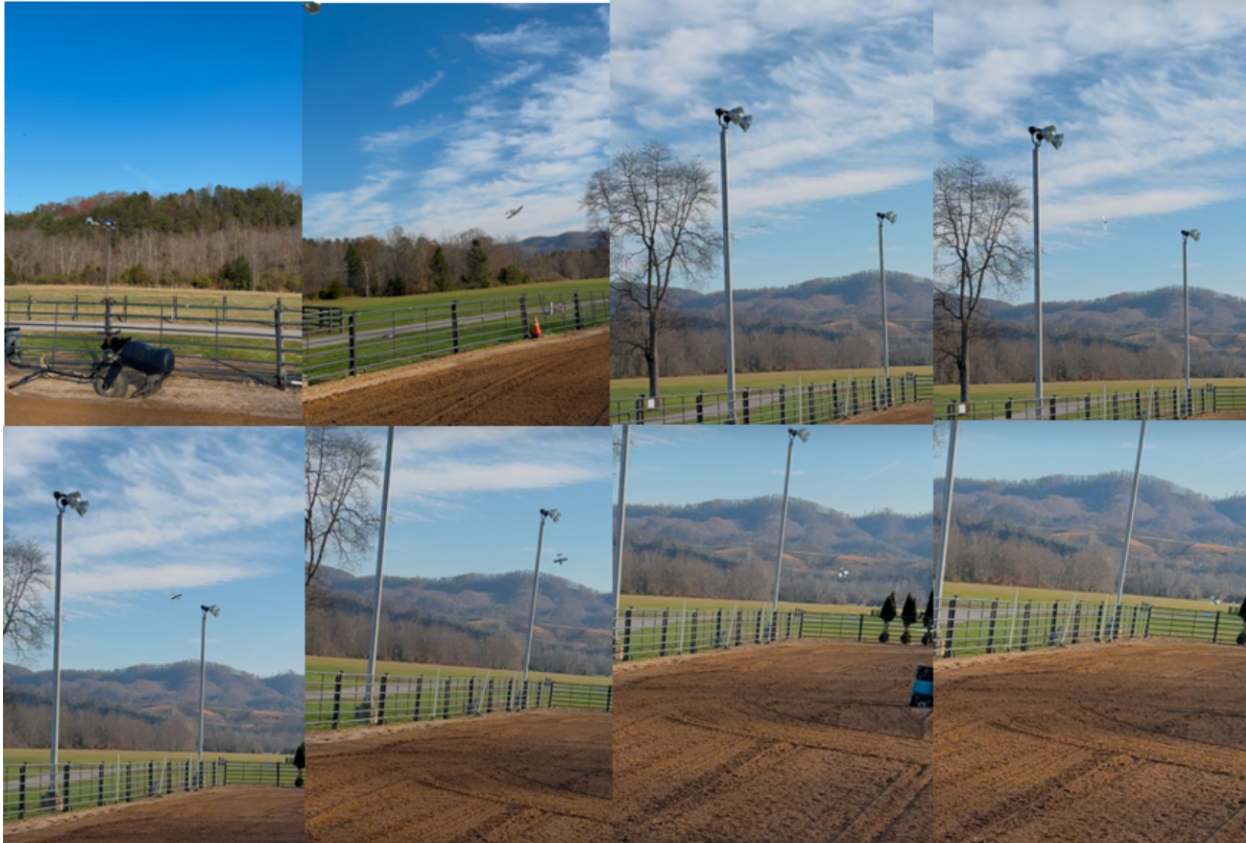
A witness recorded a video of the accident airplane as it maneuvered over the airstrip. The video depicted the airplane flying low over the turf runway before entering a short, gradual, climb. Shortly after the climb initiated, the airplane began a roll to the right that continued to an inverted attitude, after which the nose of the airplane pitched toward the ground and the airplane descended to ground impact. Figure 2 shows a series of eight still frames from the witness video.

Figure 2- Still frames from the witness video showing the airplane as it maneuvered shortly before impact.
