Aviation Investigation Preliminary Report

Location:	Orlando, FL	Accident Number:	DCA25LA065
Date & Time:	December 21, 2024, 18:30 Local	Registration:	UNREG
Aircraft:	Uvify IFO	Injuries:	1 Serious
Flight Conducted Under:	Unknown

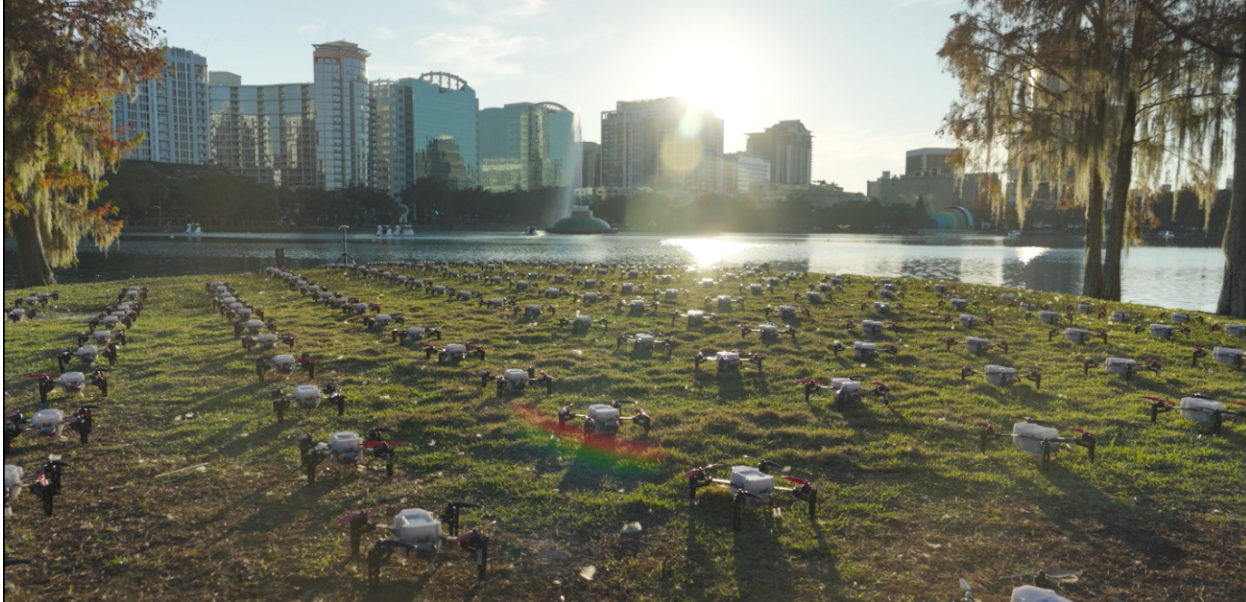
Figure 1. sUA setup at Lake Eola. (Source: Sky Elements LLC)
