# Aviation Investigation Preliminary Report

<b>Location:</b>	Fullerton, CA	<b>Accident Number:</b>	WPR25FA072
<b>Date &amp; Time:</b>	January 2, 2025, 14:09 Local	<b>Registration:</b>	N8757R
<b>Aircraft:</b>	Vans Aircraft RV-10	<b>Injuries:</b>	2 Fatal, 8 Serious, 11 Minor
<b>Flight Conducted Under:</b>	Part 91: General aviation - Personal

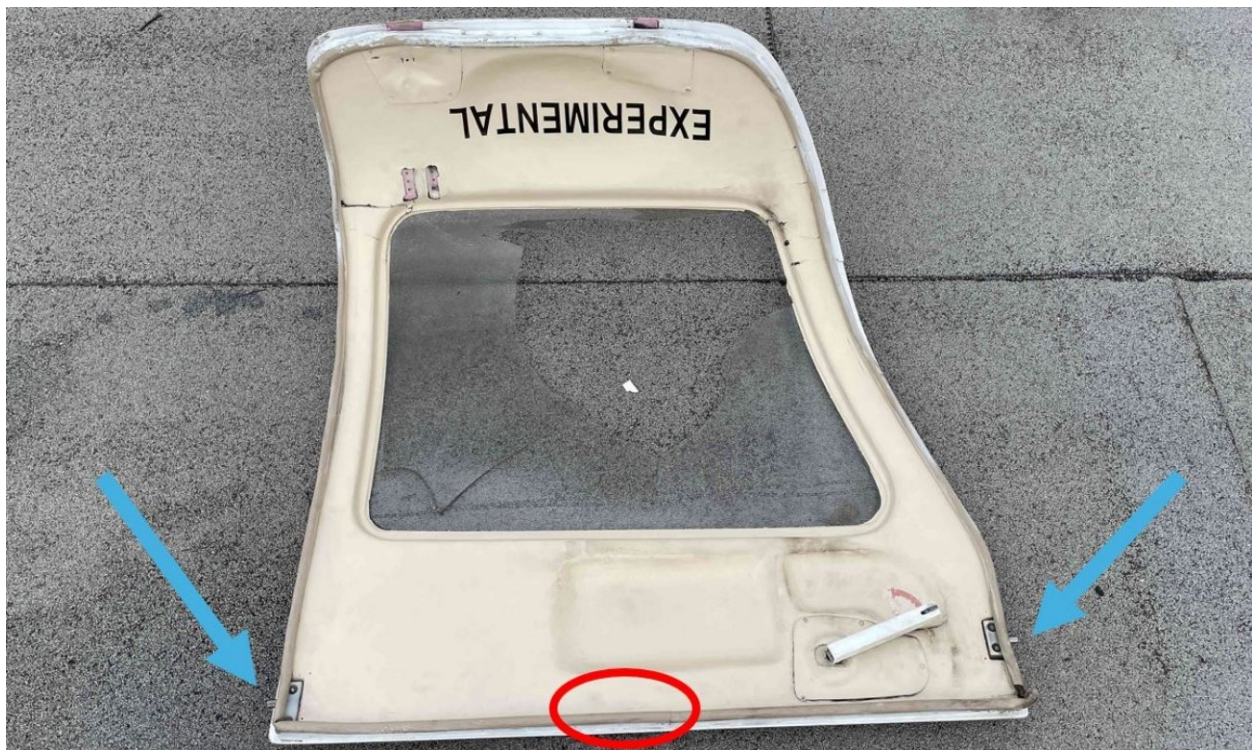
Examination of the airplane wreckage revealed that the pilot had made a series of modifications to the standard door locking system including the use of solid steel locking pins rather than the kit-supplied aluminum pins, along with replacement of the UHMW polythene door blocks with chamfered aluminum blocks. Additionally, the secondary safety latch had not been installed (see figure 1), and the door latch indicator system had been modified.

The left cabin door located on the facility roof was largely intact and had pulled away from its roof hinges. Its window had shattered, and all the plexiglass pieces were accounted for in the immediate vicinity. The door handle was found just short of the forward closed and locked position (see figure 1), and because it was not fully forward, its locking button had not engaged. The lock pins were found extended about 1/2 inch out of the door ends, and when the door handle was tested by moving it forward, the pins extended a further 7/16 inch and the locking button engaged.

Figure 1 – Left cabin door as-found, with the forward and aft door pins marked by the blue arrows. The area that the secondary door latch should have been installed is circled in red.
