Aviation Investigation Preliminary Report

Location:	Washington, DC	Accident Number:	DCA25MA108
Date & Time:	January 29, 2025, 20:48 Local	Registration:	N709PS (A1); UNREG (A2)
Aircraft:	BOMBARDIER INC CL-600-2C10 (A1); Sikorsky UH60 (A2)	Injuries:	64 Fatal (A1); 3 Fatal (A2)
Flight Conducted Under:	Part 121: Air carrier - Scheduled (A1); Armed Forces (A2)

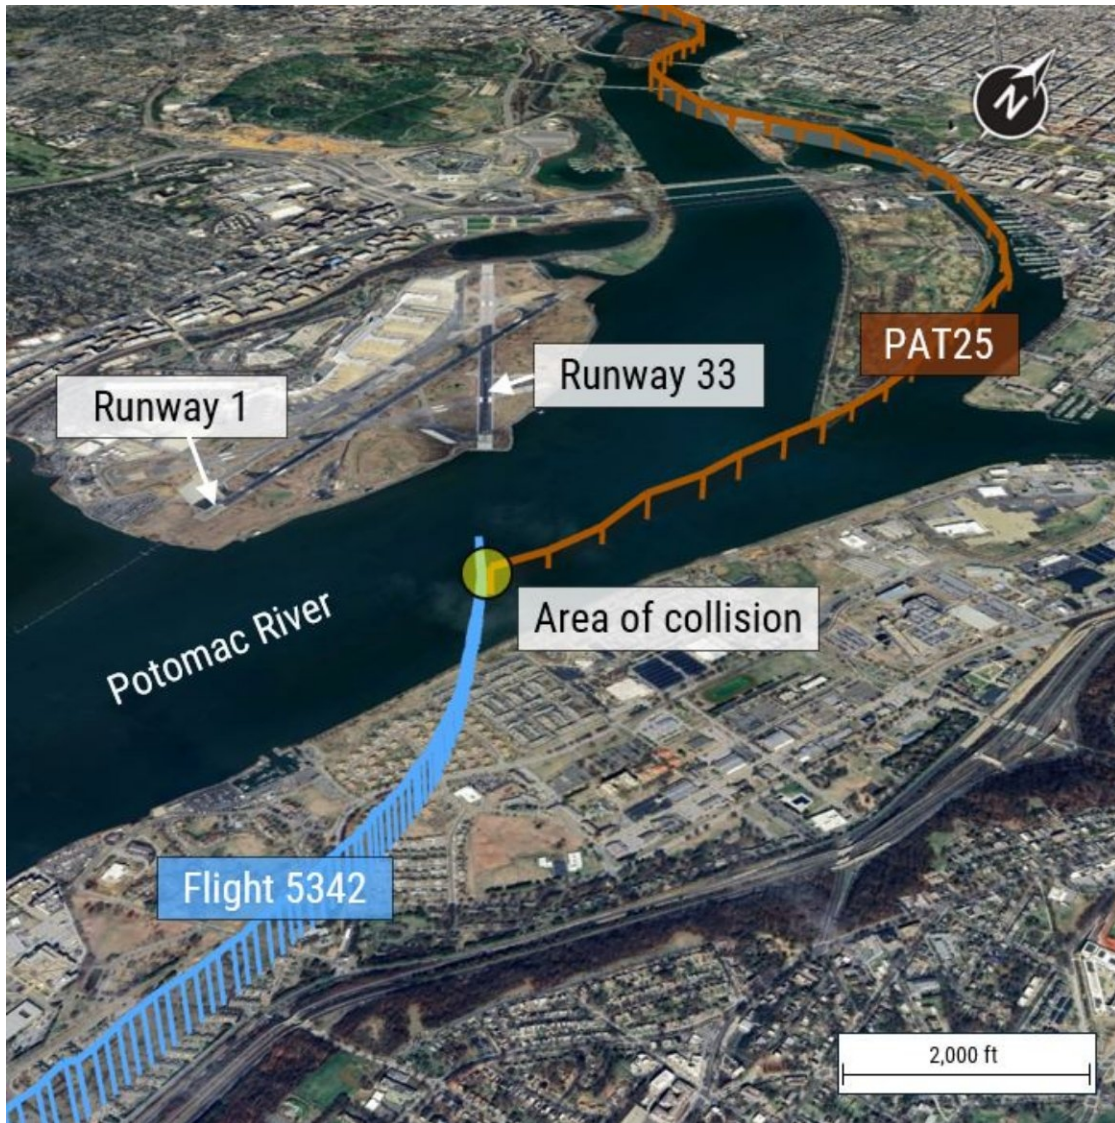
Figure 1. Google Earth image with preliminary ADS-B data for flight 5342 (blue line) and radar data for PAT25 (orange line).

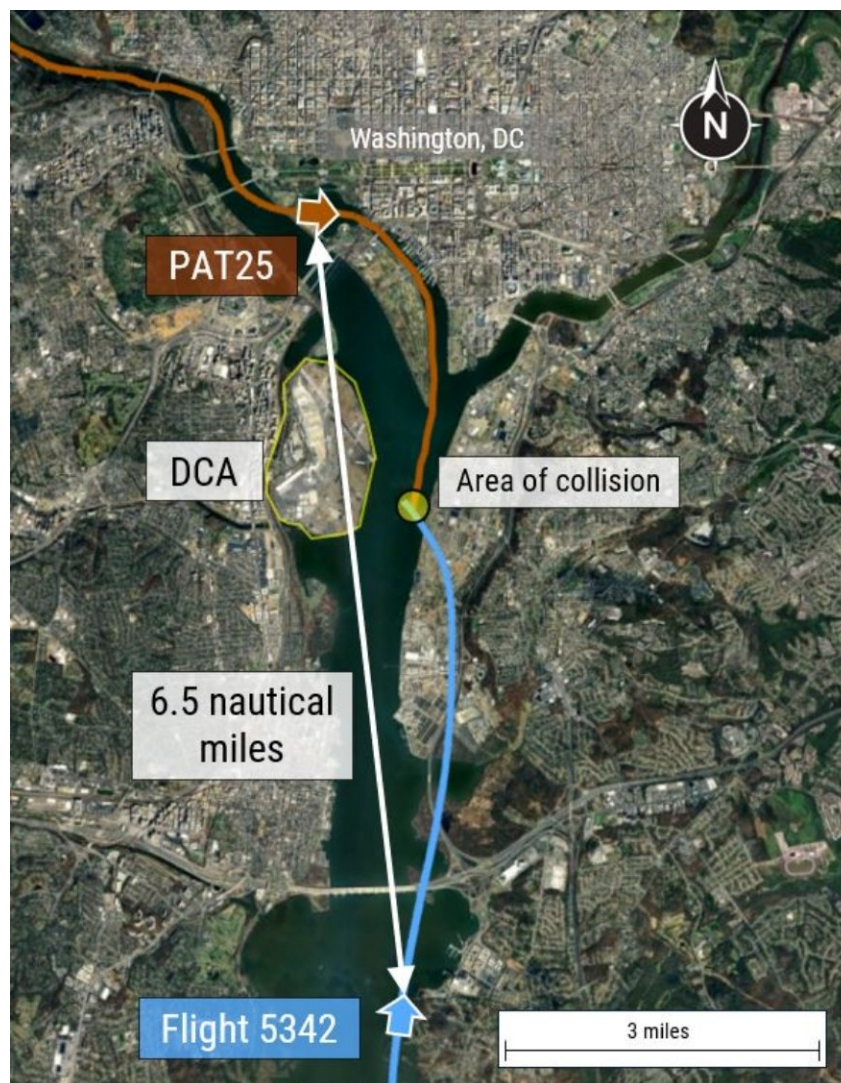
At 2046:02, a radio transmission from the tower was audible on flight 5342's CVR informing PAT25 that traffic just south of the Wilson Bridge was a CRJ (flight 5342) at 1,200 ft circling to runway 33.

At 2046:08, the PAT25 crew reported that they had the traffic in sight and requested to maintain visual separation. The controller approved the request. At this time, the distance between the two aircraft was about 6.5 nm. Figure 2 shows each aircraft's approximate position at 2046:02, when the controller first advised the crew of PAT25 of flight 5342.

Figure 2. Google Earth image with airplane and helicopter preliminary flight tracks overlaid, and each aircraft's approximate position shown at 2046:02.

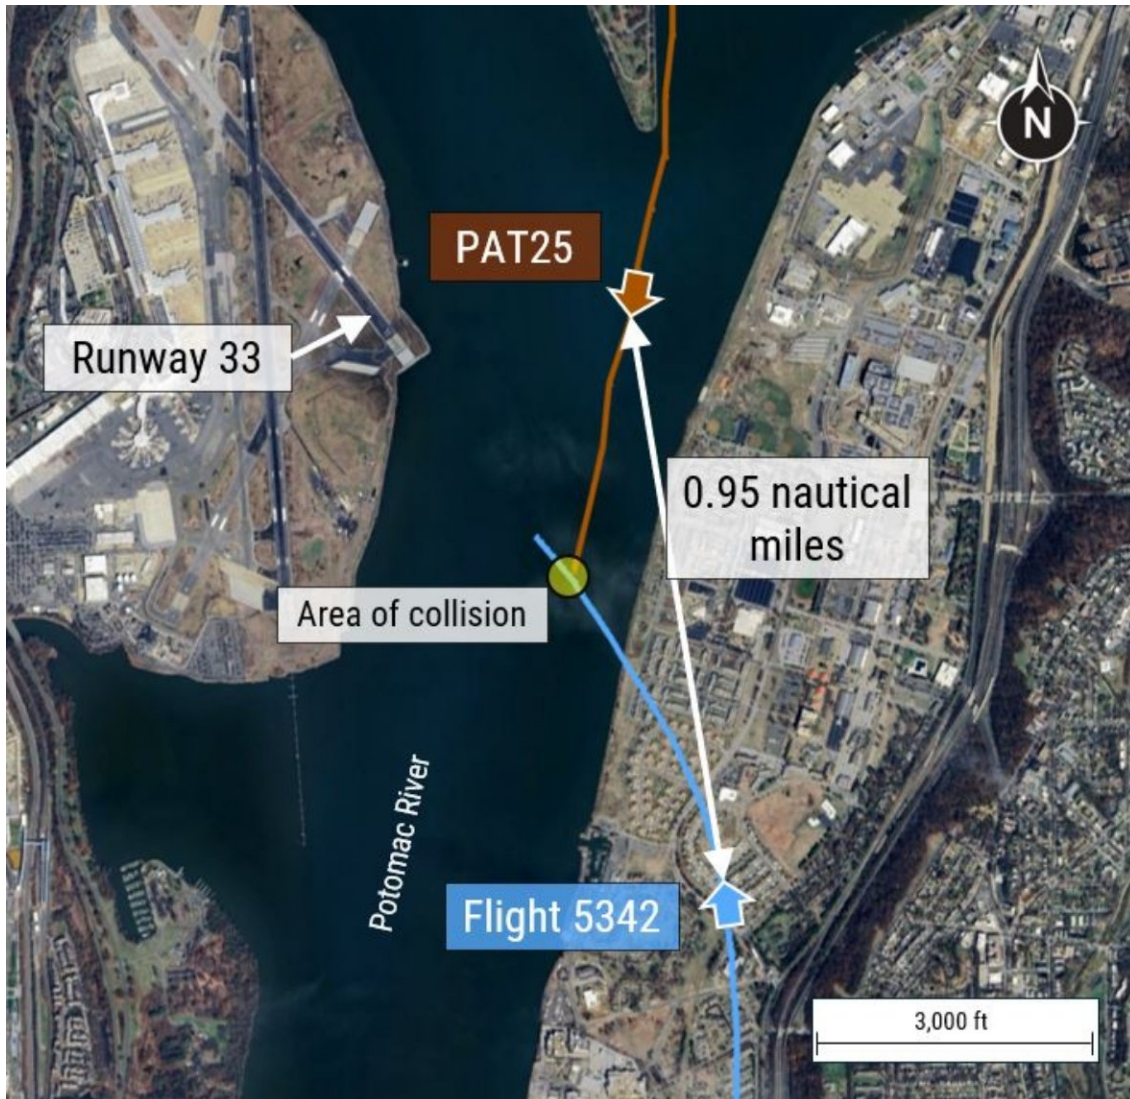
At 2047:40, the crew of flight 5342 received an automated traffic advisory from the airplane's traffic alert and collision avoidance system (TCAS) system stating, "Traffic, Traffic." At this time, the aircraft were about 0.95 nm apart, as shown in Figure 3.

Figure 3. Google Earth image showing the approximate positions of both aircraft at 2047:40.

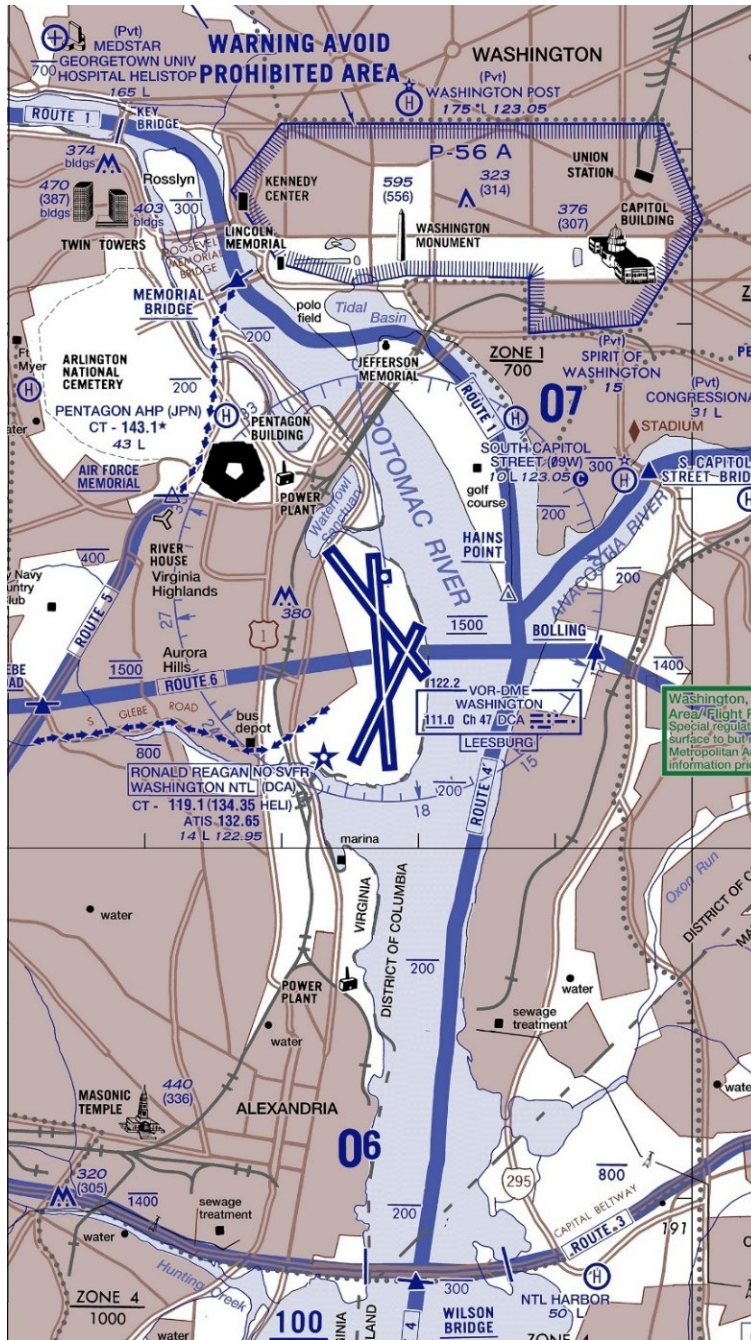
The Baltimore-Washington Helicopter Route Chart contains the helicopter routes for the Washington, DC area; the area immediately surrounding DCA is excerpted below (see figure 4). PAT25’s route on the night of the accident included Route 1, which begins in Cabin John, Maryland, and follows the western shore of the Potomac River southeast toward Washington, DC. After crossing Key Bridge, the route follows the eastern shore of the Potomac with the Kennedy Center and Lincoln Memorial to the east and Roosevelt Island to the west, crossing Memorial Bridge (a compulsory reporting point). After Memorial Bridge, the maximum allowable altitude on Route 1 is 200 ft above mean sea level (msl).

Figure 4. Excerpt of FAA Baltimore-Washington Helicopter Chart showing the area surrounding DCA. (Source: FAA.)

Route 1 then continues south of the Washington Monument, crossing West Potomac Park and the Tidal Basin before following the Washington Channel along East Potomac Park. Hains Point, the southernmost tip of East Potomac Park and located at the confluence of the Potomac and Anacostia rivers, is identified as a non-compulsory reporting point and the area where Route 4 intercepts Route 1. Route 4 continues south to the Woodrow Wilson Bridge

along the Potomac River's eastern shore, with DCA to the west. South of Wilson Bridge, the maximum allowable altitude along Route 4 increases from 200 ft msl to 300 feet msl.

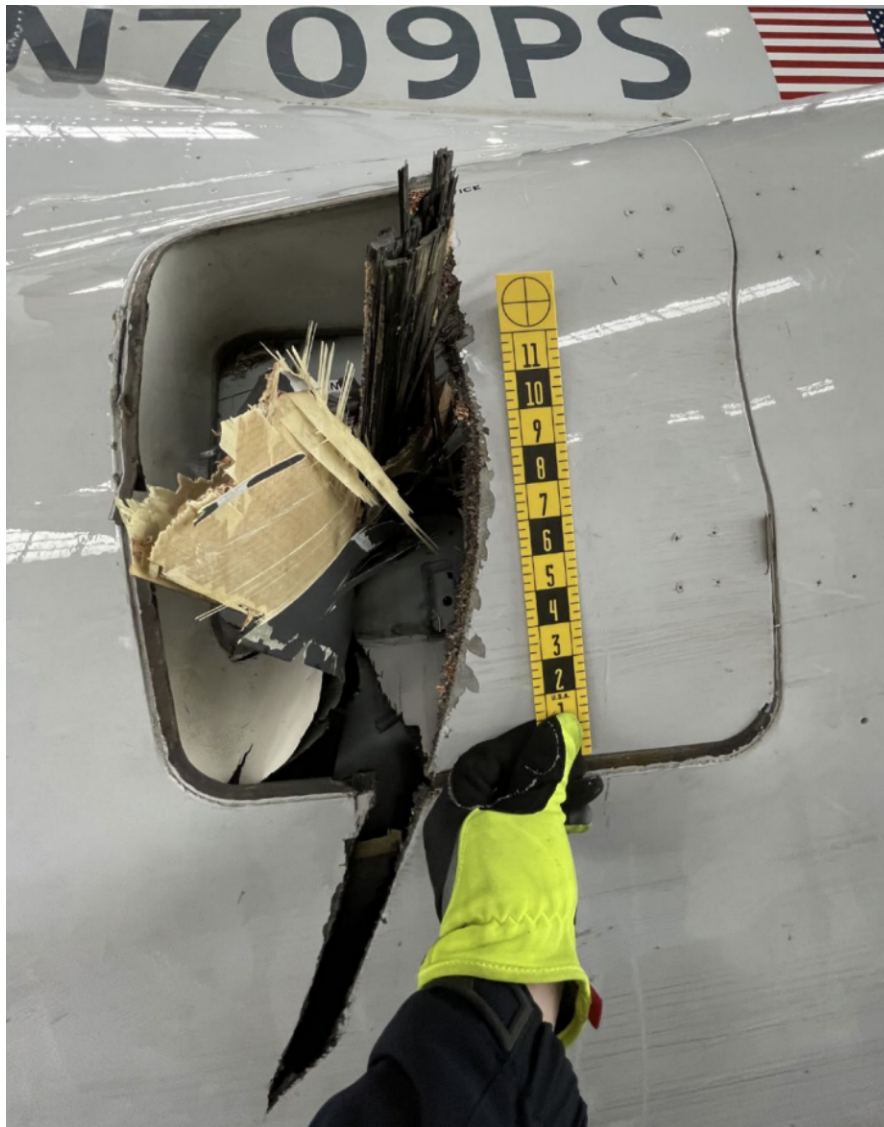
The airplane sustained extensive water impact damage to most of its structure. The fuselage was recovered in 13 major sections comprising the entire length of the airplane, from the radome in the nose to the aft fuselage and tail cone. Two areas of damage were noted to the lower right side aft fuselage wing-to-body fairing. There was a puncture in the right side of the fairing about 10 inches (in) by 8 in, and a slash through the lower surface of the fairing, internal structure, and lavatory access door about 29 in long by 2 in wide. An approximate 2-ft-long section of one of the helicopter's tail rotor blades was embedded in the slash (see figure 5).

Figure 5. Damage to aft fuselage with tail rotor blade.

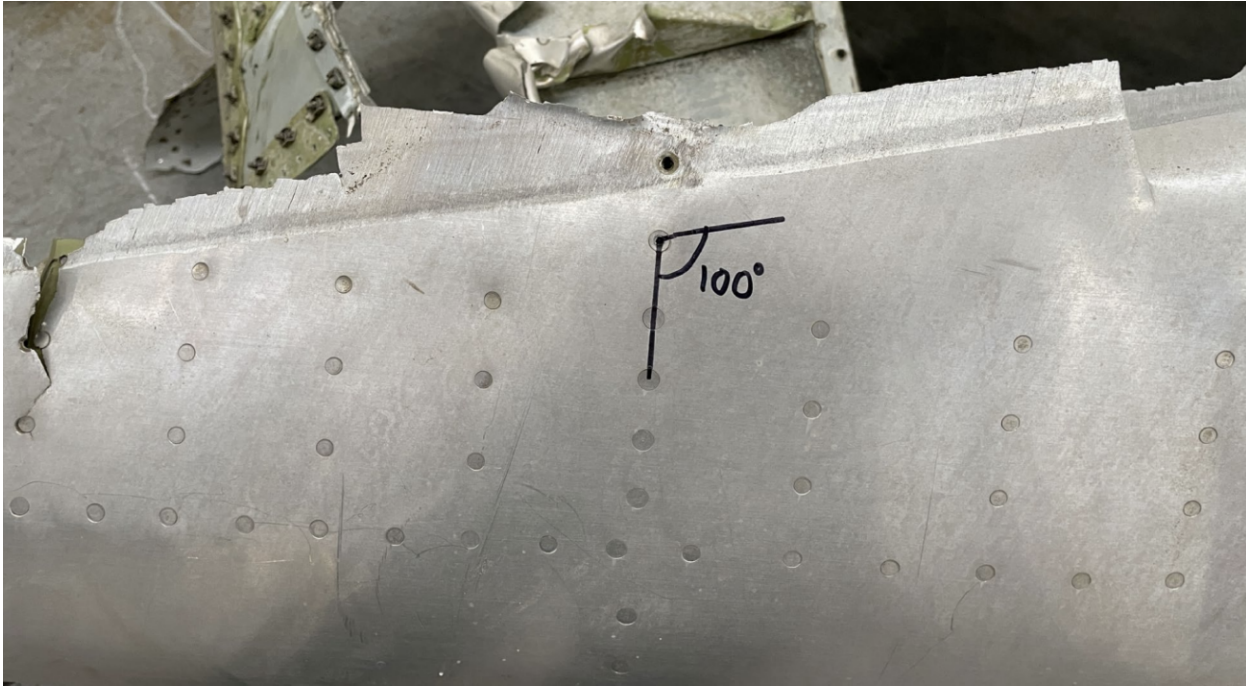
The inboard left wing between the airplane's centerline and wing station (WS) 178 was significantly fragmented. The upper portion of the left main landing gear remained attached to the left wing and the lower portion was separated; the outboard tire displayed a diagonal slash through all its layers. The outboard left wing from WS 178 to the wingtip was separated and recovered in the debris field. The inboard end of the left center slat displayed a linear slash mark about 52 inches long (see figure 6). The slat skin aft of the leading edge of the slash was

gouged and abraded linearly aftward. The left wing forward spar aft of the slat was also cut along the same diagonal line, and the interior wing structure was damaged and deformed aft and inboard. There was some black paint transfer on the interior wing structure.

Figure 6. Close up view of slash mark displayed on left outboard slat.

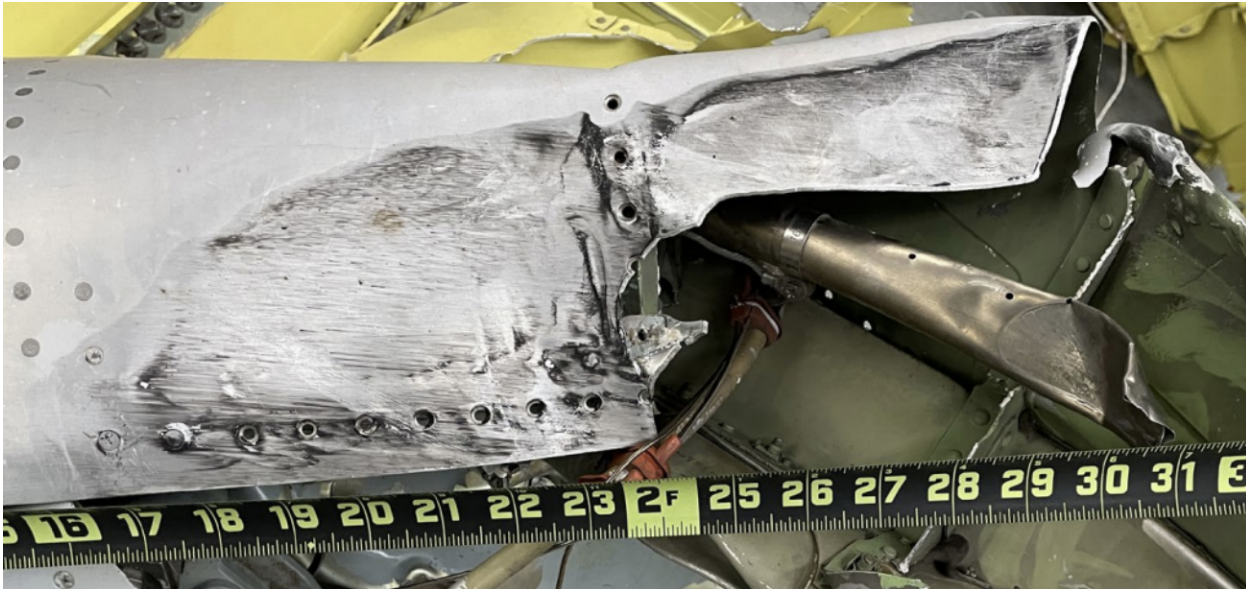
Two other sections of the inboard left slat displayed impact/denting and associated black paint transfer (see figure 7). Various pieces of fibrous materials were found in multiple sections of the airplane, including the left wing and vertical stabilizer. Samples of the fibrous material were collected for documentation and identification at the NTSB Materials Laboratory.

Figure 7. Close up view of impact mark on left inboard slat.
