# Aviation Investigation Preliminary Report

<b>Location:</b>	Nome, AK	<b>Accident Number:</b>	ANC25MA018
<b>Date &amp; Time:</b>	February 6, 2025, 15:20 Local	<b>Registration:</b>	N321BA
<b>Aircraft:</b>	TEXTRON AVIATION INC 208B	<b>Injuries:</b>	10 Fatal
<b>Flight Conducted Under:</b>	Part 135: Air taxi & commuter - Scheduled

On February 6, 2025, about 1520 Alaska standard time, a Textron Aviation (Cessna) 208B airplane, N321BA, operated as Bering Air flight 445, was destroyed when it was involved in an accident near Nome, Alaska. The pilot and nine passengers were fatally injured. The airplane was operated as a Title 14 *Code of Federal Regulations (CFR)* Part 135 scheduled commuter flight.

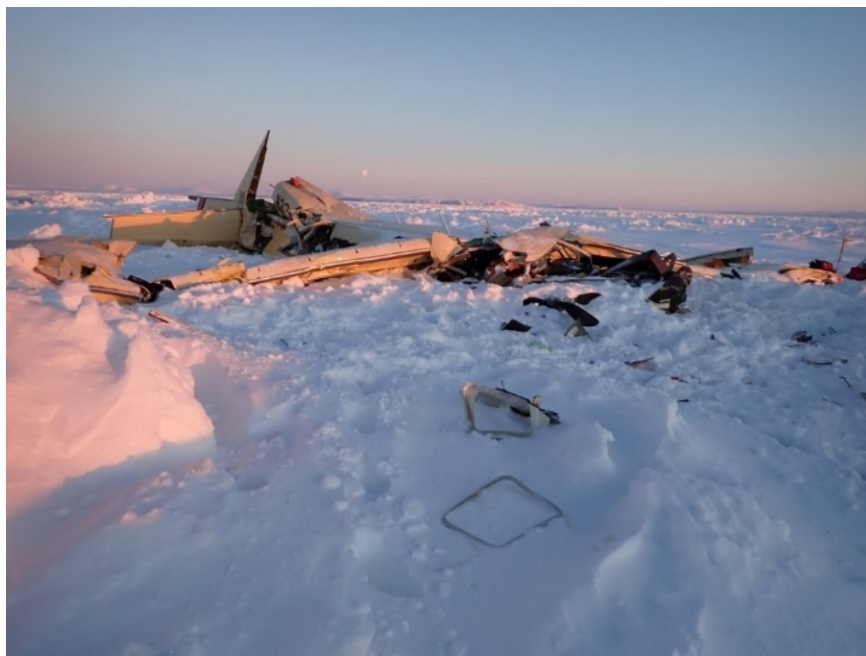
**Figure 1.** Accident site.

The airplane came to rest upright. The propeller assembly separated from the engine and was located adjacent to the wreckage. The engine cowling was dislocated and fragmented. The engine remained secured to the mount; however, both the engine assembly and the mount were damaged consistent with impact forces. The fuselage exhibited upward crushing damage along the entire length. Both wings were damaged, with the left wing being partially separated from the fuselage. Both wings exhibited leading-edge crushing damage along the entire spans. The outboard portion of the right wing was rotated aft and partially separated. An initial airframe examination revealed no evidence of an in-flight structural failure.

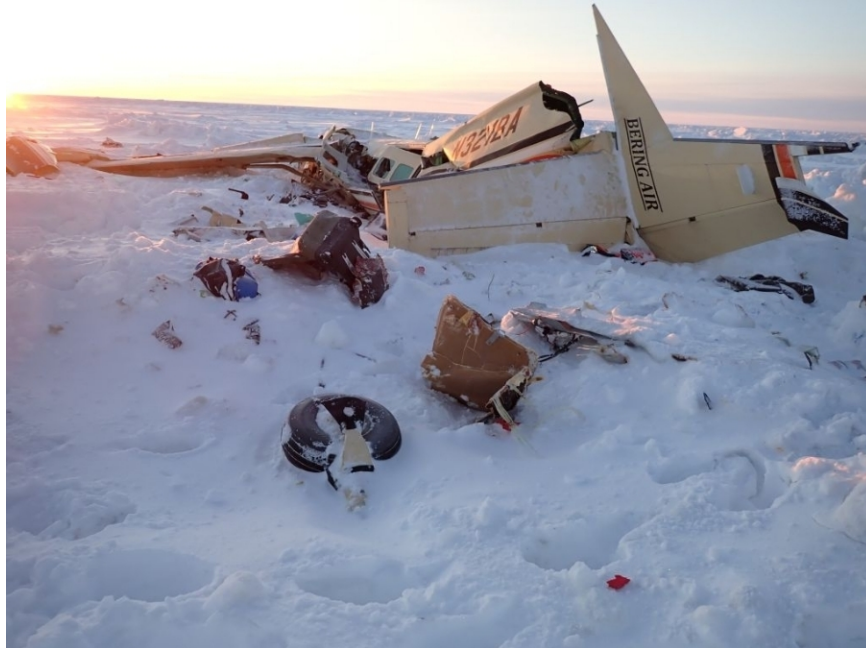
**Figure 2.** Accident site.

The flight control surfaces remained attached to the airframe. The ailerons remained attached to each wing at the hinges; however, they displayed similar damage to the wings. The wing flaps and spoilers remained attached. The horizontal and vertical stabilizers remained attached to the aft fuselage. The elevators and rudder remained attached to the stabilizers at the hinges. The outboard right elevator and the upper portion of the rudder were damaged. A preliminary examination of the flight control system revealed damage and control cable separations consistent with the impact sequence. The extension of the wing flap actuator was consistent with the wing flaps being retracted (up) at the time of the accident.

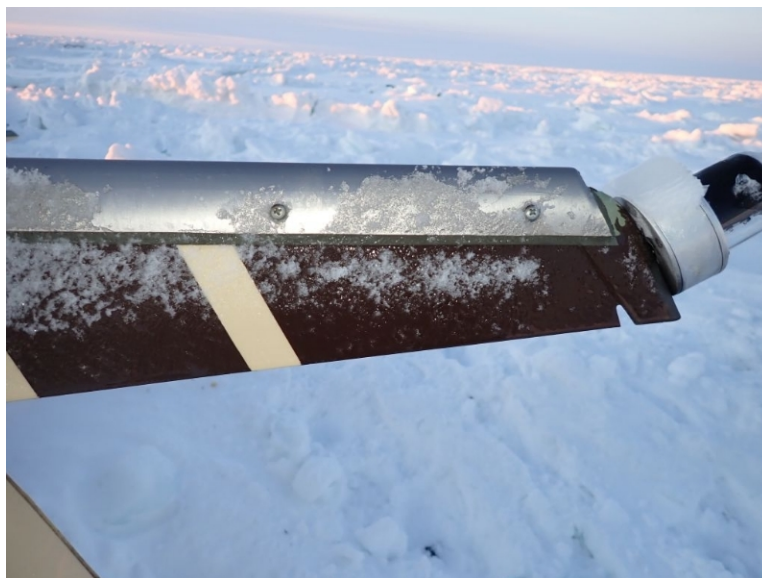
**Figure 3.** Vertical stabilizer at accident site.

Minor ice accumulation was observed on the leading-edge surfaces aft of the TKS porous membranes. Significant ice accumulation was observed on the base of the beacon/strobe light located at the top of the vertical stabilizer. A dusting of blown snow had accumulated on the airplane after the accident.
