Aviation Investigation Preliminary Report

Location:	Scottsdale, AZ	Accident Number:	WPR25FA088
Date & Time:	February 10, 2025, 14:38 Local	Registration:	N81VN
Aircraft:	GATES LEARJET CORP. 35A	Injuries:	1 Fatal, 3 Serious, 1 Minor
Flight Conducted Under:	Part 91: General aviation - Executive/Corporate

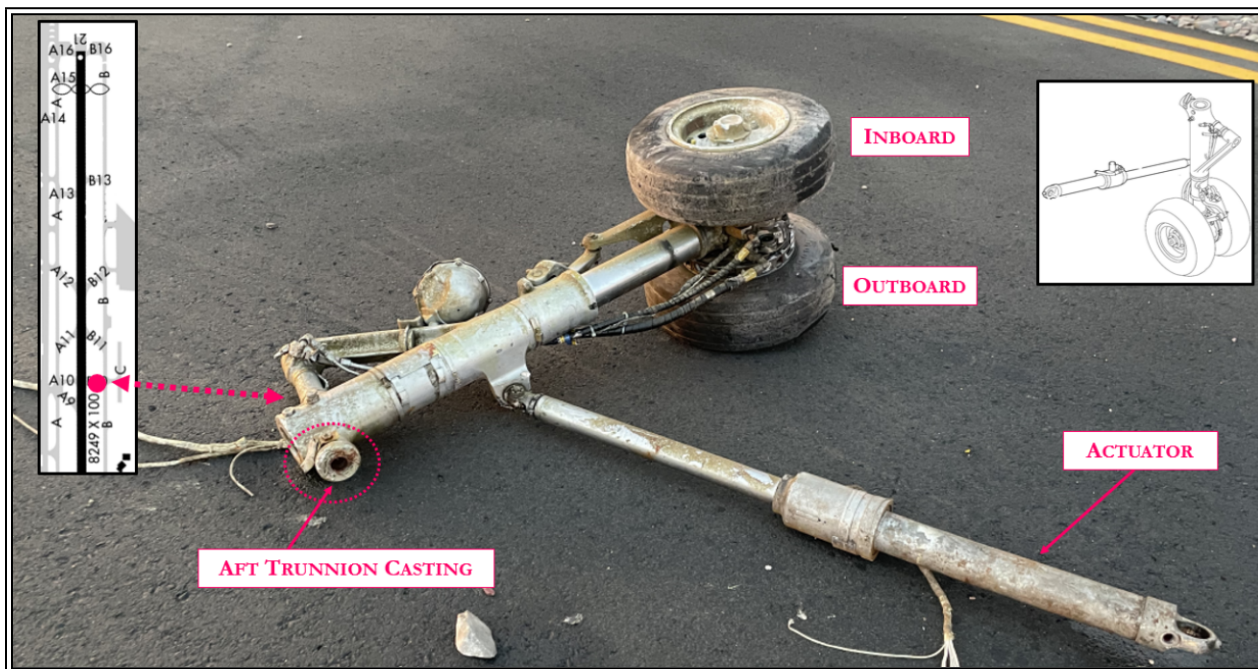
The left main landing gear came to rest on Taxiway Bravo 10 adjacent to Taxiway Bravo (see figure 5). The forward trunnion pin remained secured in the forward trunnion casting. The aft trunnion pin was

Figure 5: Left main landing gear at the accident site

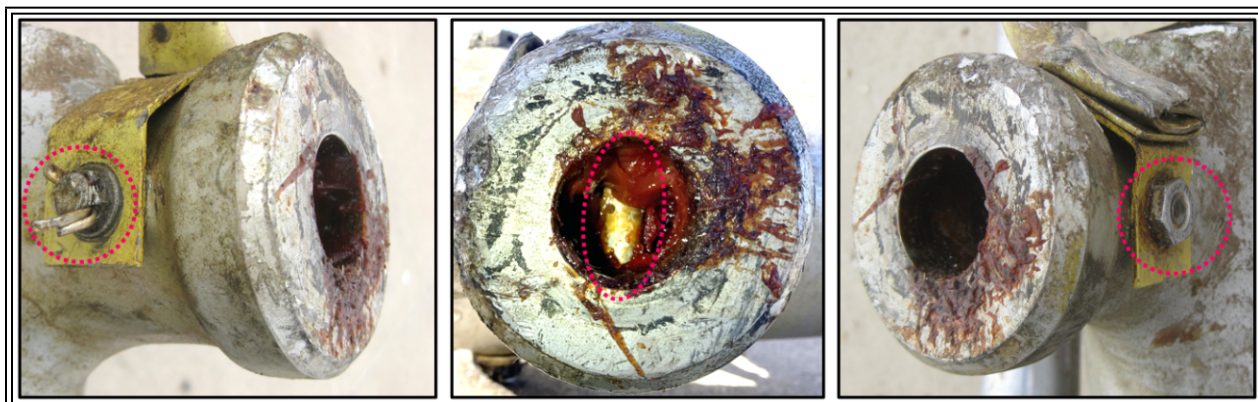
not present within the trunnion casting, though the retaining bolt with striker bracket was secured with the castle nut and cotter pin (see figure 6). The actuator remained connected to the strut, but the inboard attachment point was no longer fastened to the airframe. The right main landing gear remained attached to the airframe and was in the down and locked position with the outboard gear door separated and located within the debris field and the inboard door in the locked position.

Figure 6: Left main landing gear aft trunnion casting at the accident site
