Aviation Investigation Preliminary Report

Location:	Scottsdale, AZ	Accident Number:	WPR25FA088
Date & Time:	February 10, 2025, 14:38 Local	Registration:	N81VN
Aircraft:	GATES LEARJET CORP. 35A	Injuries:	1 Fatal, 3 Serious, 1 Minor
Flight Conducted Under:	Part 91: General aviation - Executive/Corporate

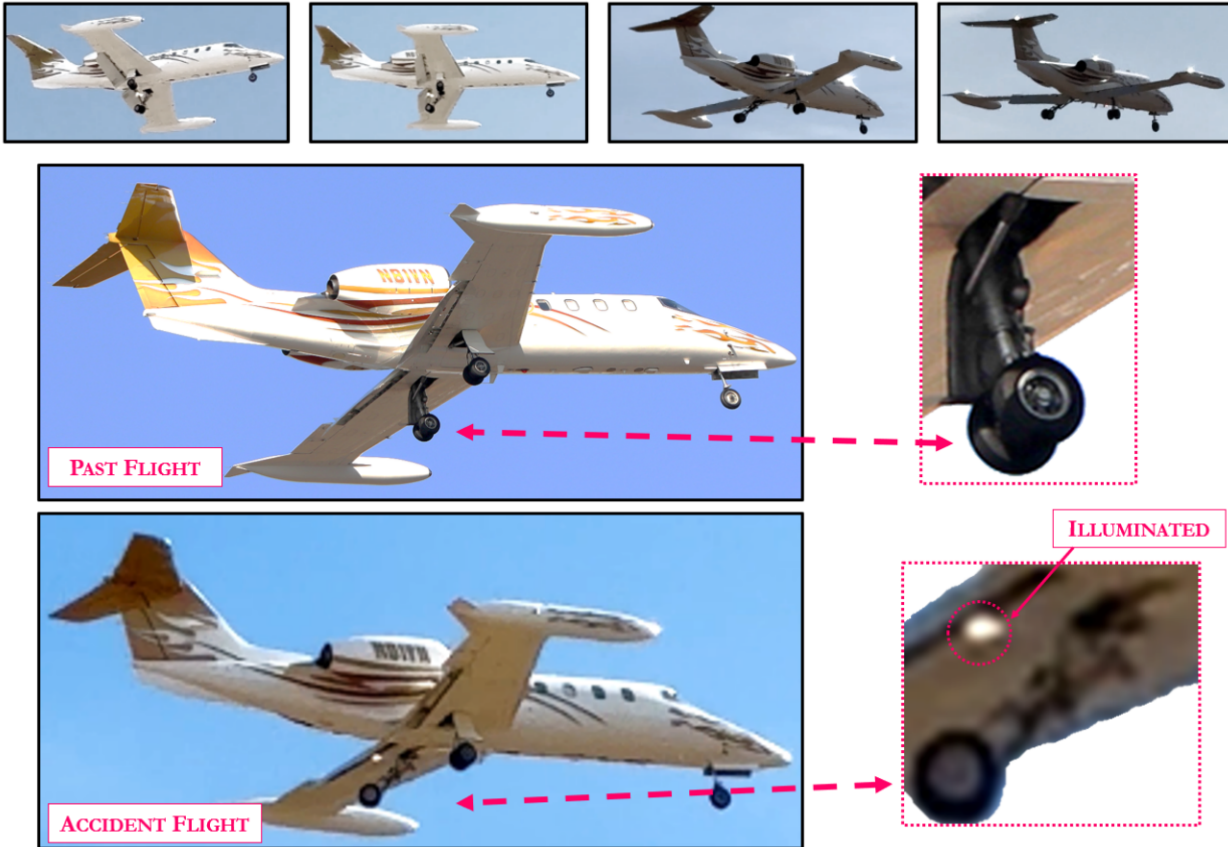
Investigators obtained security camera footage and numerous videos from personal cell phone cameras. A witness provided video taken from a golf course near the final approach path that captured the airplane for 11 seconds starting at 1437:52. The airplane can be seen on final approach with the left landing gear trailing aft from its normal position. Additionally, there is a circular bright spot seen above the landing gear strut, consistent with the landing gear light illuminating the bottom of the wing flap and the landing gear strut positioned facing aft (see figure 1).

Figure 1: Excerpts from a witness supplied video showing the left landing gear askew while on approach to the runway. (Past Flight Photo Source: www.jetphotos.com)
