Aviation Investigation Preliminary Report

Location:	Gladewater, TX	Accident Number:	CEN25LA096
Date & Time:	February 17, 2025, 22:15 Local	Registration:	N26071
Aircraft:	GRUMMAN AMERICAN AVN. CORP. AA-5A	Injuries:	1 Minor
Flight Conducted Under:	Part 91: General aviation - Personal

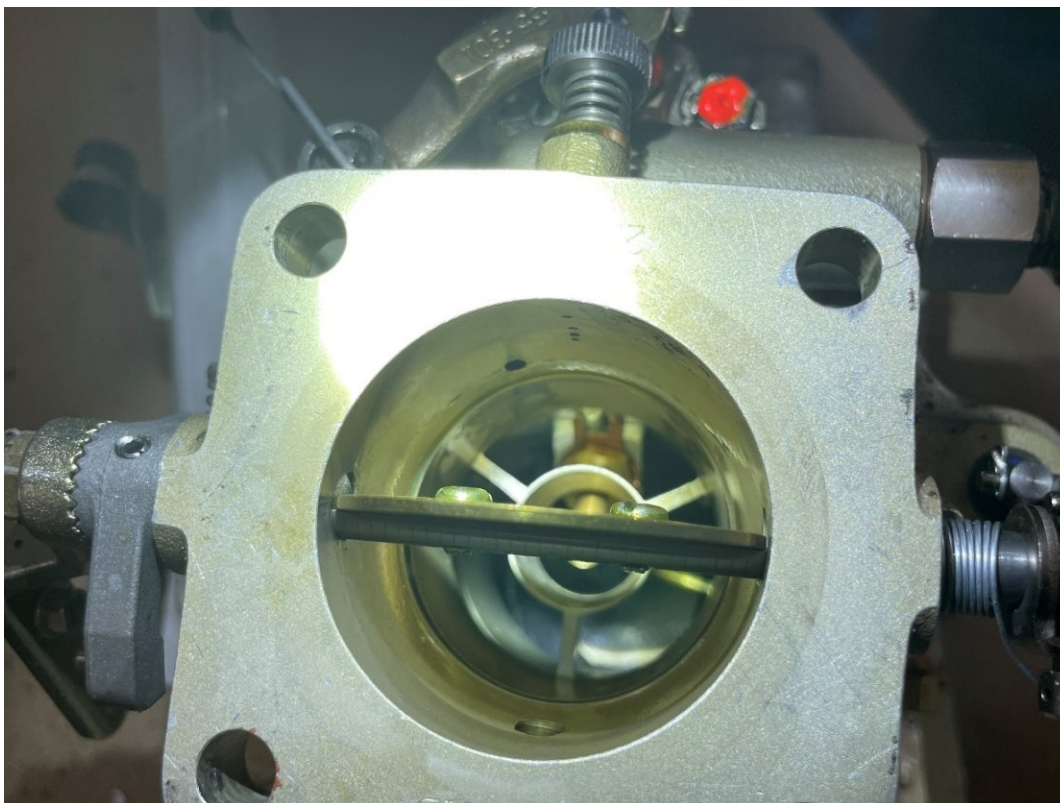
Postaccident examination of the engine revealed that the carburetor inlet rubber duct between the airbox and carburetor was puckered inward at both the airbox outlet and carburetor inlet. The puckering of the duct was observed to be partially blocking the carburetor venturi.

Figure 1. View through the carburetor.
