Aviation Investigation Preliminary Report

Location:	Chicago, IL	Occurrence Number:	DCA25LA141
Date & Time:	February 25, 2025, 08:48 Local	Registration:	N8517F (A1); N560FX (A2)
Aircraft:	Boeing 737-800 (A1); Bombardier BD-100-1A10 (CL-35) (A2)	Injuries:	142 None (A1); 3 None (A2)
Flight Conducted Under:	Part 121: Air carrier - Scheduled (A1); Part 91 subpart k: Fractional (A2)

On February 25, 2025, about 0848 central standard time (CST), Flexjet flight 560 (LXJ 560), a Bombardier Challenger 350 CL-35, registration N560FX and Southwest Airlines flight 2504 (SWA2504), a Boeing 737-800, registration N8517F, were involved in a runway incursion that resulted in SWA2504 performing a go-around at Chicago Midway International Airport (MDW), Chicago, Illinois.

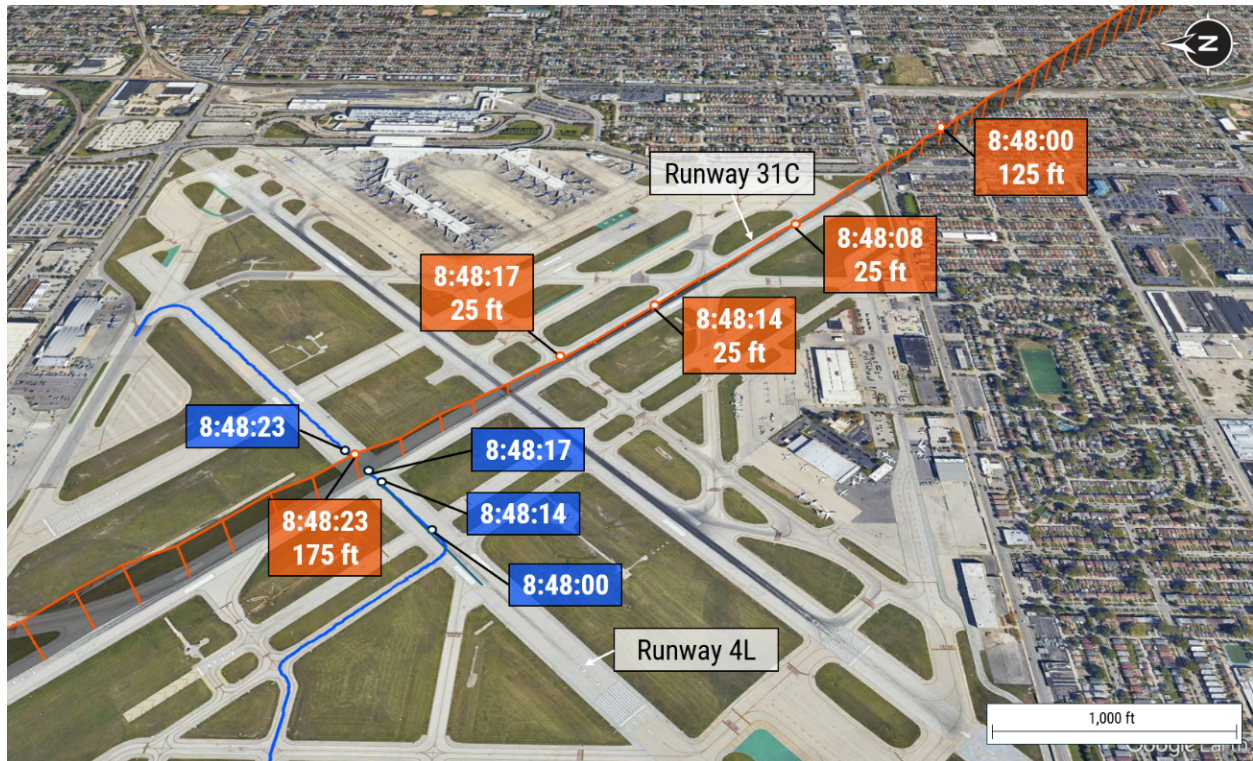
SWA2504 initiated the go-around while LXJ560 was crossing runway 31C. As LXJ560 cleared the active runway, SWA2504 passed less than 200 ft behind it (figures 1 and 2). SWA2504 subsequently made an uneventful landing a few minutes later. There was no damage to the involved airplanes and none of the 142 occupants aboard the SWA airplane and none of the 3 occupants on the Flexjet airplane were injured. LXJ560 was operating under the provisions of Title 14 *Code of Federal Regulations (CFR)* Part 91K as a flight from MDW to Tyson McGhee Airport (TYS), Alcoa, Tennessee. SWA2504 was operating under Title 14 *CFR* Part 121 as a regularly scheduled domestic passenger flight from Eppley Airfield (OMA), Omaha, Nebraska to MDW.

Figure 1. Flight paths for SWA2504 (orange) and ground path for LXJ560 (blue) with times and altitudes.

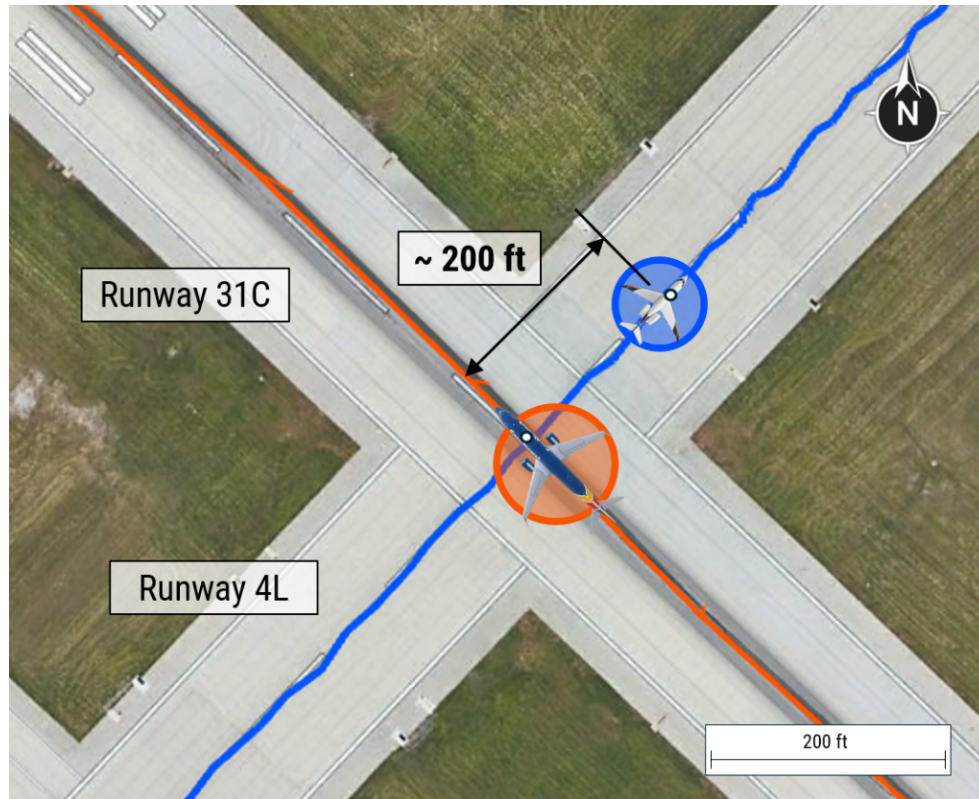
Figure 2. Flight paths for SWA2504 (orange) and ground path for LXJ560 (blue) showing minimum separation. The about 200 ft distance shown is the lateral distance between the approximate location of each airplanes' GPS antenna.

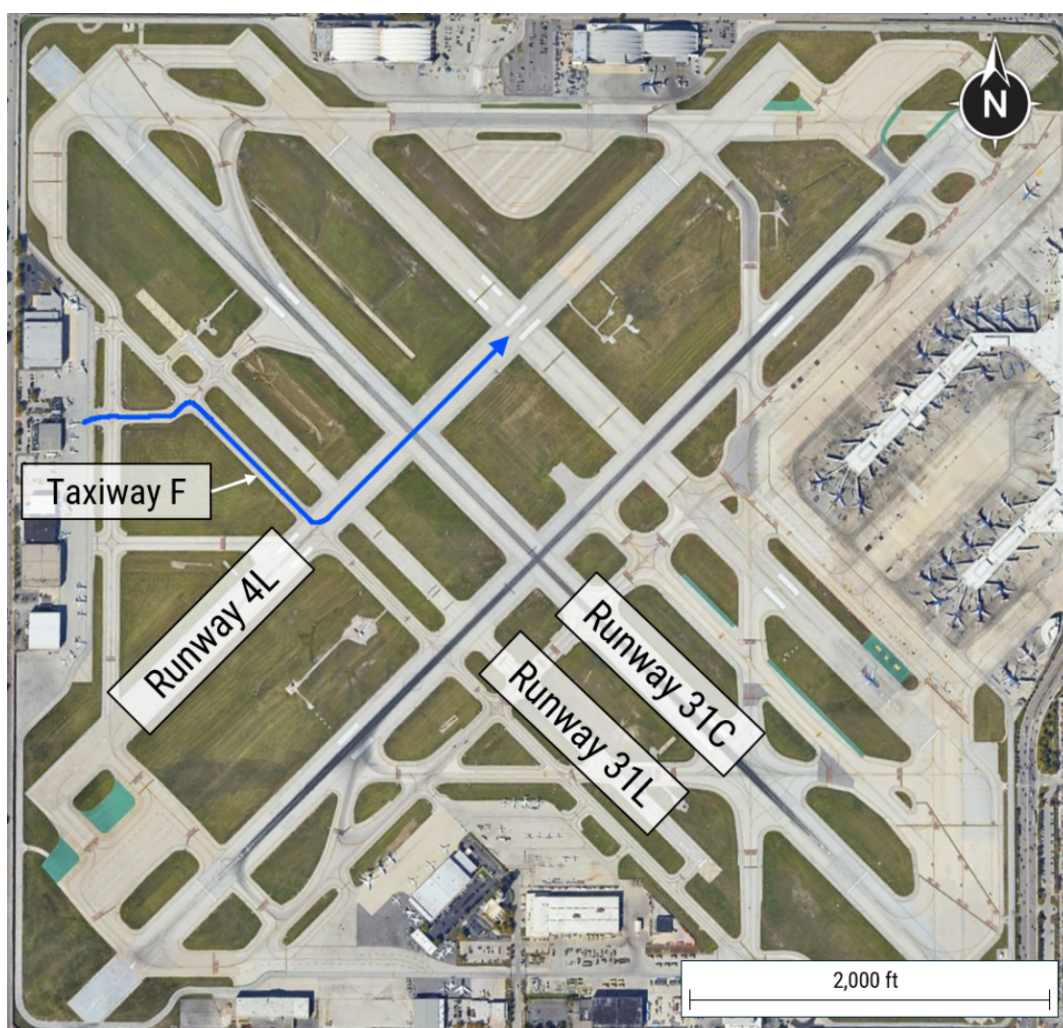
Figure 3. The blue line shows the taxi route for LXJ560.

According to postincident statements, the flight crew of LXJ560 indicated that as they turned left onto runway 4L/22R, the sun was impeding visibility from the right side of the aircraft, however they did not recall seeing any hold short line/pavement markings or any other signs for the 31L intersection as they taxied onto runway 04L/22R. They stated that taxiway F and runway 13R/31L were in close proximity to each other and by the time the nosewheel had straightened out, they were likely halfway across runway 13R/31L. They further stated that runway 13R/31L appeared to have a very similar width to taxiways and that they had not recognized it as a runway. The captain stated that as he approached runway 13C/31C he had thought it was runway 13R/31L. As they approached the runway intersection the crew stated they both looked to the left and to the right and did not observe the SWA airplane on final.

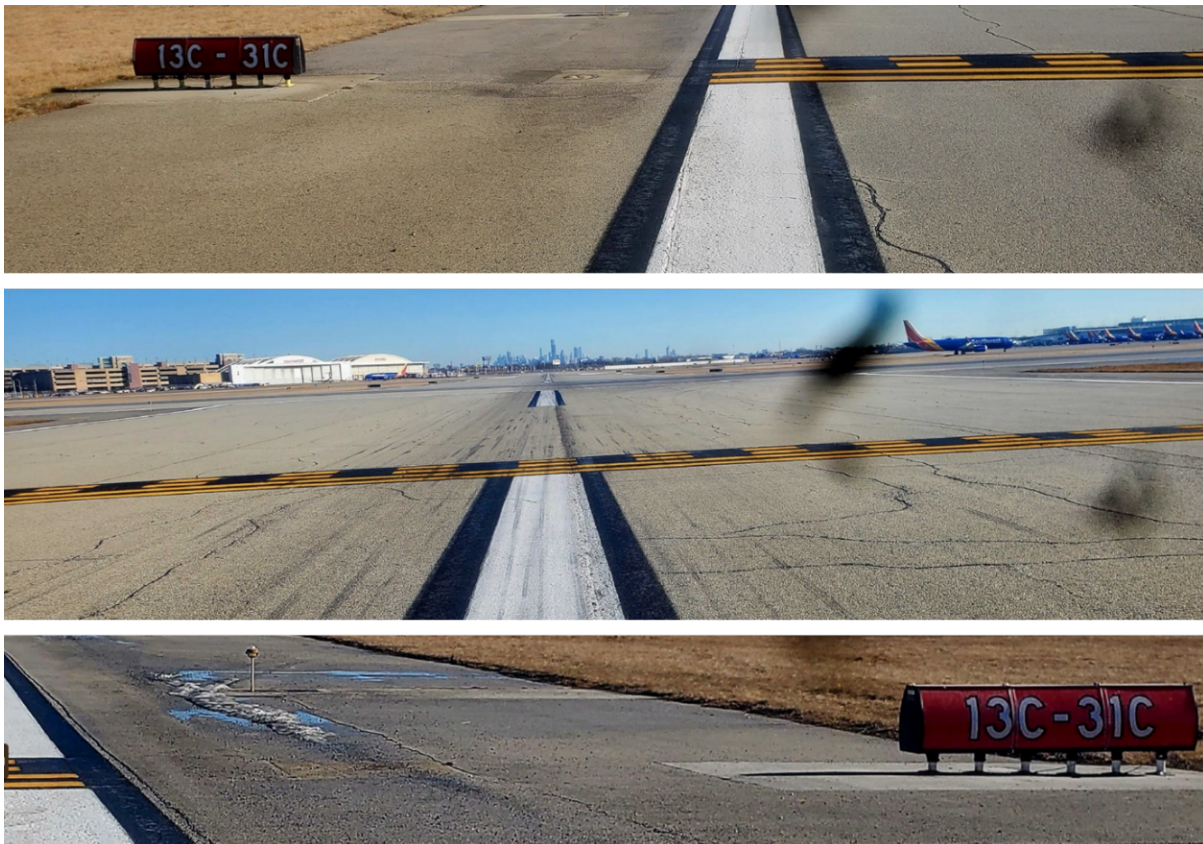
Certified ADS-B data and audio recordings were provided to the NTSB by the FAA. In addition, photos were provided by Midway Airport Operations of the runway environment showing the runway signs (vertical white-on-red signs erected on either side of the runway hold short position markings) and the hold short line for runway 13C/31C (figure 4).

Figure 4. Photos of the hold short line for runway 13C/31C (source – Midway Airport Operations)

The weather at the time of the incursion was winds from the northwest at 8 kts, better than 10 statute miles of visibility and clear skies. In addition, the sun was 22.4° above the horizon and from the intersection of runway 4L/22R and runway 13C/31C it was on an azimuth of 126°.
