Aviation Investigation Preliminary Report

Location:	Chicago, IL	Occurrence Number:	DCA25LA141
Date & Time:	February 25, 2025, 08:48 Local	Registration:	N8517F (A1); N560FX (A2)
Aircraft:	Boeing 737-800 (A1); Bombardier BD-100-1A10 (CL-35) (A2)	Injuries:	142 None (A1); 3 None (A2)
Flight Conducted Under:	Part 121: Air carrier - Scheduled (A1); Part 91 subpart k: Fractional (A2)

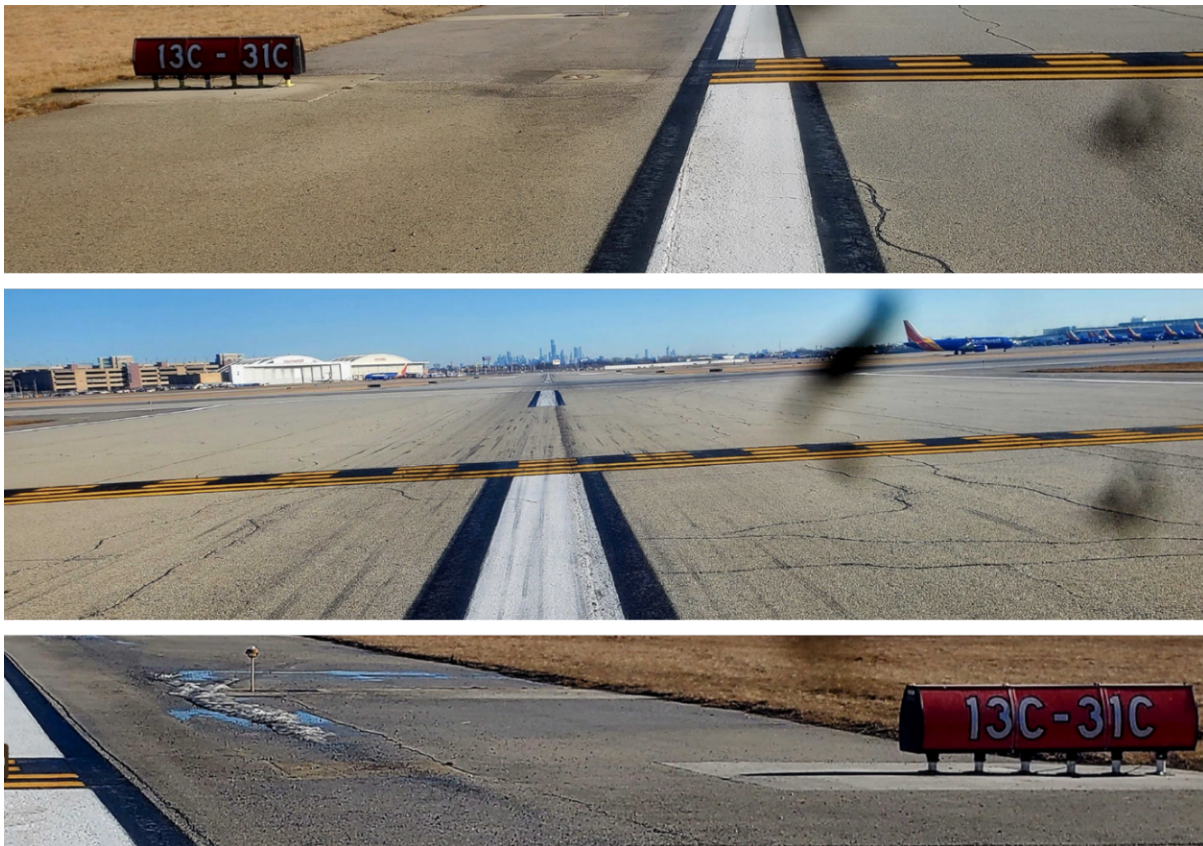
Certified ADS-B data and audio recordings were provided to the NTSB by the FAA. In addition, photos were provided by Midway Airport Operations of the runway environment showing the runway signs (vertical white-on-red signs erected on either side of the runway hold short position markings) and the hold short line for runway 13C/31C (figure 4).

Figure 4. Photos of the hold short line for runway 13C/31C (source – Midway Airport Operations)

The weather at the time of the incursion was winds from the northwest at 8 kts, better than 10 statute miles of visibility and clear skies. In addition, the sun was 22.4° above the horizon and from the intersection of runway 4L/22R and runway 13C/31C it was on an azimuth of 126°.
