Aviation Investigation Preliminary Report

Location:	Cape Fair, MO	Accident Number:	CEN25FA151
Date & Time:	April 10, 2025, 09:04 Local	Registration:	N83952
Aircraft:	Aeronca 7AC	Injuries:	1 Fatal, 1 Serious
Flight Conducted Under:	Part 91: General aviation - Personal

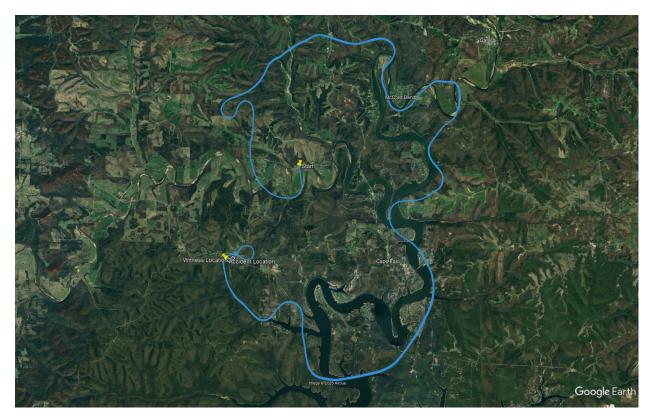
Figure 1. Entire flight path of airplane.

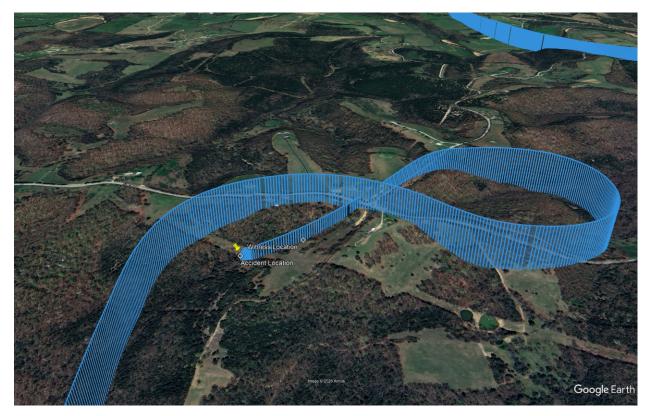
Figure 2. The final portion of the accident flight.
