# Aviation Investigation Preliminary Report

| <b>Location:</b> | Hampton, VA | <b>Accident Number:</b> | ERA25FA185 |
| <b>Date &amp; Time:</b> | April 24, 2025, 11:35 Local | <b>Registration:</b> | N530RH |
| <b>Aircraft:</b> | MX AIRCRAFT TECH PTY LTD MXS | <b>Injuries:</b> | 1 Fatal |

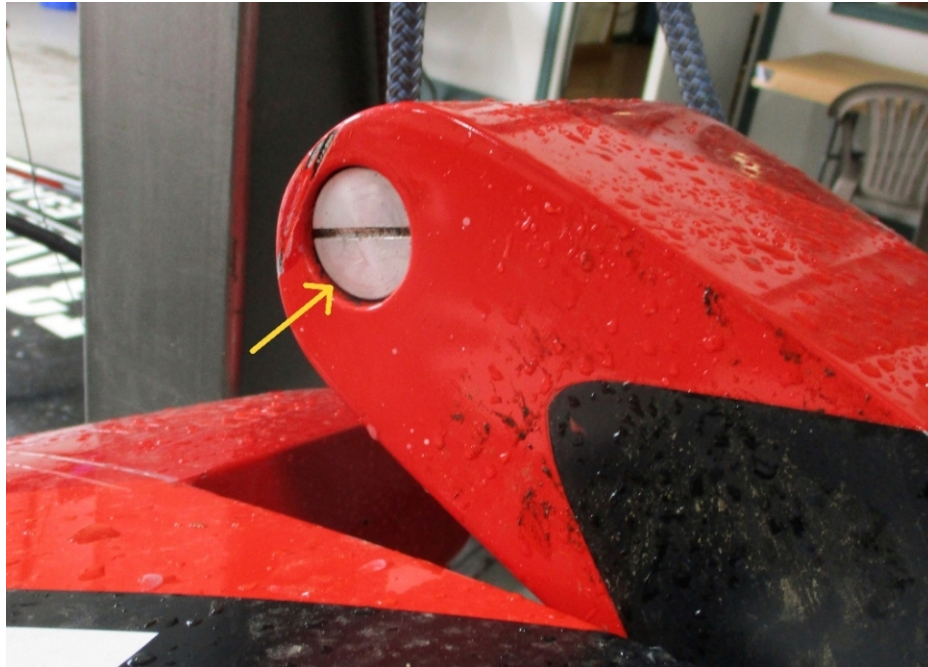
The single-seat aerobatic airplane, serial number MXS-001, was issued a special airworthiness certificate in the experimental category for the purpose of exhibition and air racing by the Federal Aviation Administration (FAA) on July 26, 2019. The pilot collaborated with the manufacturer to modify the airplane to his specifications, which included an access hole on the left and right elevator to insert counterweights to adjust elevator feel depending on the aerobatic routine performed. An aluminum threaded plug was used to access the counterweight hole (figure 1).

Figure 1. Counterweight plug as installed on the right elevator (postaccident photograph).

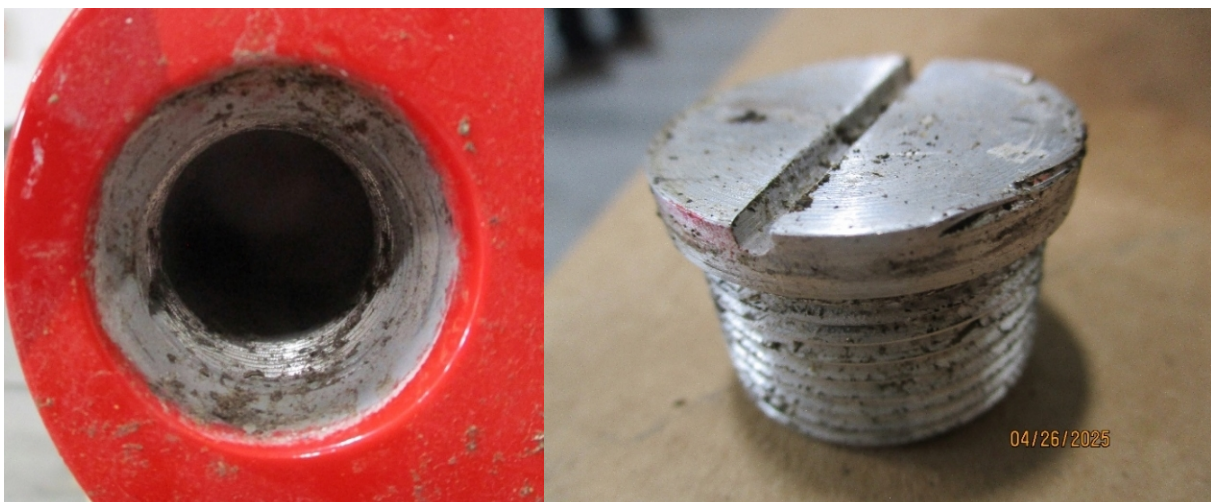
The airplane came to rest on a heading of 150° in a grass ditch about 100 ft from the left side of runway 08 and 500 ft beyond the approach threshold. All major components of the airplane were accounted for at the accident site. The left elevator counterweight plug was not installed and was located about 10 ft behind the wreckage in the grass. Dirt consistent with that found in the vicinity of the accident site was identified on the elevator, as well as in the counterbore and threaded area where the counterweight plug would have been installed. The counterweight plug threads were intact and also contained similar dirt contamination consistent with that found on the elevator. Additionally, about half of the circumference of the left elevator counterweight plug displayed gouging and there was evidence of paint transfer (figure 2).

Figure 2. Left elevator counterweight installation hole (left) and recovered counterweight plug (right). Note: gouging and paint transfer on counterweight plug.

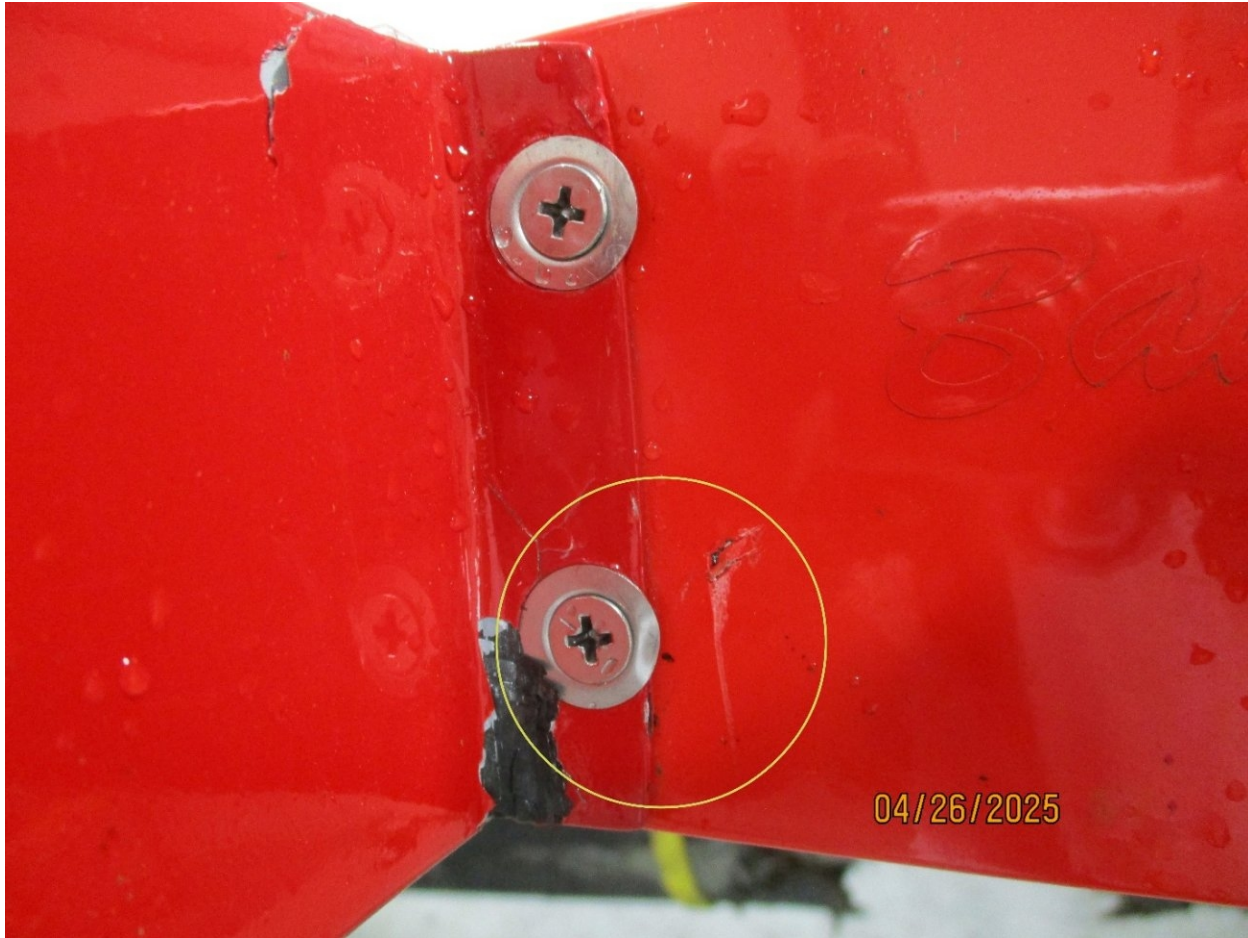
The horizontal stabilizer structure adjacent to the elevator position where the counterweight plug would have been installed displayed dents and paint scrapes consistent with contact with the counterweight plug (figure 3).

Figure 3. Horizontal stabilizer structure adjacent to the left elevator counterweight plug. Note: dented washer and scrapes, circled in yellow.
