Aviation Investigation Preliminary Report

Location:	Kearney, MO	Accident Number:	CEN25FA346
Date & Time:	August 27, 2025, 11:58 Local	Registration:	N888MT
Aircraft:	Cessna 340	Injuries:	2 Fatal
Flight Conducted Under:	Part 91: General aviation - Personal

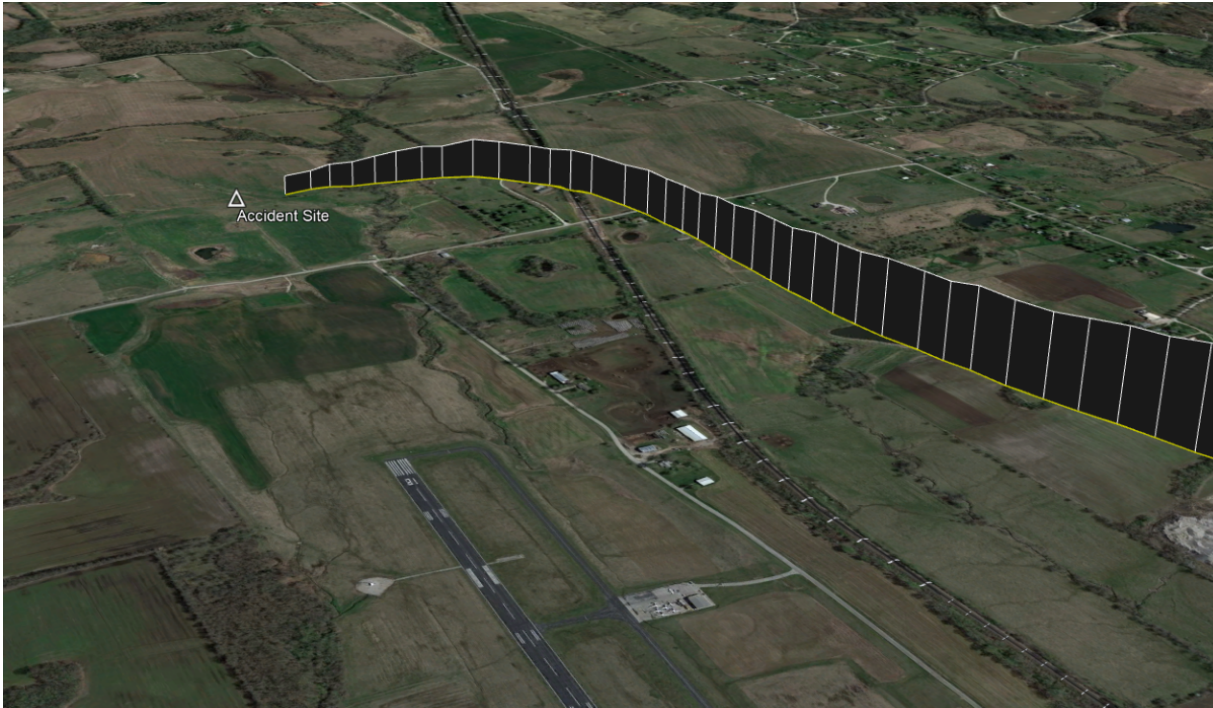
Figure 1 ADS-B and Accident Site

ADS-B data showed that the airplane departed the Washington Regional Airport (KFYG), Washington, Missouri, about 1057, and cruised at 4,500 ft mean sea level towards the Midwest National Air Center Airport (KGPH), Mosby, Missouri. About 25 miles from the airport, the airplane descended and entered the traffic pattern for a left base turn. The airplane's altitude was lower than normal for a standard traffic pattern and continued to descend.

The airplane impacted an uncultivated soybean field about 0.6 miles from the approach end of runway 18. The initial impact point consisted of ground scars consistent with the left wing and airplane nose. A divot in the ground made by the right engine contained the right propeller assembly which had fractured at the crankshaft. The debris field was about 95 ft long, orientated along a 225° magnetic heading. The main wreckage consisted of the remainder of the airplane, to include the fuselage, empennage, tail section, both wings, both engines, and the left propeller. The main wreckage was aligned on a 120° magnetic heading. A postimpact fire had consumed a large portion of the fuselage.
