# Aviation Investigation Preliminary Report

<b>Location:</b>	Monroe, WI	<b>Accident Number:</b>	CEN26FA050
<b>Date &amp; Time:</b>	November 24, 2025, 23:13 UTC	<b>Registration:</b>	N700PT
<b>Aircraft:</b>	Socata TBM 700	<b>Injuries:</b>	2 Fatal
<b>Flight Conducted Under:</b>	Part 91: General aviation - Personal

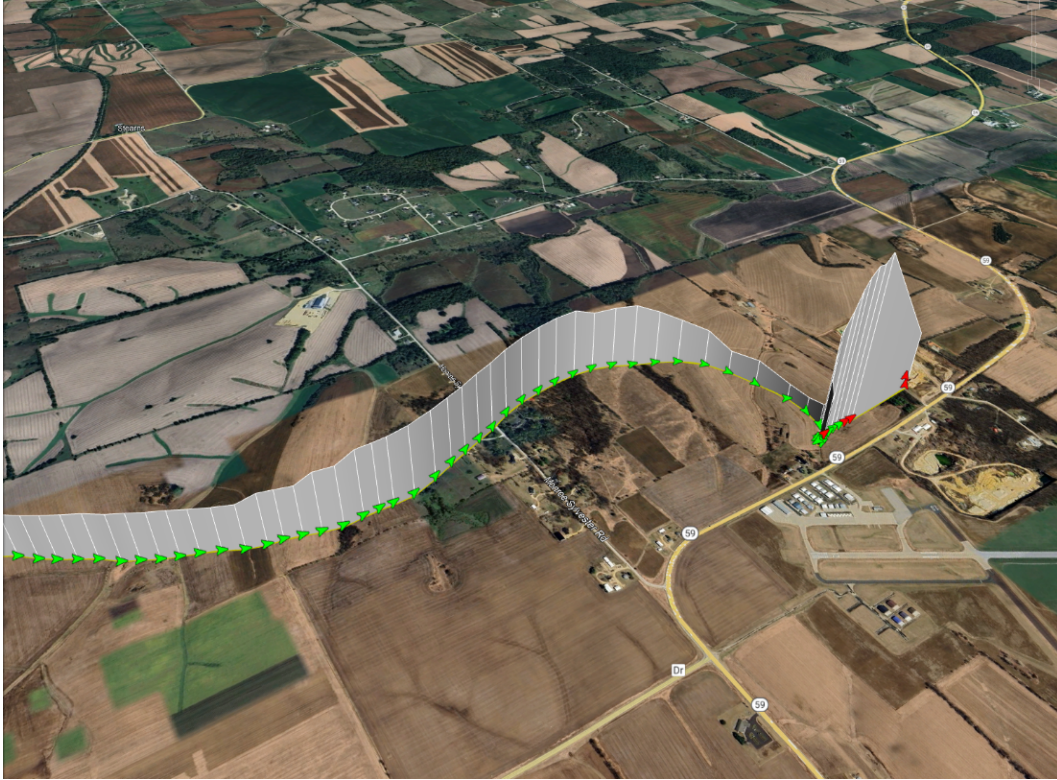
Figure 1. ADS-B Flight Track

A witness at the airport reported that he heard the airplane increase engine power for a missed approach and he began searching for it in the fog. Shortly after the power up, he witnessed a bright orange glow and heard a loud explosion. Review of ADS-B data showed the airplane on a track of 121°, at an altitude of 1,500 ft MSL, and a ground speed of 110 knots crossing the RNAV 12 Visual Decent Point (VDP). The airplane then started a left turning climb to 1,800 ft msl to a track of 067° while increasing ground speed to 146 knots. The airplane continued to increase ground speed to 188 knots while entering a right turning decent to 1,100 ft MSL before starting a rapid right 270° climbing turn to an altitude of 3,000 ft msl (see Figure 1).

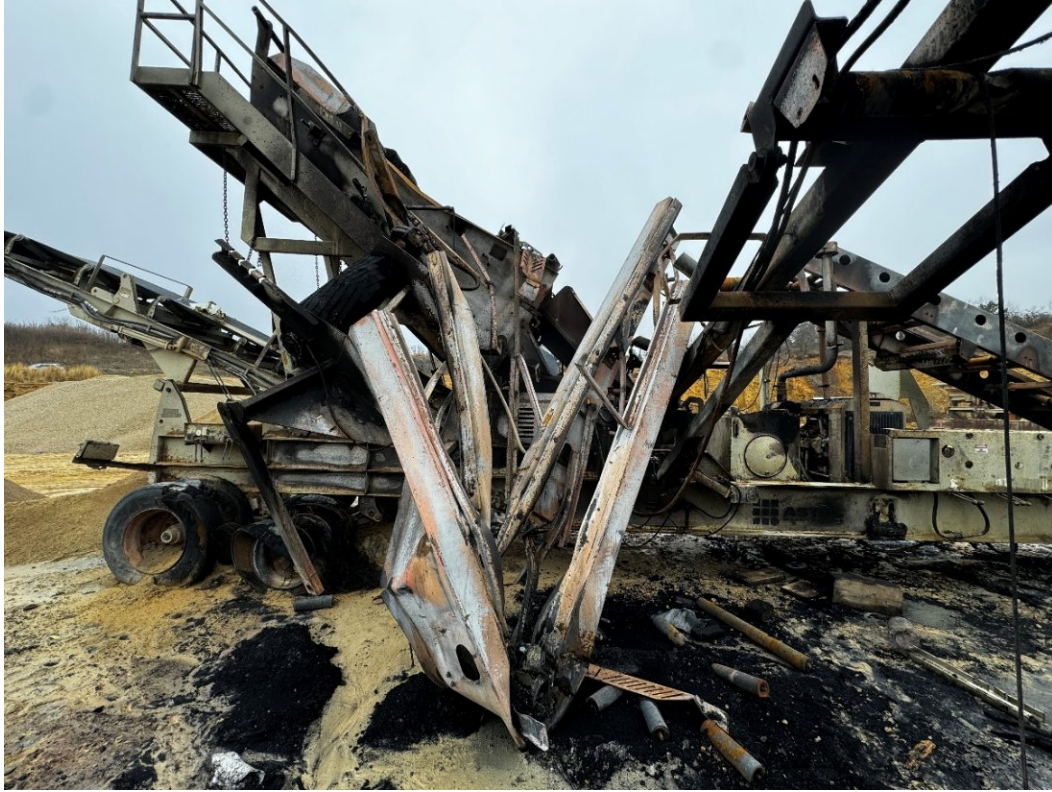
Figure 2. Rock Shaker Table

The airplane subsequently impacted mining equipment inside a gravel quarry about 0.5 nautical miles north of the airport. An initial impact point was the airplane's right wing embedded in an elevated rock shaker table mounted on a semi-trailer (see Figure 2).

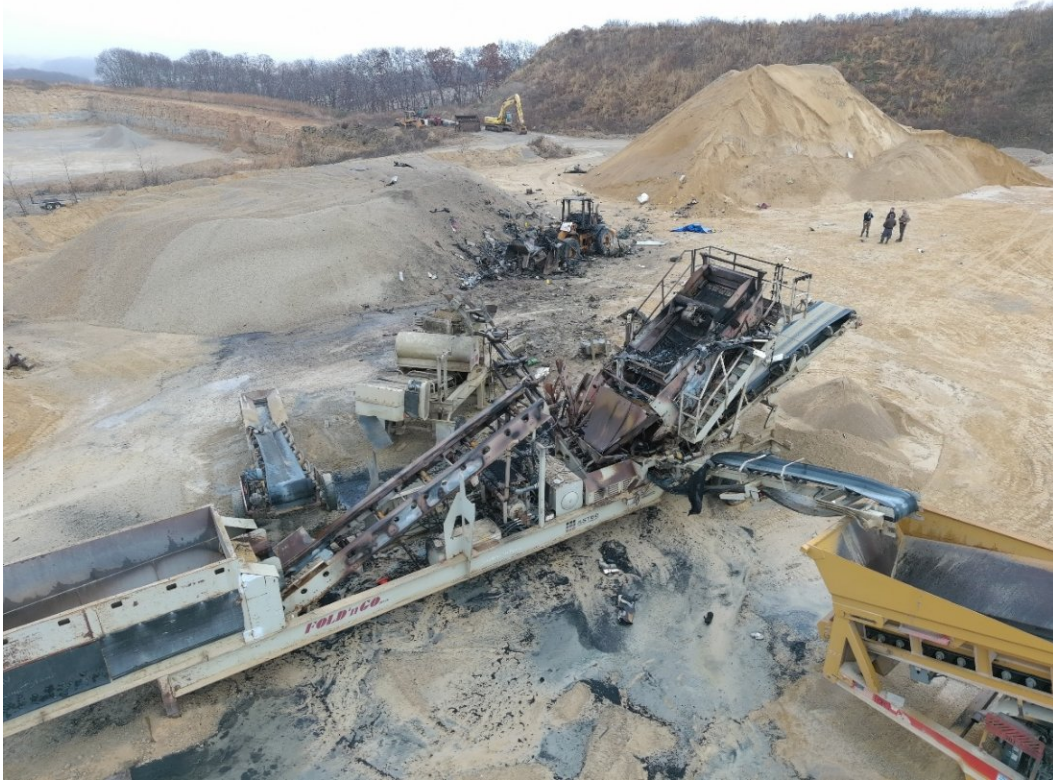
Figure 3. Debris Field from direction of travel

The airplane continued through another portable rock crusher and impacted a parked mine wheel loader which resulted in fragmentation of the airframe. Witness marks and impact damage on the portable mining equipment was consistent with a nose down high-speed impact. The debris field was about 300 ft in length and 200 ft in width on a heading of about 062° with evidence of an explosion and postaccident fire (see Figure 3).

Post accident examination of the debris field showed that the flaps and landing gear were in the retracted position. The PT6A-64 turboprop engine was found separated and fragmented through out the debris field. The turbine discs from the power section were located and found with all turbine blades fractured from the hub consistent with power at impact.
