# Aviation Investigation Final Report

<b>Location:</b>	Jackson, Wyoming	<b>Incident Number:</b>	DCA081A044
<b>Date &amp; Time:</b>	February 25, 2008, 21:16 Local	<b>Registration:</b>	N442UA
<b>Aircraft:</b>	Airbus Industrie A320	<b>Aircraft Damage:</b>	Minor
<b>Defining Event:</b>	Sys/Comp malf/fail (non-power)	<b>Injuries:</b>	1 Minor, 124 None
<b>Flight Conducted Under:</b>	Part 121: Air carrier - Scheduled

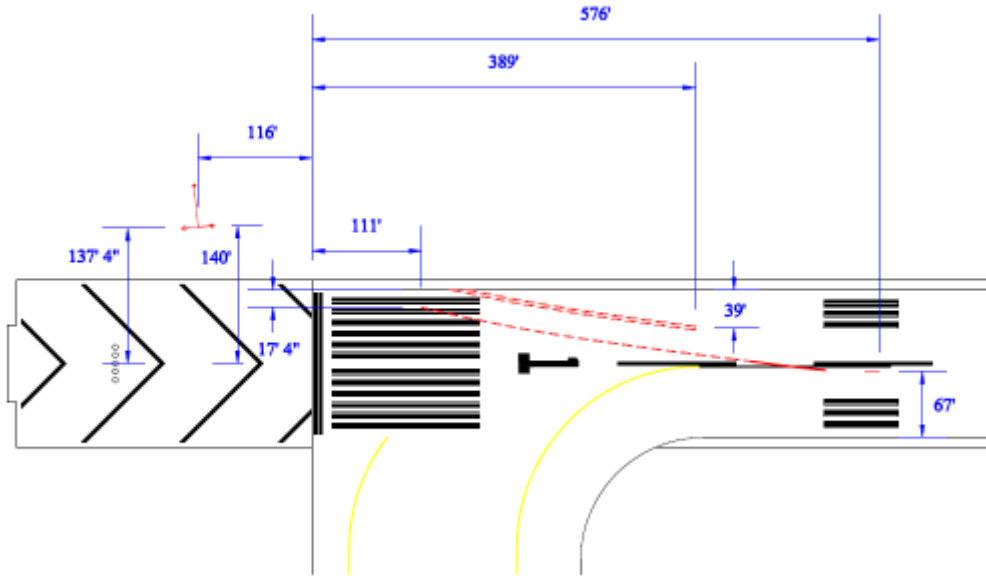
*Figure 1 – Diagram of Skid Marks*

Examination of the runway revealed distinct rubber transfer marks leading to an area of disturbed snow on the right side of the runway (Figure 1). The longest of the rubber transfer marks began about 576 feet from the departure threshold of runway 19 (or the approach threshold of runway 1) and 67 feet from the left runway edge and arced to the right. The mark was very light for the first 55 feet then became very heavy for 76 feet followed by 332 feet of light markings (as measured along the mark). The mark stopped about 111 feet from the threshold and 17 feet, 4 inches from the right runway edge. The heavy mark crossed the centerline at an angle of about 31 degrees. A second set of two light rubber transfer marks began about 389 feet from the threshold and 39 feet from the right runway edge. The two marks were parallel and separated by about 40 inches. The marks ended at the disturbed snow at the right runway edge. At the edge of the runway there were three sets of parallel tracks through the snow consistent with the landing gear wheels on the airplane. The center of the right main landing gear (RMLG) tracks was 149 feet from the threshold, the center of the nose landing gear (NLG) tracks was 99 feet from the threshold, and the center of the LMLG tracks was 36 feet from the threshold. The perpendicular distance between the centers of the tracks was 13 feet, 9 inches between the LMLG and NLG and 10 feet, 3 inches between the RMLG and NLG.

The airplane came to rest in the snow on the right side of the overrun area. The two RMLG and two NLG tires each left distinct impressions with tread ribs in the soil and snow where they came to rest. The LMLG outboard tire left a distinct impression with tread ribs while the inboard tire left only a light impression. The center of the RMLG was 140 feet from the extended centerline, the center of the LMLG was 137 feet, 4 inches from the centerline, and the center of the NLG was 42 feet, 2 inches forward of a line connecting the center of both MLG. The distance between the RMLG and LMLG was 28 feet. A point midway between the MLG (airplane centerline) was 116 feet beyond the threshold.

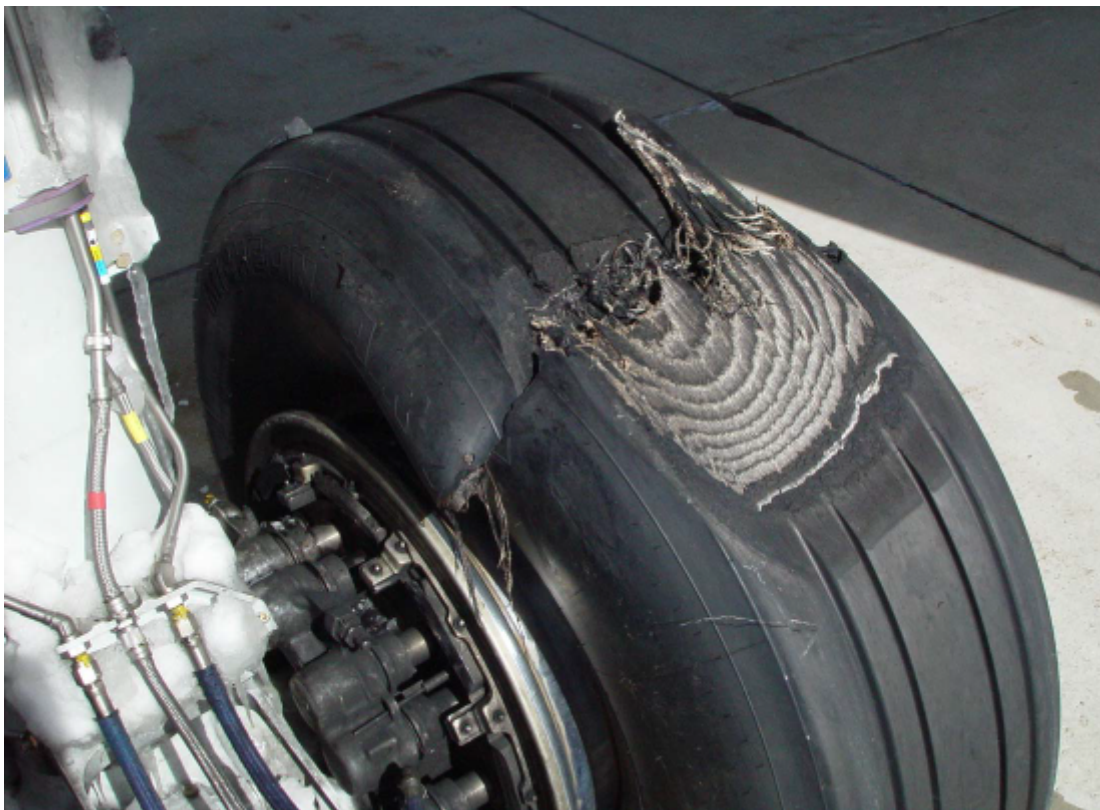
*Figure 2– LMLG Inboard Tire*

There were no faults logged in the maintenance systems that were relevant to the antiskid or brake systems, however, the inboard (IB) and outboard (OB) tachometer wires on the left main landing gear (LMLG) were found to be cross connected. With the wires crossed connected, when the IB tire began to skid (stop rotating) the Brake Steering and Control Unit (BSCU) would have commanded a reduction in the hydraulic pressure to the OB brake, instead of the IB brake, causing a loss of braking on the OB wheel. At the same time, the BSCU would have continued to command an increase in hydraulic pressure to the IB brake, causing it to fully skid and fail. Therefore, when the captain applied full manual braking, the braking action on the LMLG was almost fully lost while the right MLG braking remained normal, resulting in the airplane veering to the right and exiting the runway.

The National Transportation Safety Board determines the probable cause(s) of this incident to be: the loss of braking action on the left main landing gear due to the cross connection of the wheel speed tachometer wires that was caused by inadequate maintenance performed on the airplane during the installation of the main landing gear.

Snow and ice was packed around all of the landing gear and up into the wheel well. The LMLG inboard tire exhibited a large flat spot with a rupture through the aft end from sidewall to sidewall (Figure 2). The LMLG outboard tire was intact with some minor abraded areas on the center tread rib. The RMLG tires were intact with some minor abraded areas on the center rib and some small cuts in the shoulder area. There was no other obvious damage to the landing gear.
